**The first home of the
NorCal Collaborative (NCC)**

Ellen & George Beeler

Live/Work Building Rehabilitation

CASE STUDY

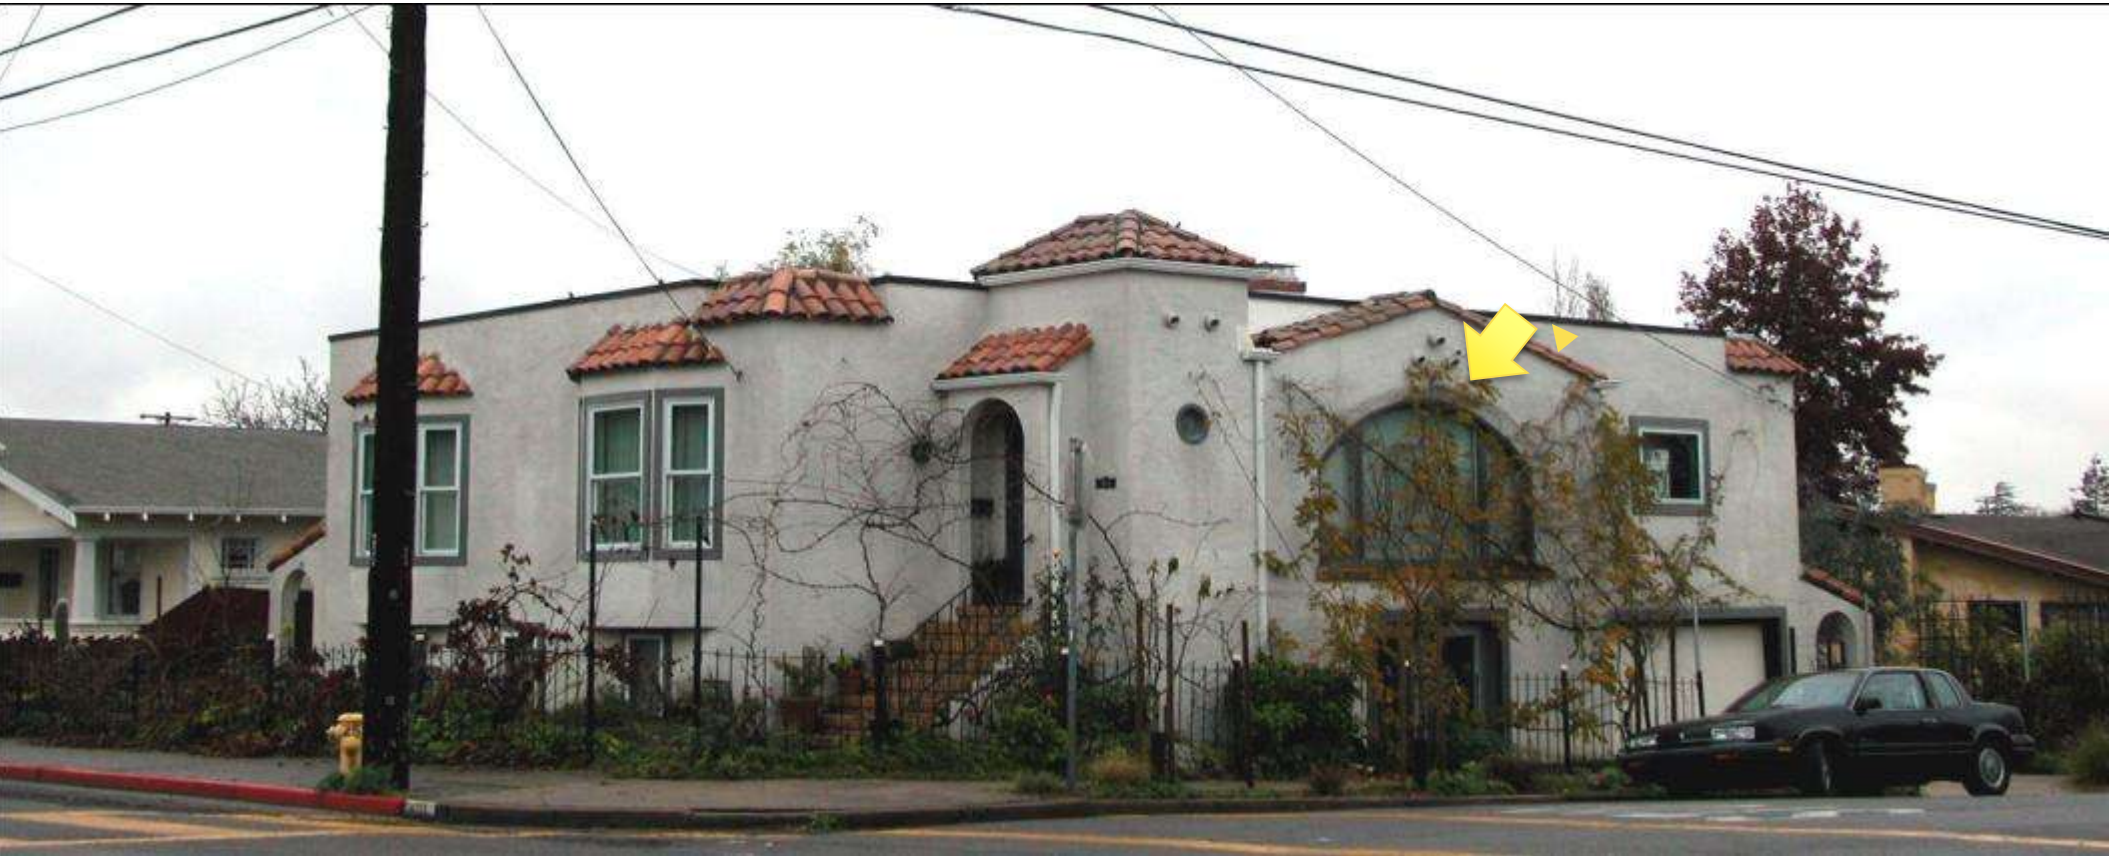
Pre-renovation of 2005

The deciduous wisteria vine on cable trellis provides good summer shading on the arched southeast window, but leaves hang on until December so solar heating is compromised

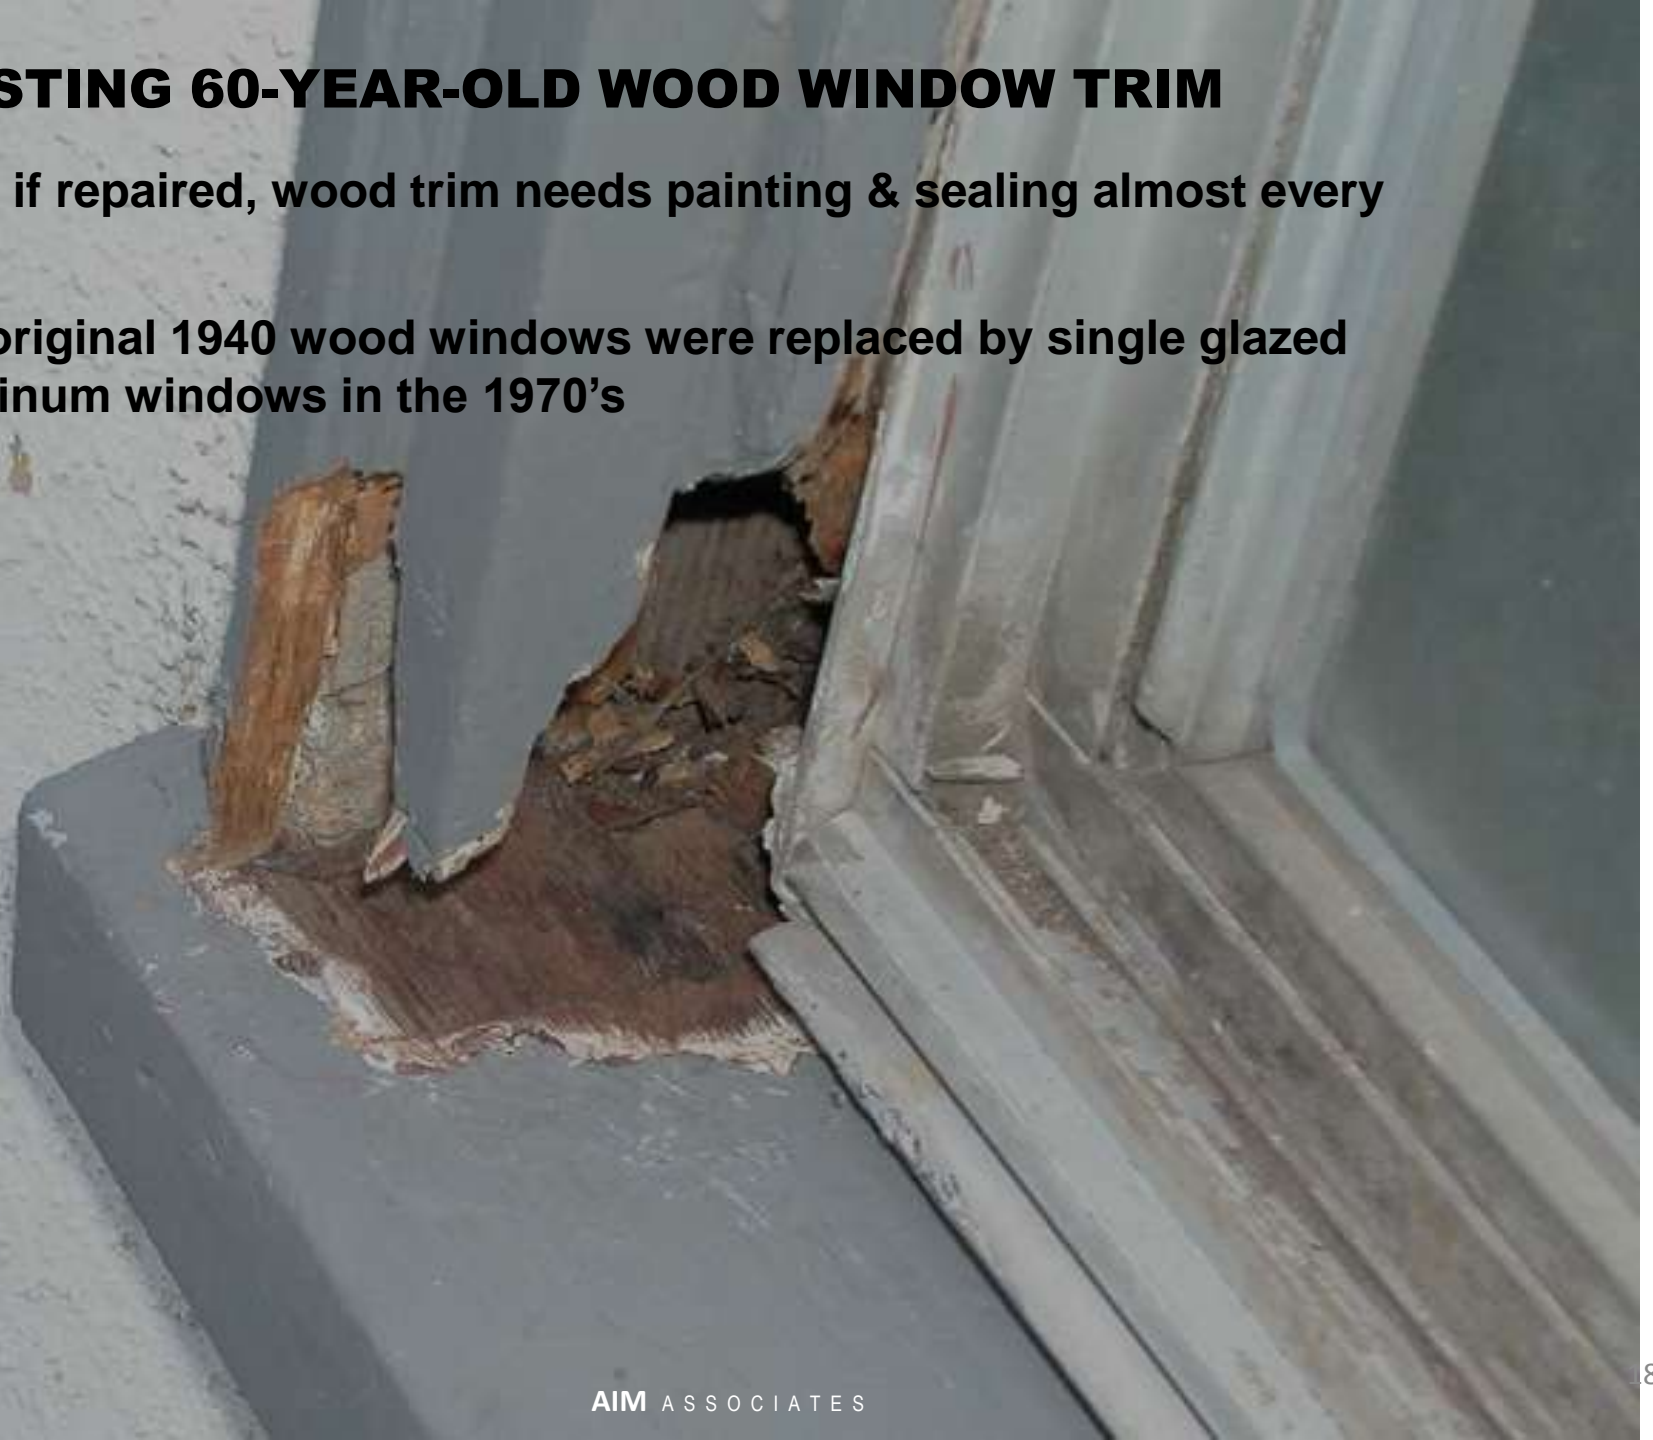
EXISTING 60-YEAR-OLD WOOD WINDOW TRIM

Even if repaired, wood trim needs painting & sealing almost every year

The original 1940 wood windows were replaced by single glazed aluminum windows in the 1970's

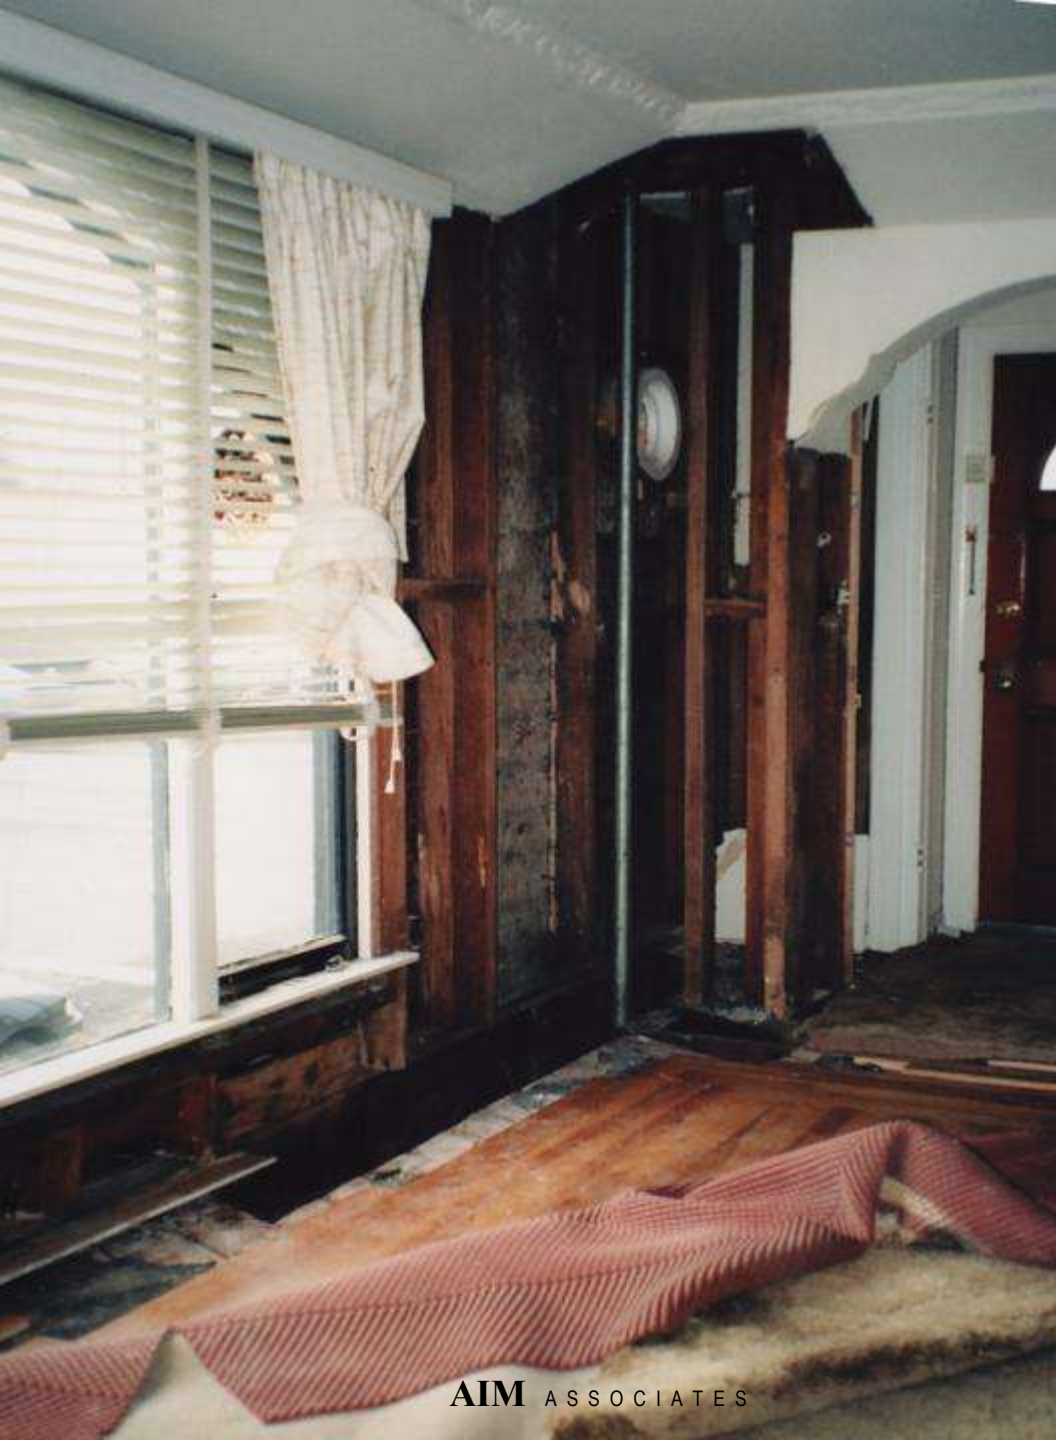
MAIN FLOOR INTERIOR IN VERY GOOD CONDITION, *EXCEPT:*

- Termites had eaten damp wood from the foundation to the roof in the southeast corner of the living room**
- The shag carpet was in good condition & given to neighbors who wanted it**
- Windows given away for greenhouse**
- The dampness came from a tiny hole in a solder joint of an interior rain water pipe, probably from when the house was built in 1940**

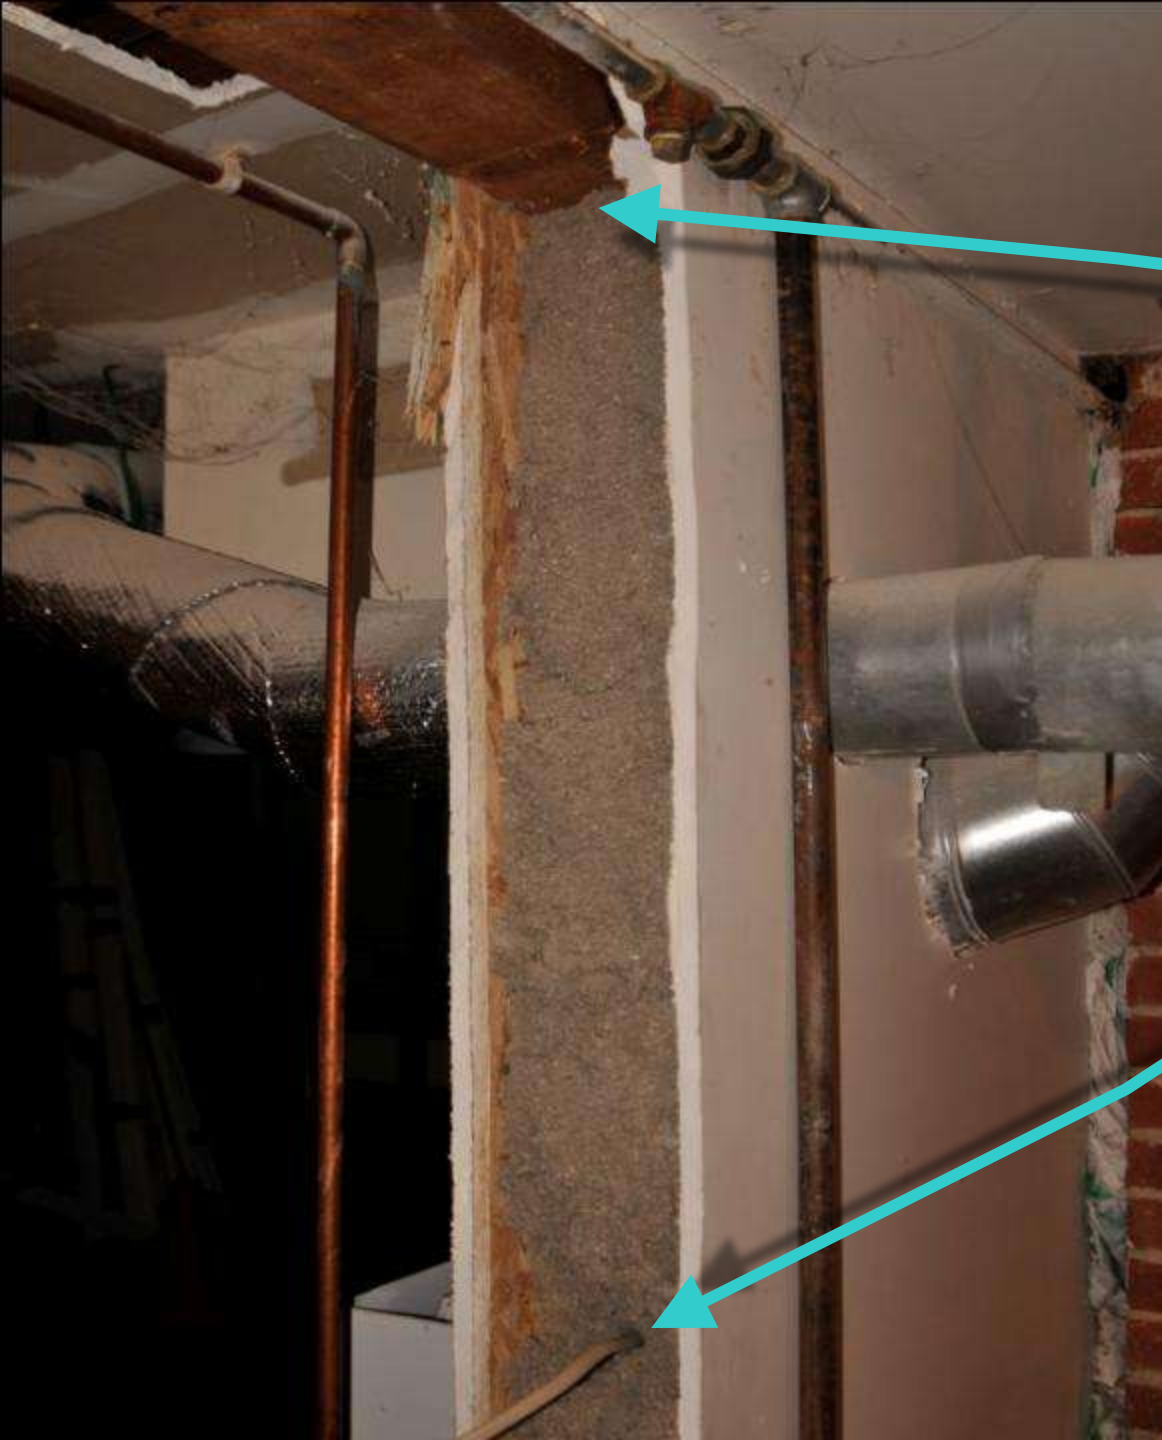
GOOD WORKMANSHIP!

No voids in the insulation from settling!

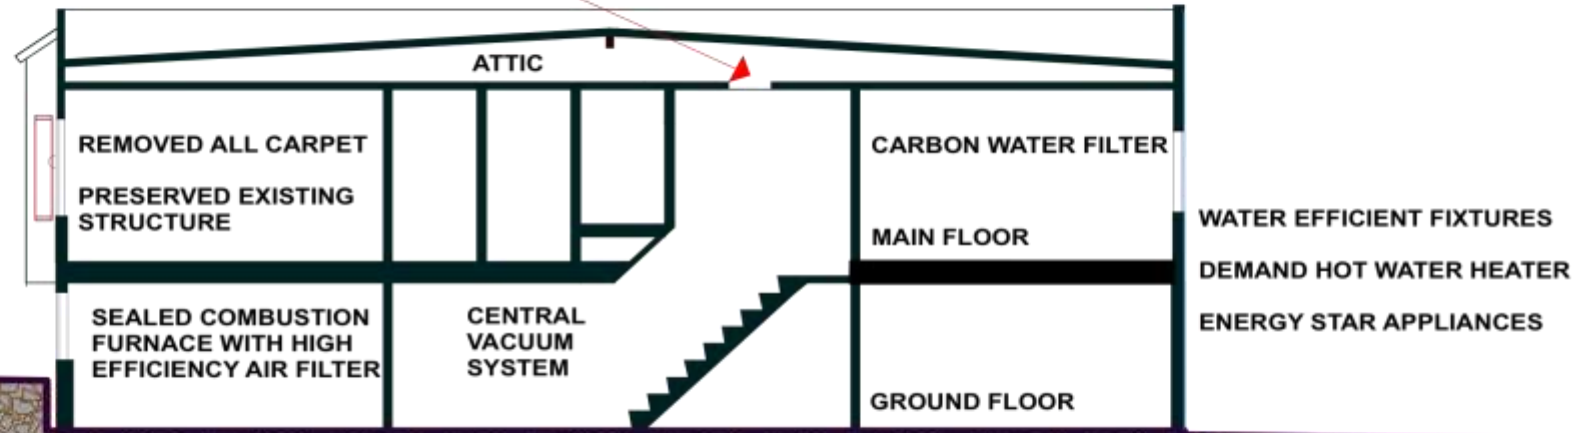
BUILDING SECTION 1998 REHABILITATION

EXISTING ARMSTRONG FOAMED URETHANE ROOFING COST
 PREVIOUS OWNER AS MUCH AS A 4-PLY 20-YEAR ROOF BUT
 ONLY CAME WITH A 5-YEAR WARRANTY

CELLULOSE INSULATION BLOWN INTO ATTIC
 R-38 INTENDED BUT DIFFICULT WORKING CONDITIONS ONLY
 ACHIEVED APPROXIMATELY R-30
 SMALL ACCESS PANEL WAS ONLY ATTIC ACCESS

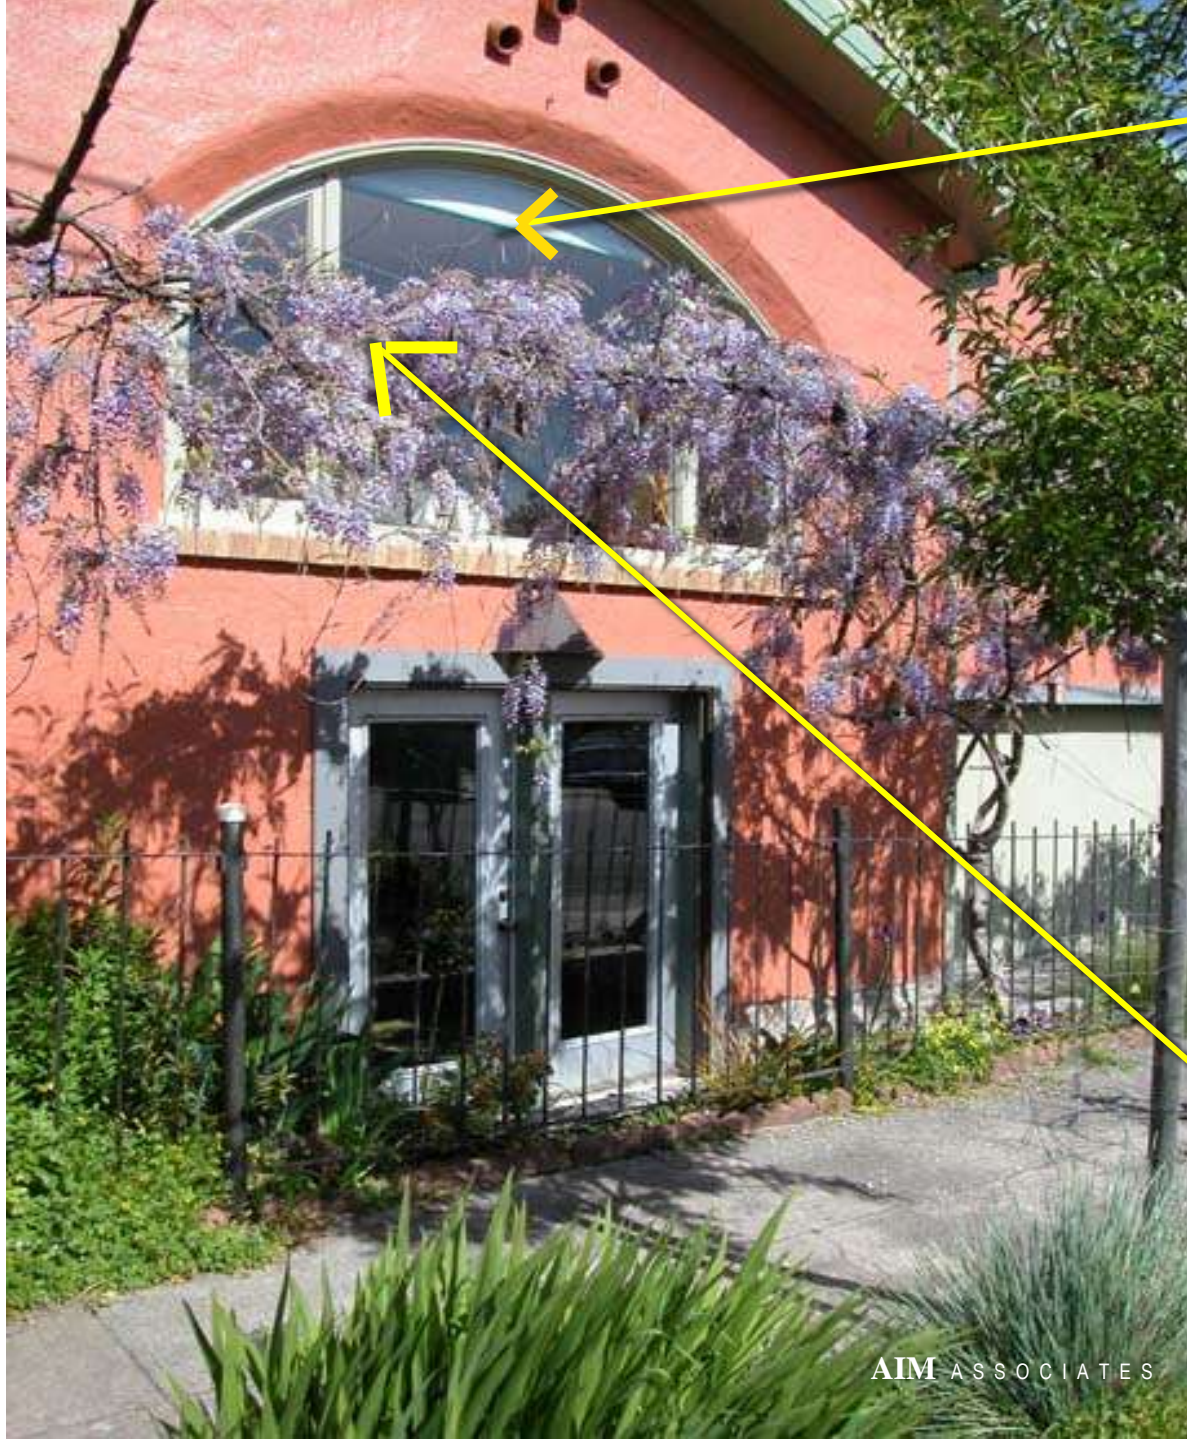
In the first phase, all existing windows were replaced with high-performance windows, except this living room window because it was too expensive (unusual shape). That is why the R-4, three-layer honeycomb interior shade is needed

However, it is difficult to keep cold air from flowing out from around the edges of the shade

Cable trellis was modified, so vines shade office glass door but do not shade living room window

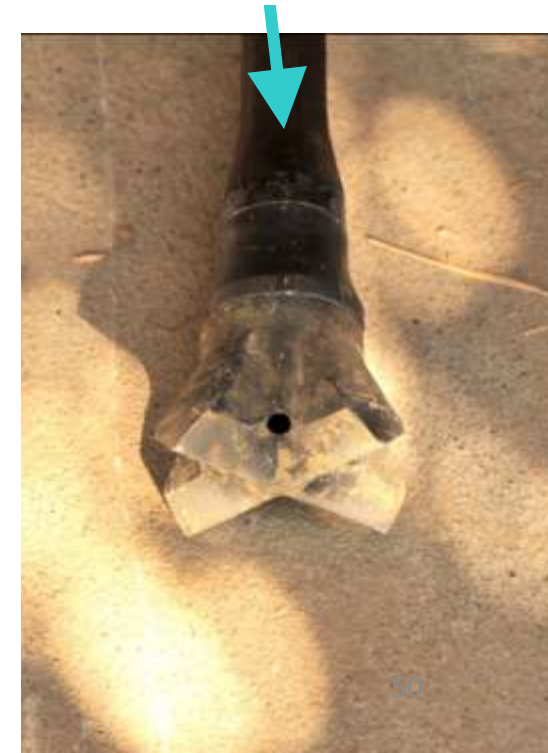
We tried this 3” diameter drill bit with a jackhammer

It took 1½ weeks to drill 12 holes

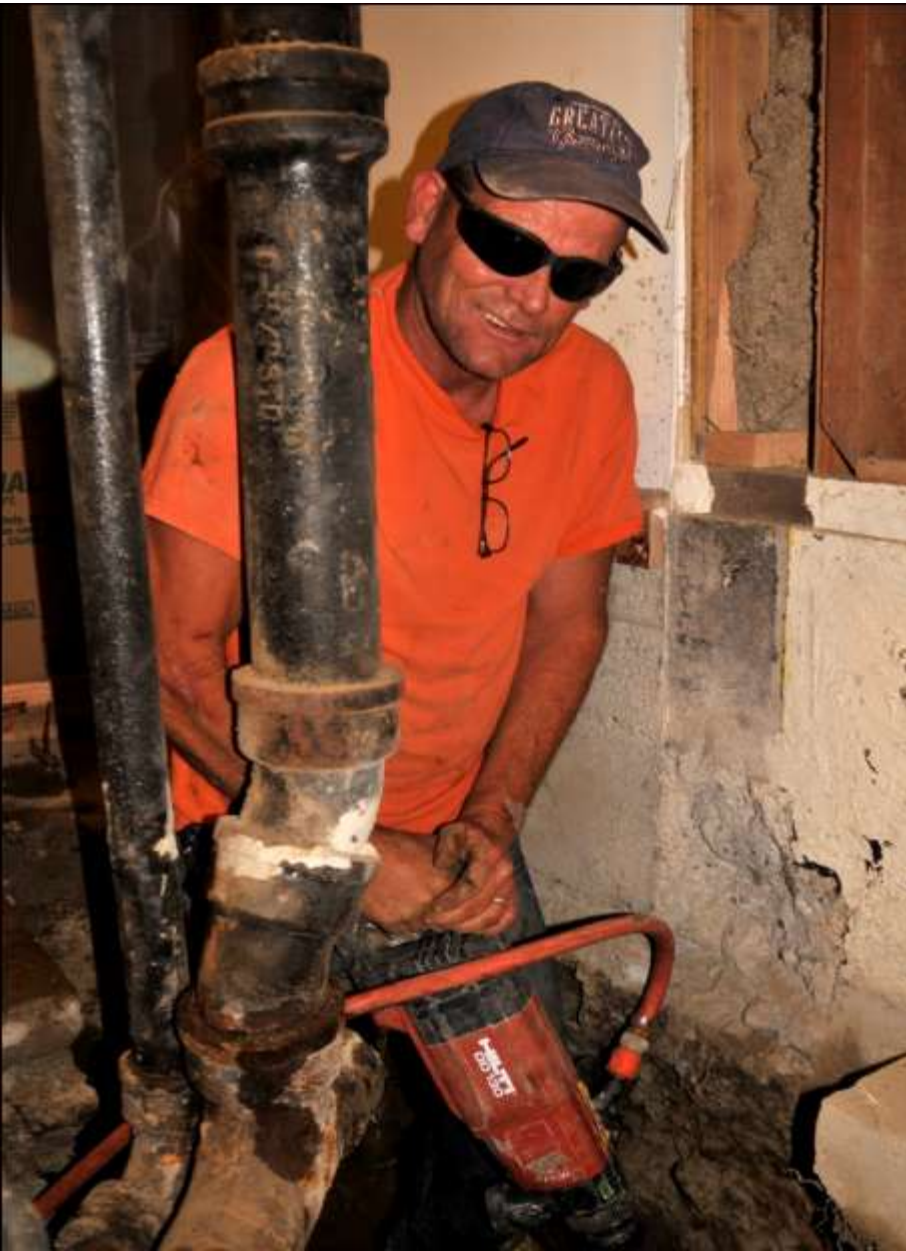
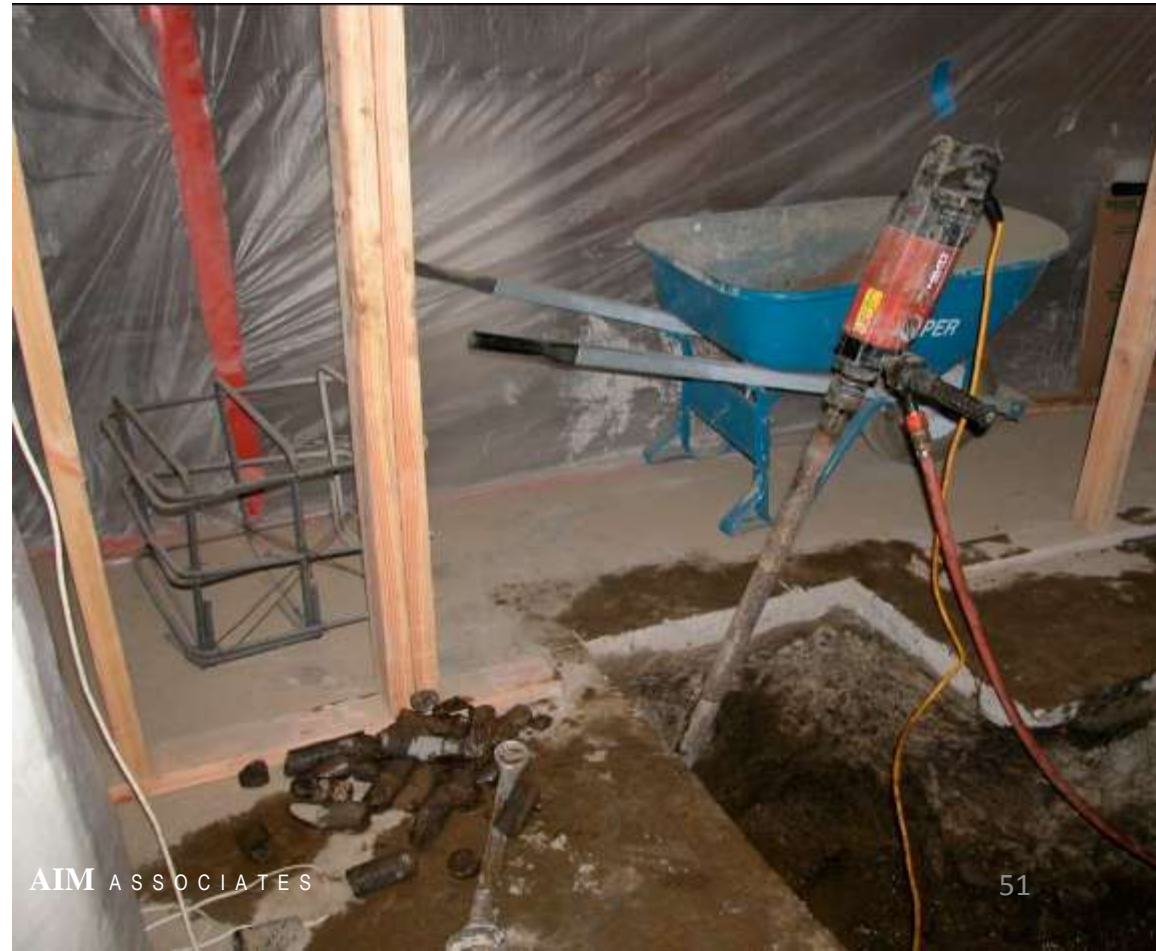
THE RIGHT EXPERIENCE & TOOLS GOT THE JOB DONE

Kent Williams, concrete repair journeyman of Durling Concrete, determined that core drilling was the appropriate technique even with the clay veins

The remaining 12 holes were drilled in one day!

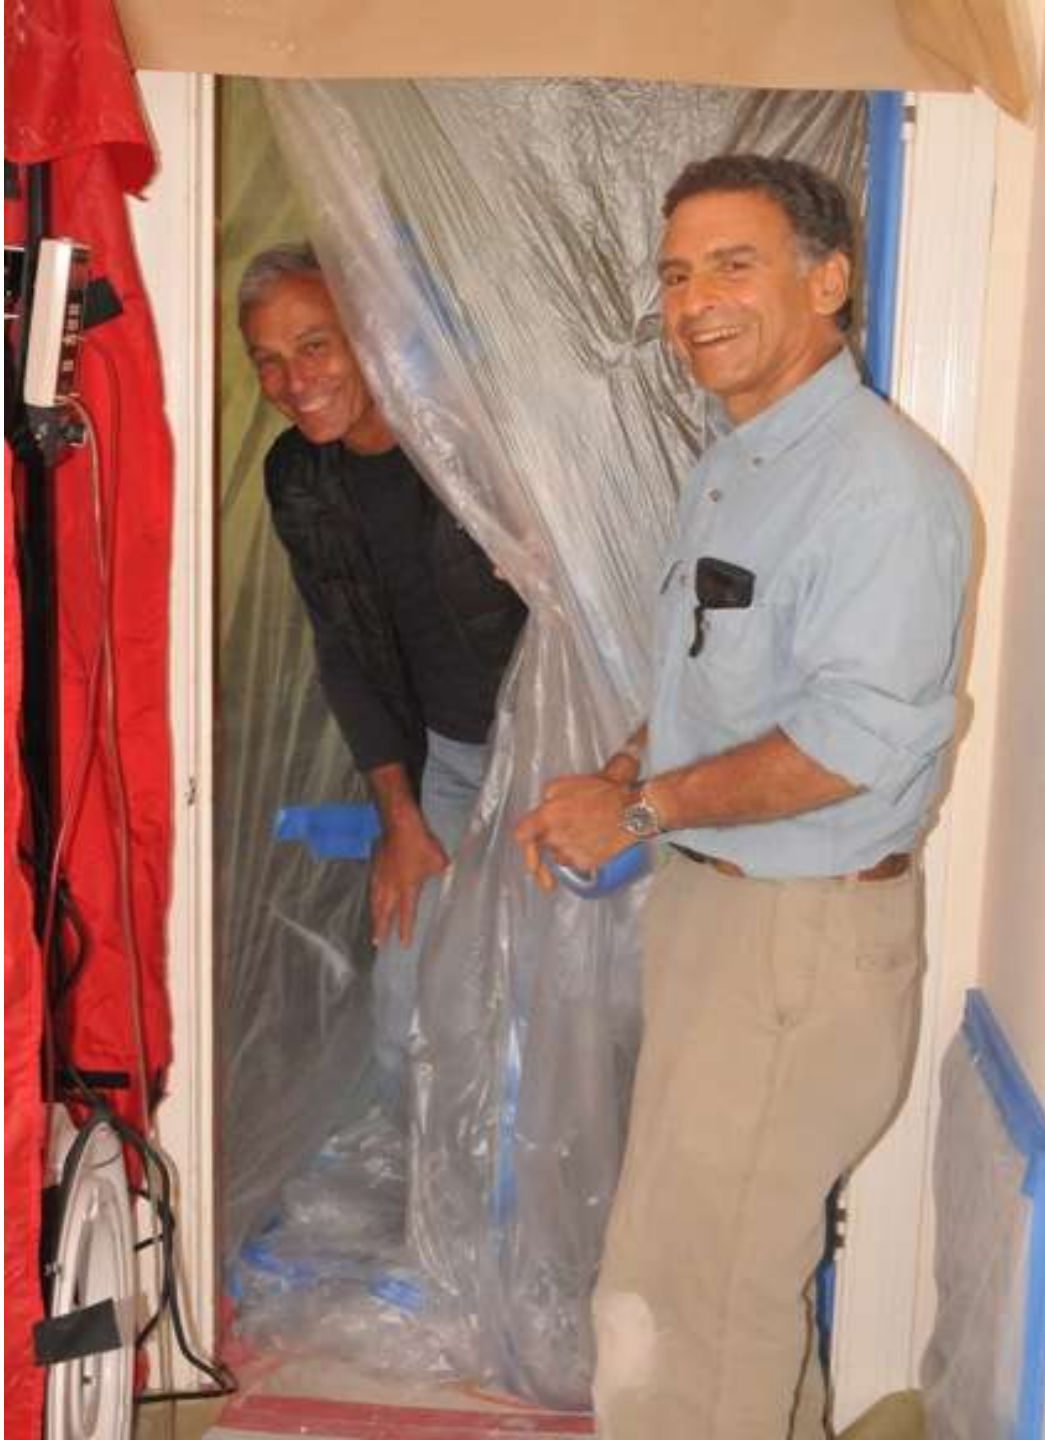
BEFORE BLOWER DOOR TEST

Bruce Dichter & Mike Winter isolate the den to see if there is much difference in air infiltration compared to the rest of the main floor

Infiltration rate, entire main floor (1,800 CFM50 x 60 min./hr)/(17.2 x 1,540 ft² x 8' ceiling) = 0.51 air changes per hour natural

Infiltration rate, minus den & kitchen (1,065 CFM50 x 60 min./hr)/(17.2 x 1,018 ft² x 8' ceiling) = 0.46 air changes per hour natural

The results showed that the den's wall & ceiling wood paneling does not leak air nearly as bad as was suspected

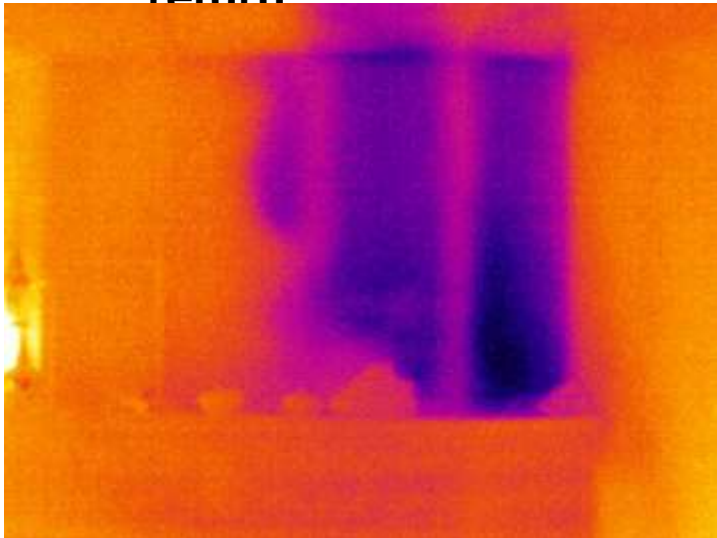
Air infiltration from attic at fireplace chimney interior wall
