Thousand Home Challenge, <u>Phased</u> <u>Retrofit</u> Cold Climate Sustainability₃₋₁₂₋₁₅ Case Study By: W. Turner & K. Turner (70%? Reduction)

Year-round home, 800 ft², 8-9,000 degree days

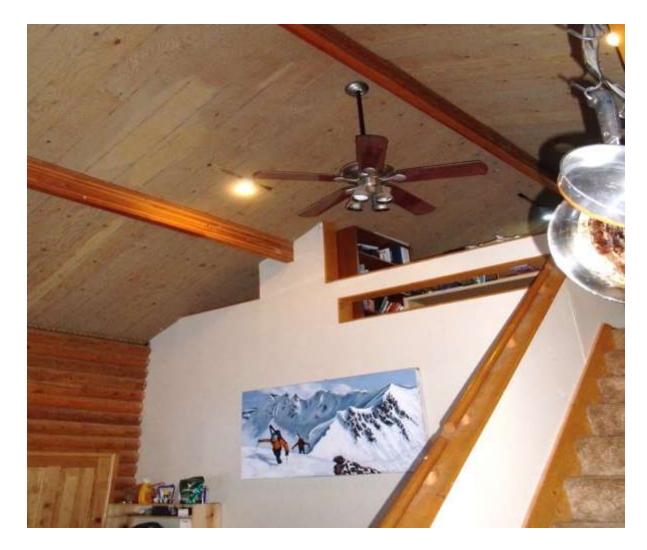
Ceiling: Cathedral Ceiling & Loft Air Leakage

(T-111Paneling & no continuous air/vapor barrier)

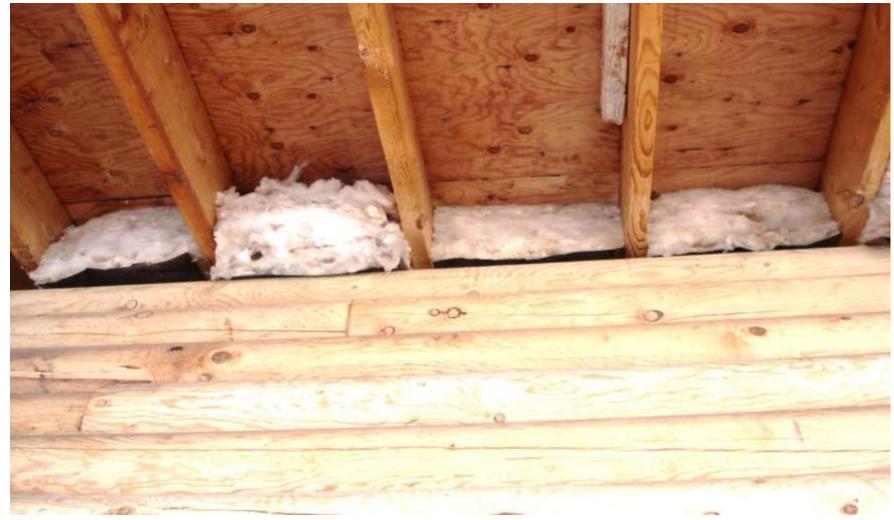
Unfinished? Soffit: under East & West Overhangs (daylight is seen at the roof rake area)

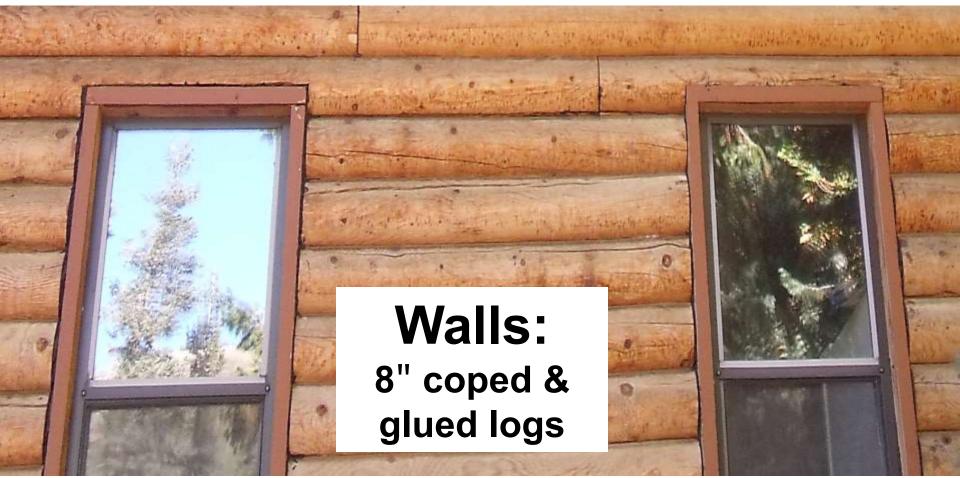
Windows: Functional aluminum 2-pane, non-thermally broken (double-hung, sliders, & two fixed unit picture windows)

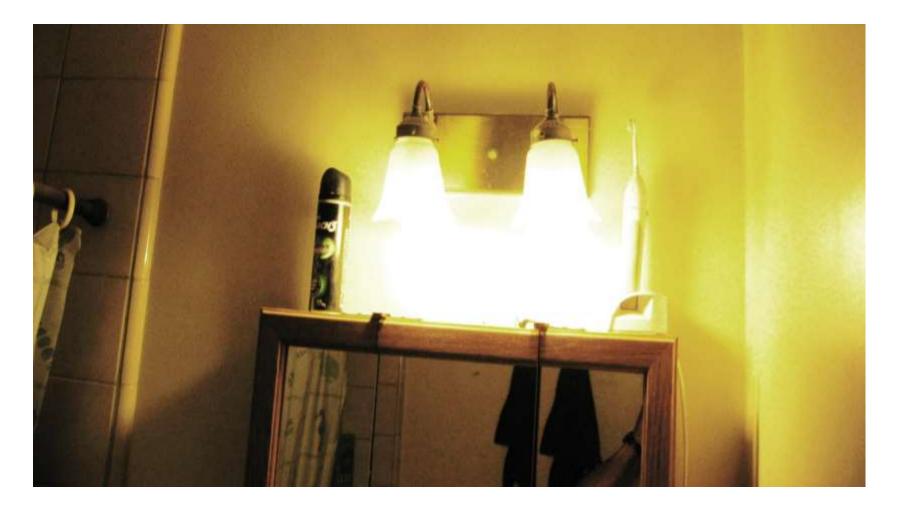
Bathroom: Some visible mold on ceiling & wall , no exhaust fans, operable window above bathtub

Ventilation/Mold Fix for Bathroom

Added bath exhaust

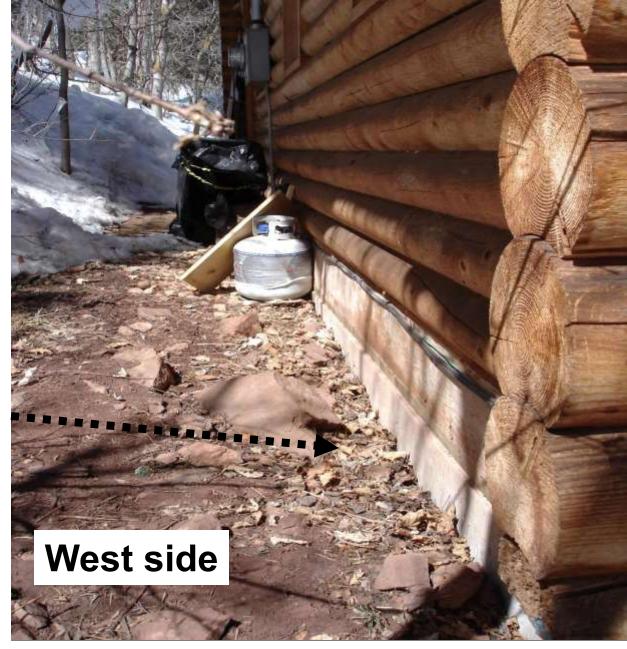
No uphill swale

All upslope water (600 vertical feet) drains toward the basement wall & into the basement

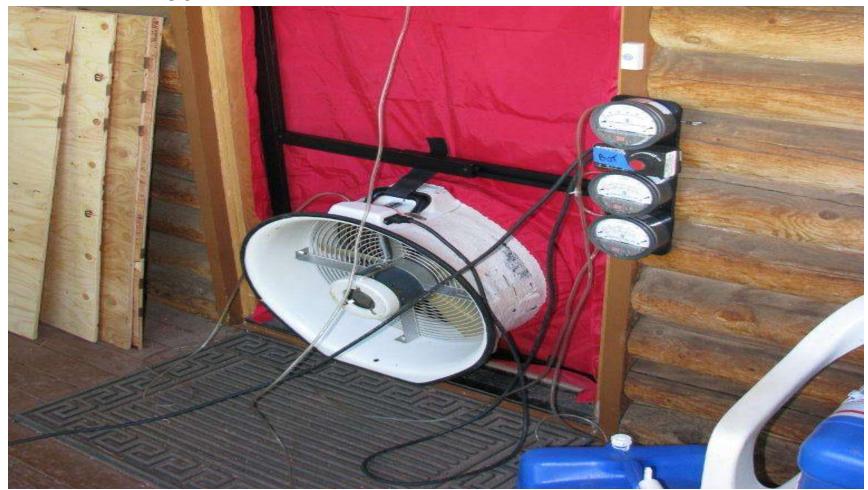
Blower Door: 23 ACH₅₀ (including basement) 5,400 CFM₅₀ 152 in.² ELA 1.55 CFM₅₀/ft² (six-sided surface area)

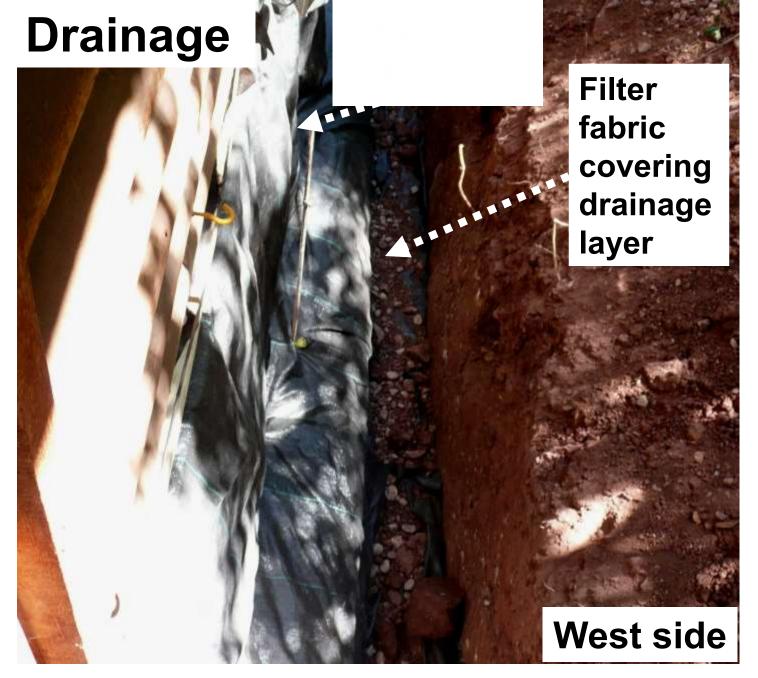
West side

What We Found: Were They Thinking.....?

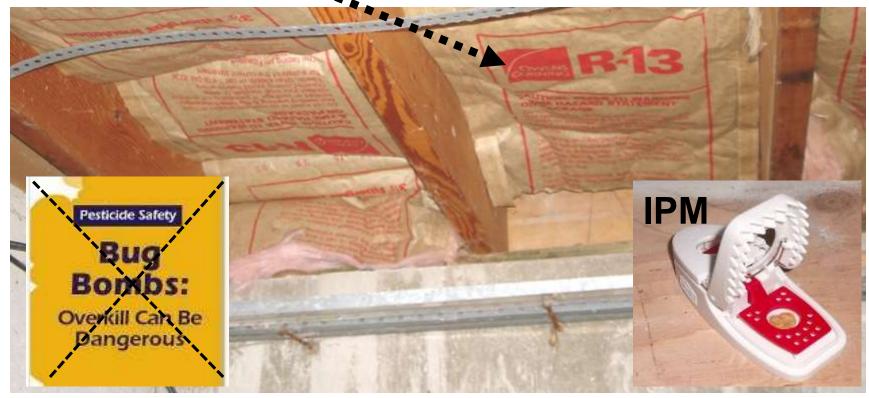
✓ **Pests** (worker & occupant safety)

- ✓ Field mouse nesting removed under <u>negative air</u> <u>containment</u>, droppings HEPA vacuumed
- Salvageable FG insulation reused in storage area walls without kraft paper

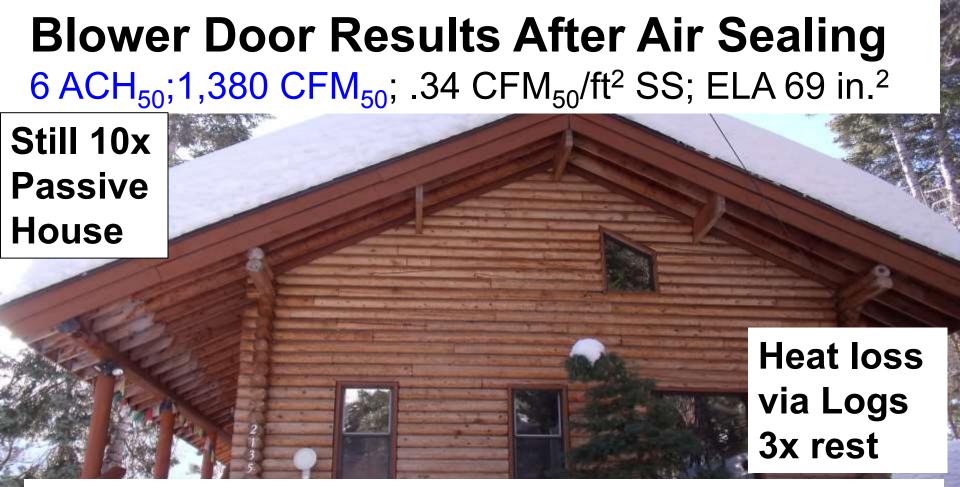
Blower Door prior to 2-part spray foam in gap 13 ACH_{50} ; .79 CFM₅₀/ft² SS(six-sided SA); $3,200 \text{ CFM}_{50}$; ELA 159 in.² Est. ?? Gap size .15" by 720" = 108 in.² ?? (at project start with same volume was 23 ACH₅₀)

Rake: Air sealed

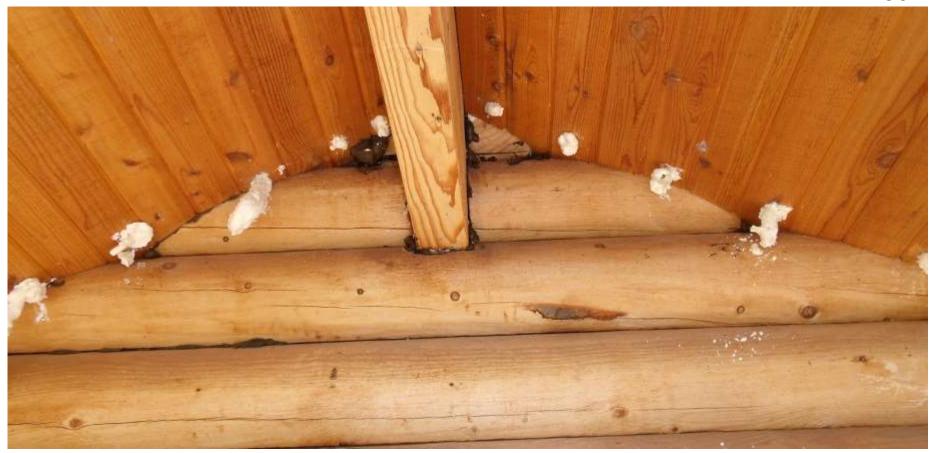
Further Air Sealing August 2012 & 13 Focused on Rake, log corner joints, & seams Blower door results after air sealing O O Oonly 5% further reduction at 50 Pascals, 6 to 5? ACH₅₀

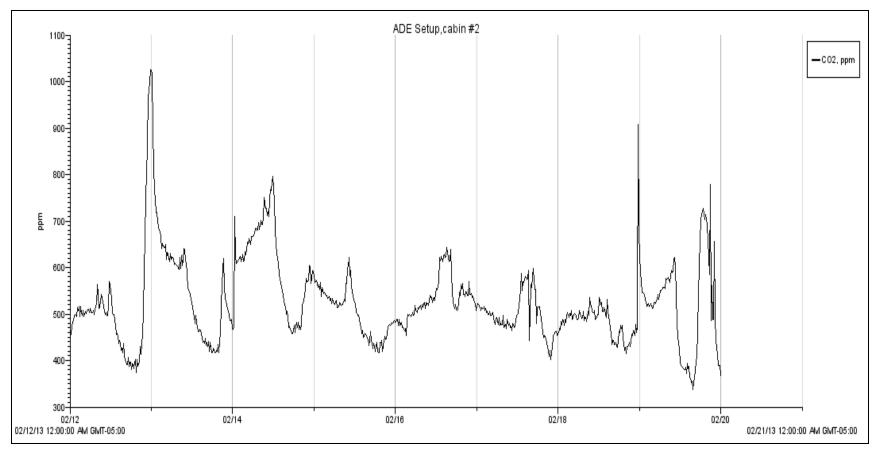
Where Are We Now, Ventilation Rate? Carbon Dioxide 1 week Feb 12-19, 2013

Conclusion: currently over-ventilation in winter

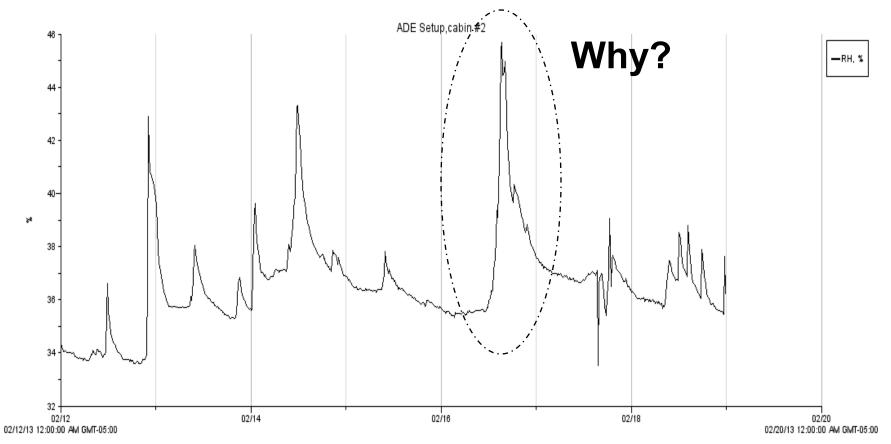
Where Are We Now IAQ, Humidity ? Relative Humidity 1 week Feb 12-19, 2013

Conclusion: (more air sealing likely ok, exhaust microwave?, ask about moisture on windows?, if tighter consider small HRV?)

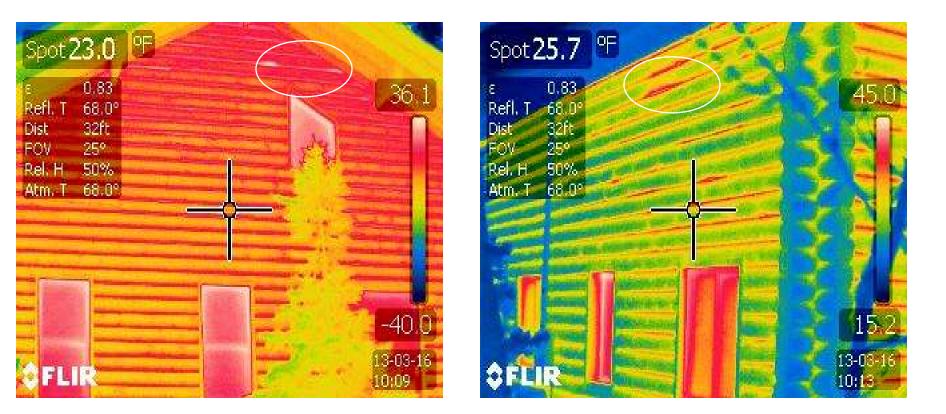
To find more air leaks, do infrared imaging: done March 16, 2013

more air sealing work on a ladder Done Aug.2013

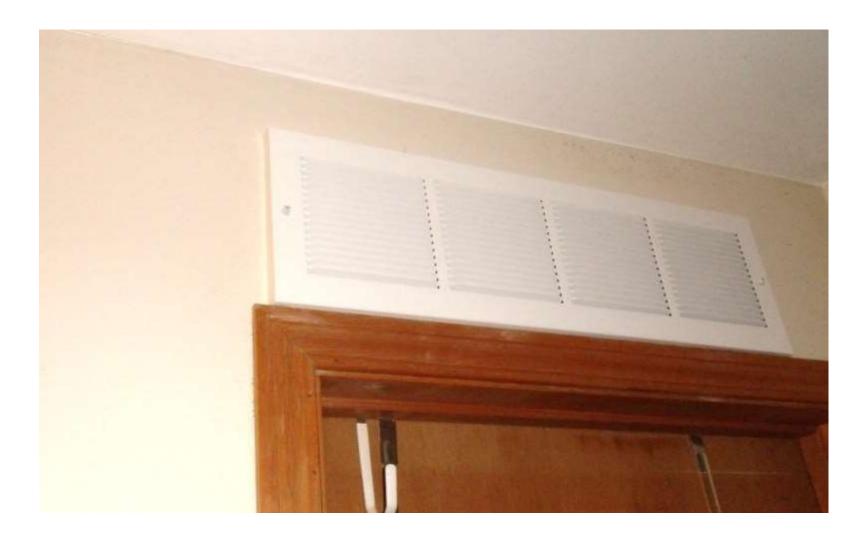
Large transfer grills needed to relieve bathroom and bedroom pressures
