MAINE ANTIQUE REHAB (80% reduction)

Sustainability Case Study “Optimization”

By: William Turner

Year-round home, 3,600 ft², 8,000 degree days

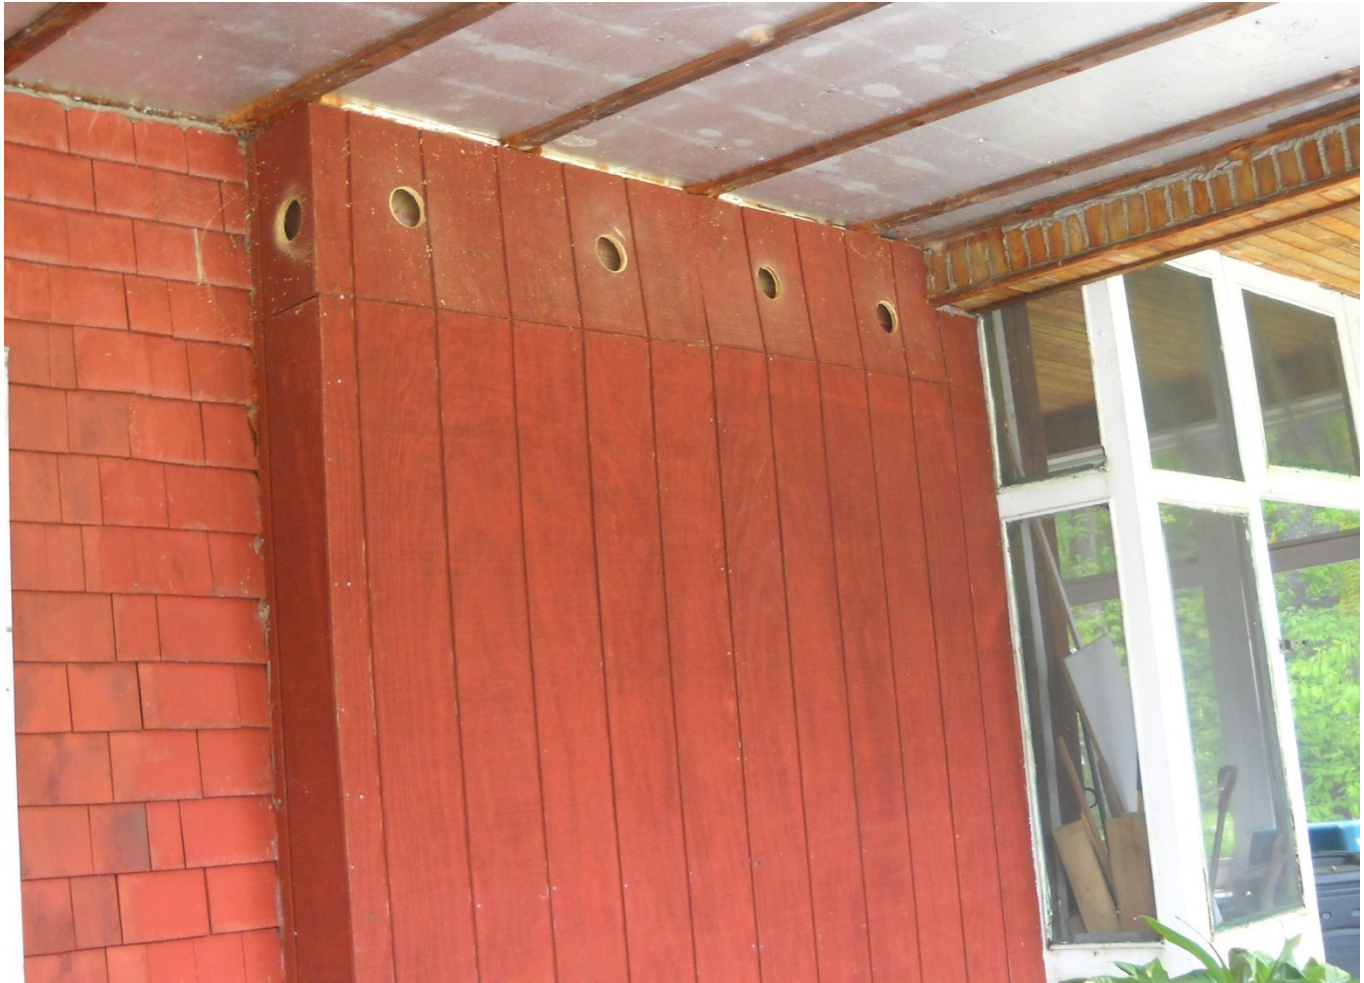
1982 Windows: 33 French Style, 24 replaced with double hung thermal pane; all windows covered with triple track aluminum storms

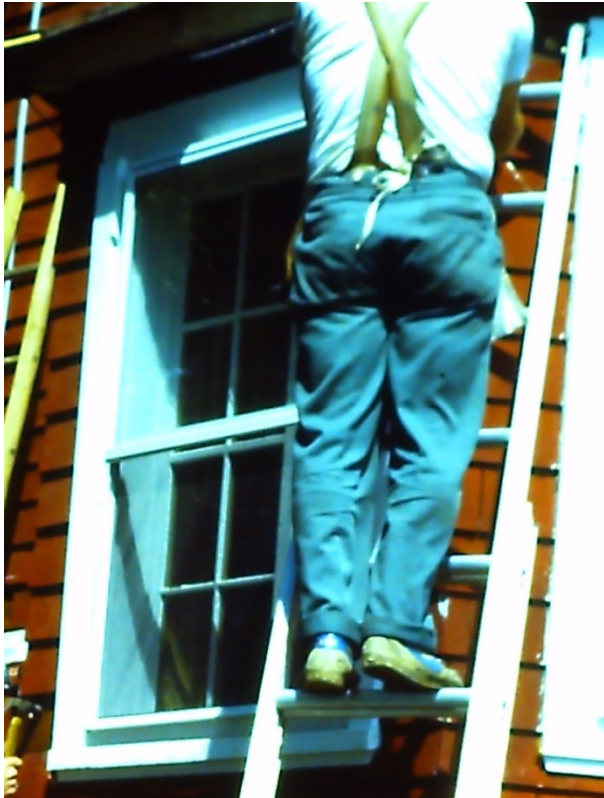
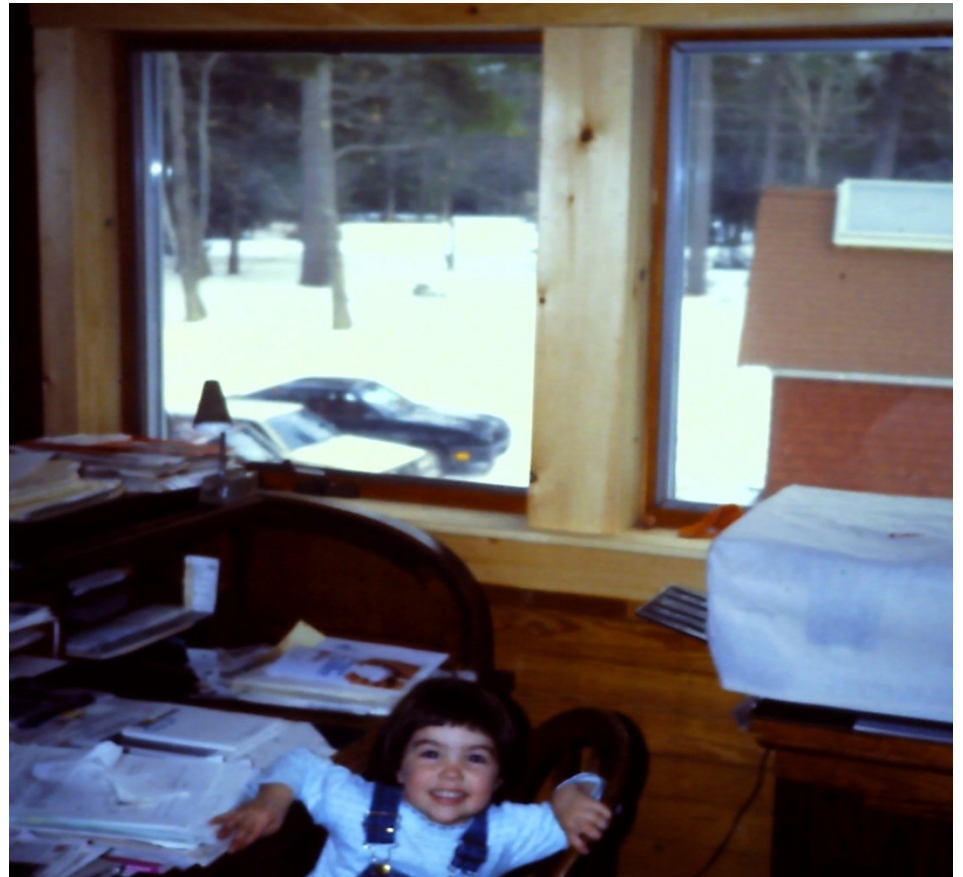
1982: Installed
96 ft² of
Vertical
Sunspace
(southwest
exposure)

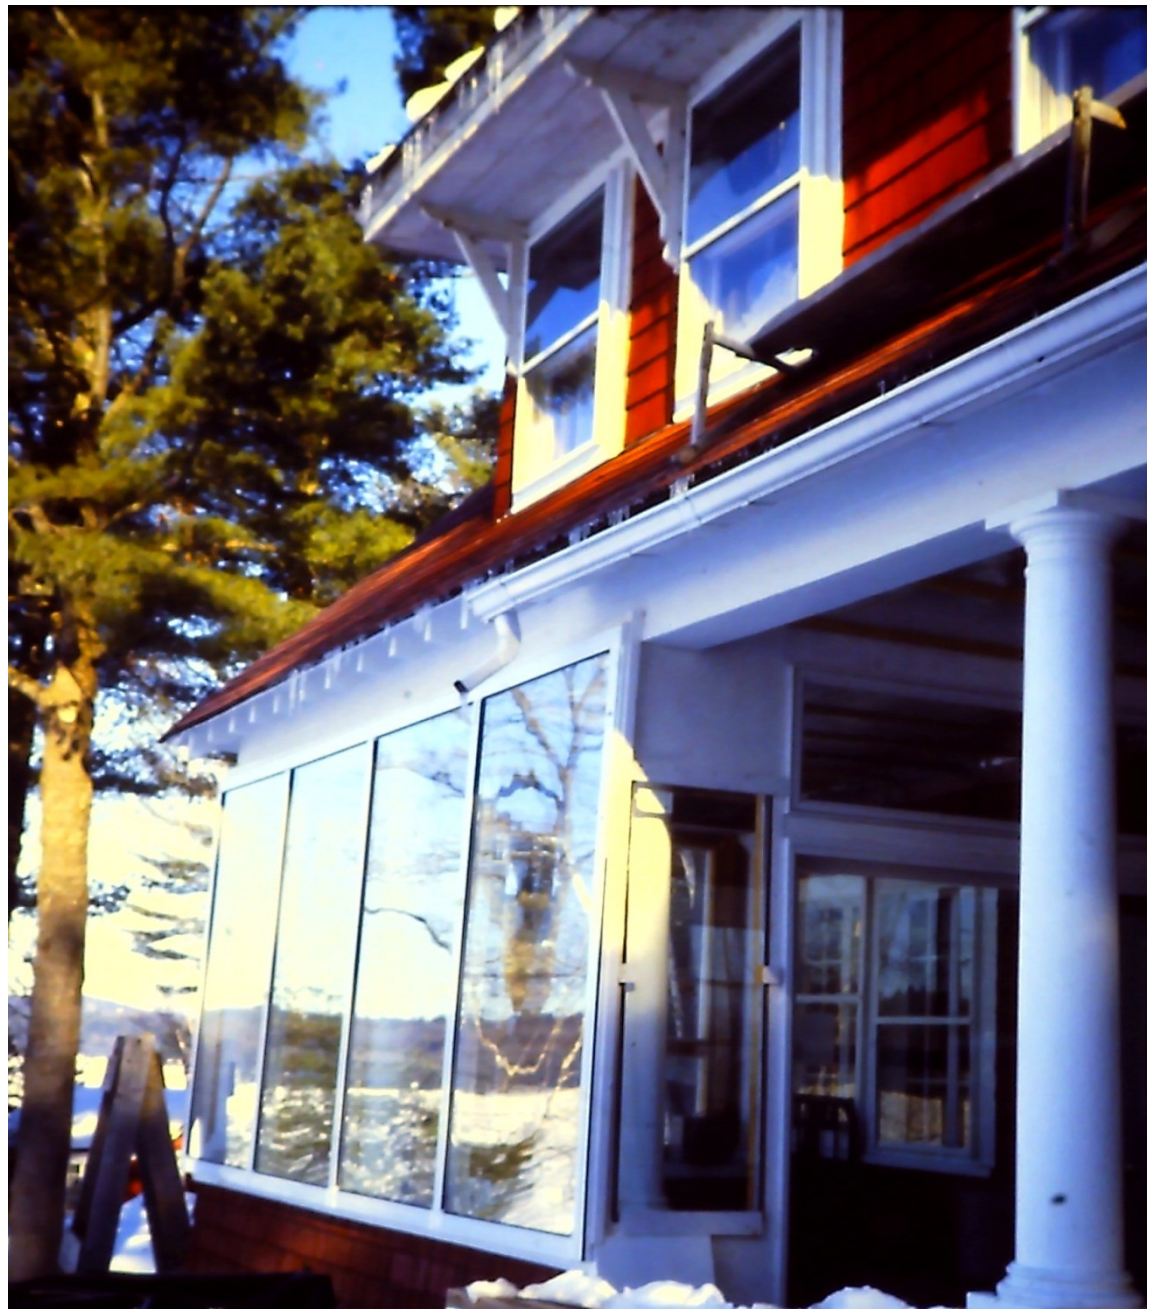
1982 Crawl Space Fix: Added 3 " or 6" of XPS foam under the FG batts, sealed all joints

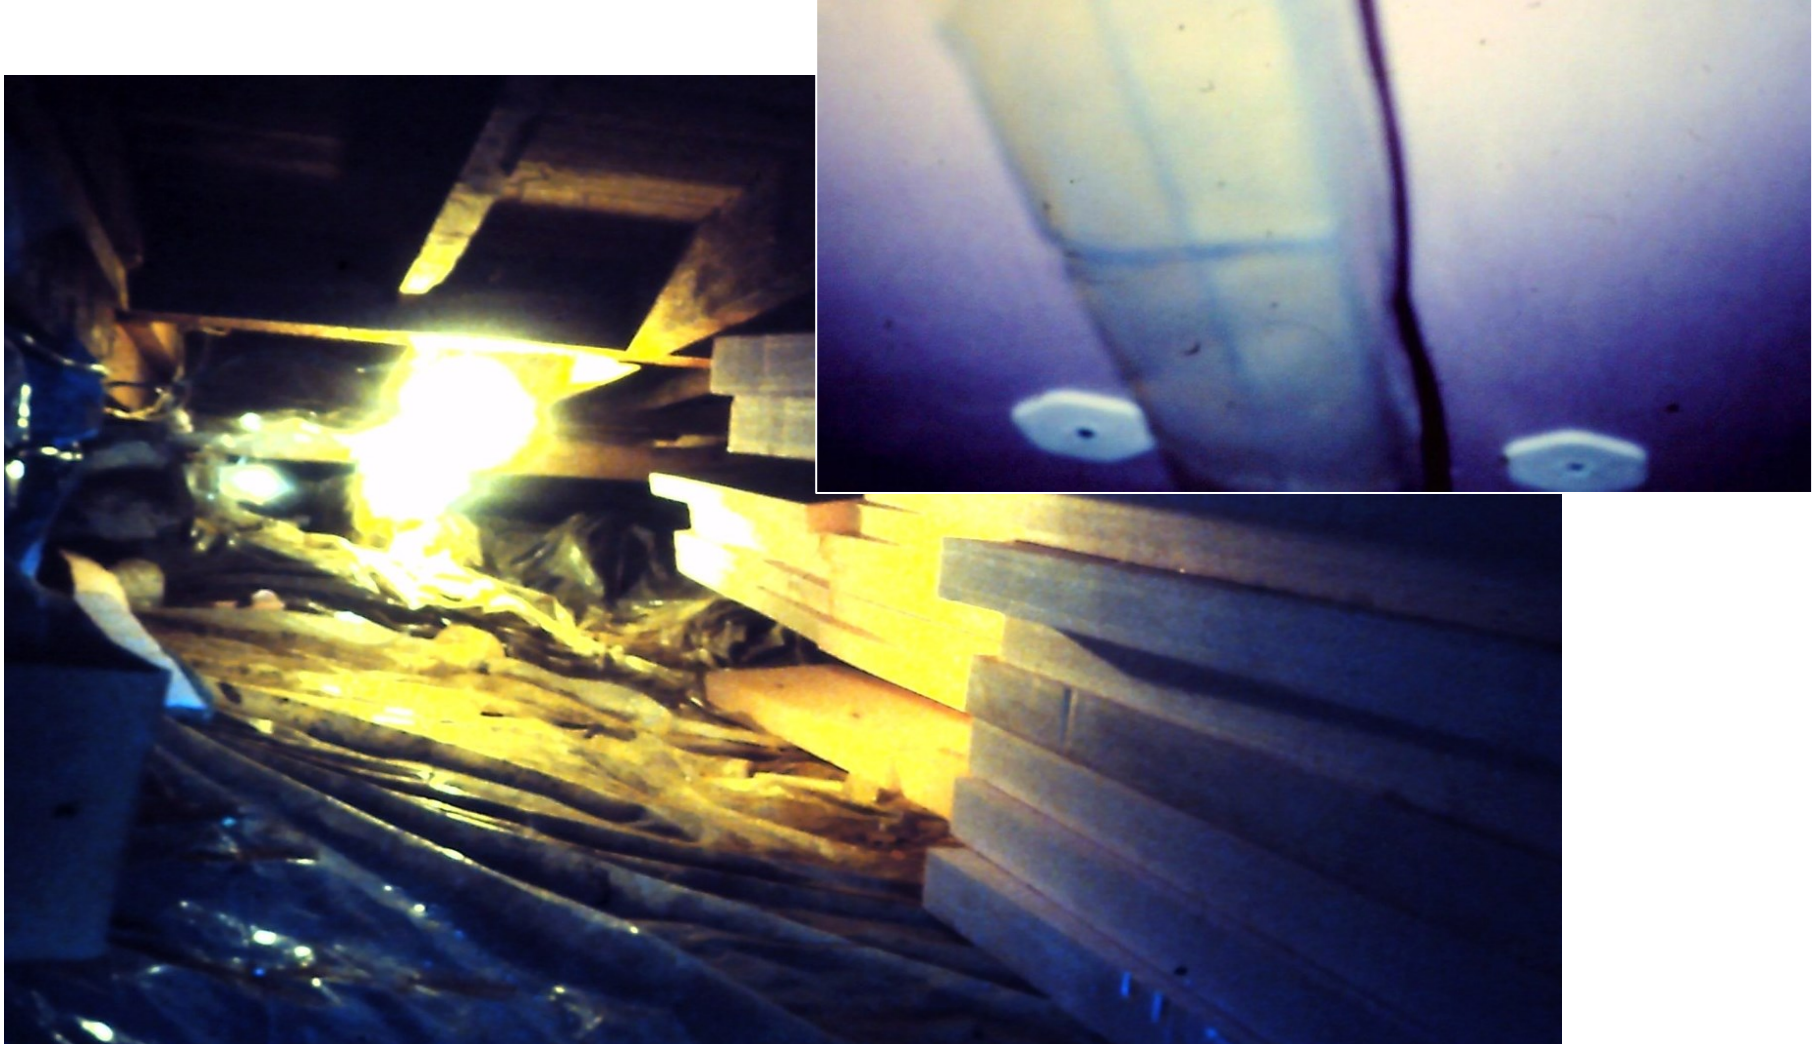
1882 Complete Crawlspace Isolation

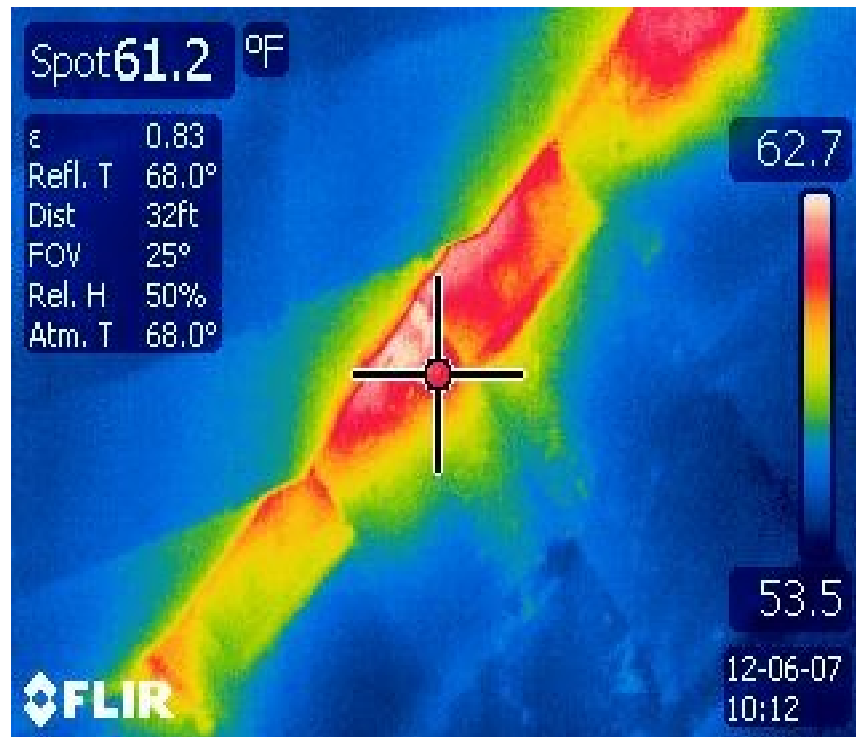
IR Inside Attic: Identified Remaining Major Attic Bypasses (2011-12 winter)

Red & white indicate remaining air leaks inside cold attic at floor, mainly at junctions in framing.

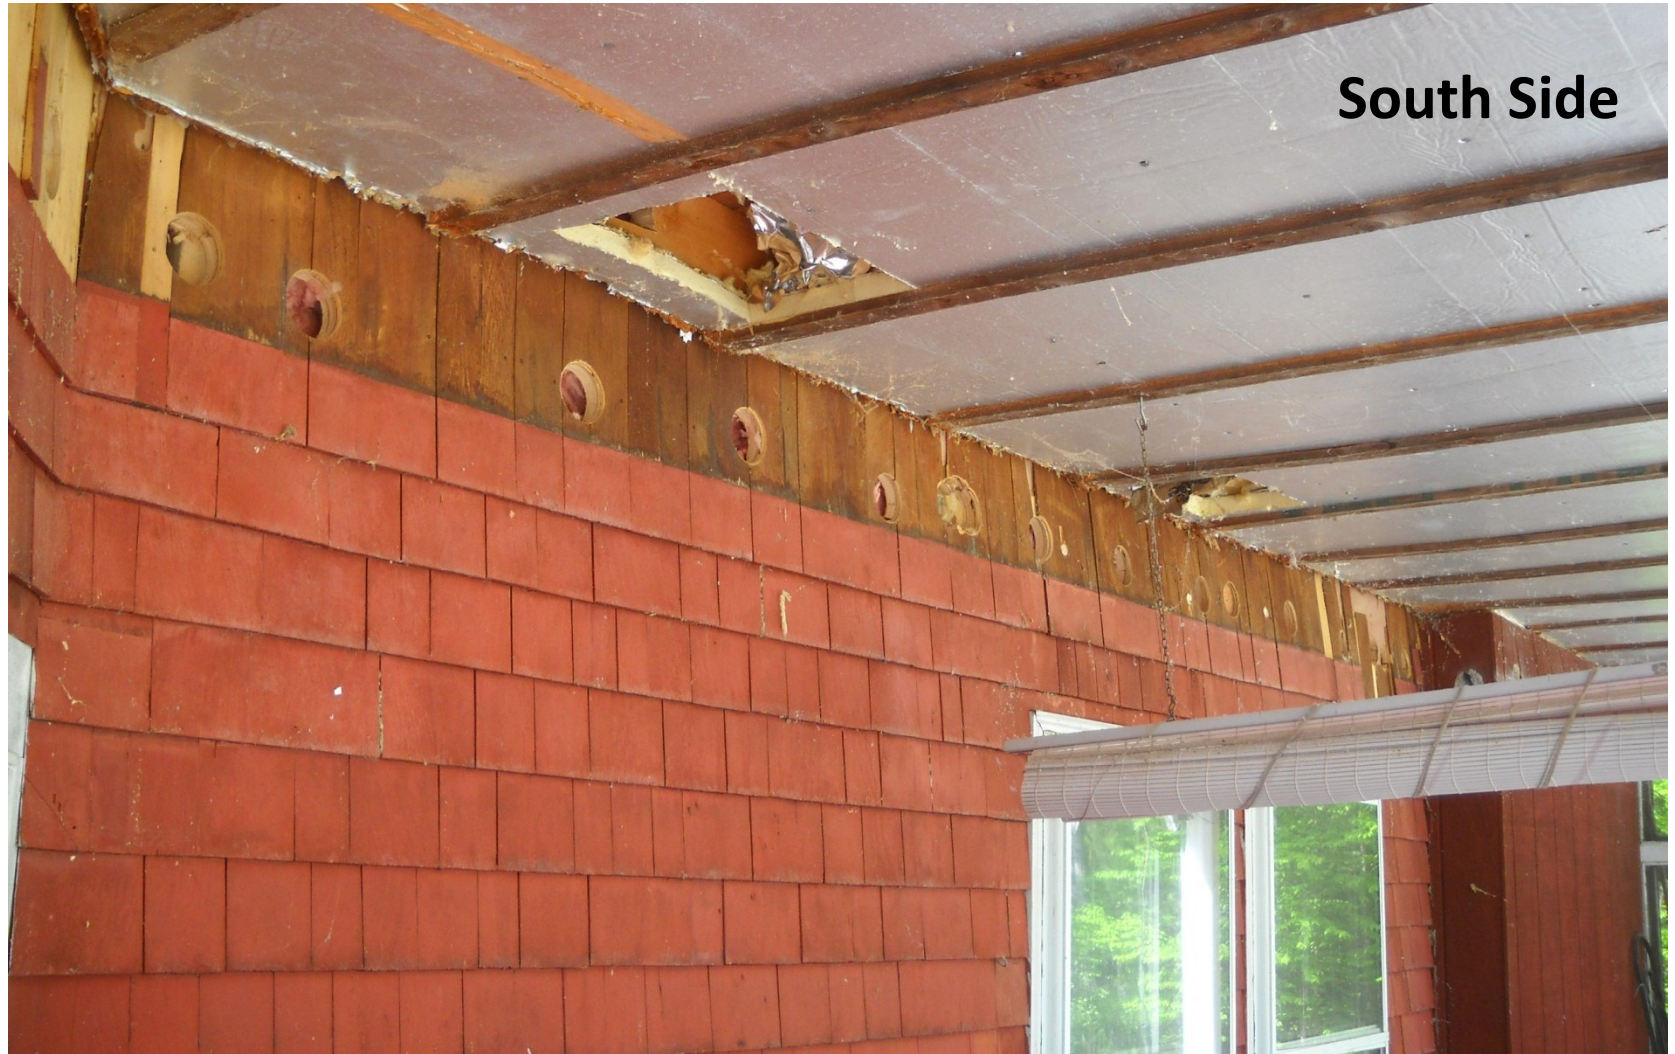
Interstitial cavity between 1st and 2nd floor accessed for cellulose dense packing, insulation and air sealing

Interstitial floor space is where flying squirrels were living & commuting at perimeter of space

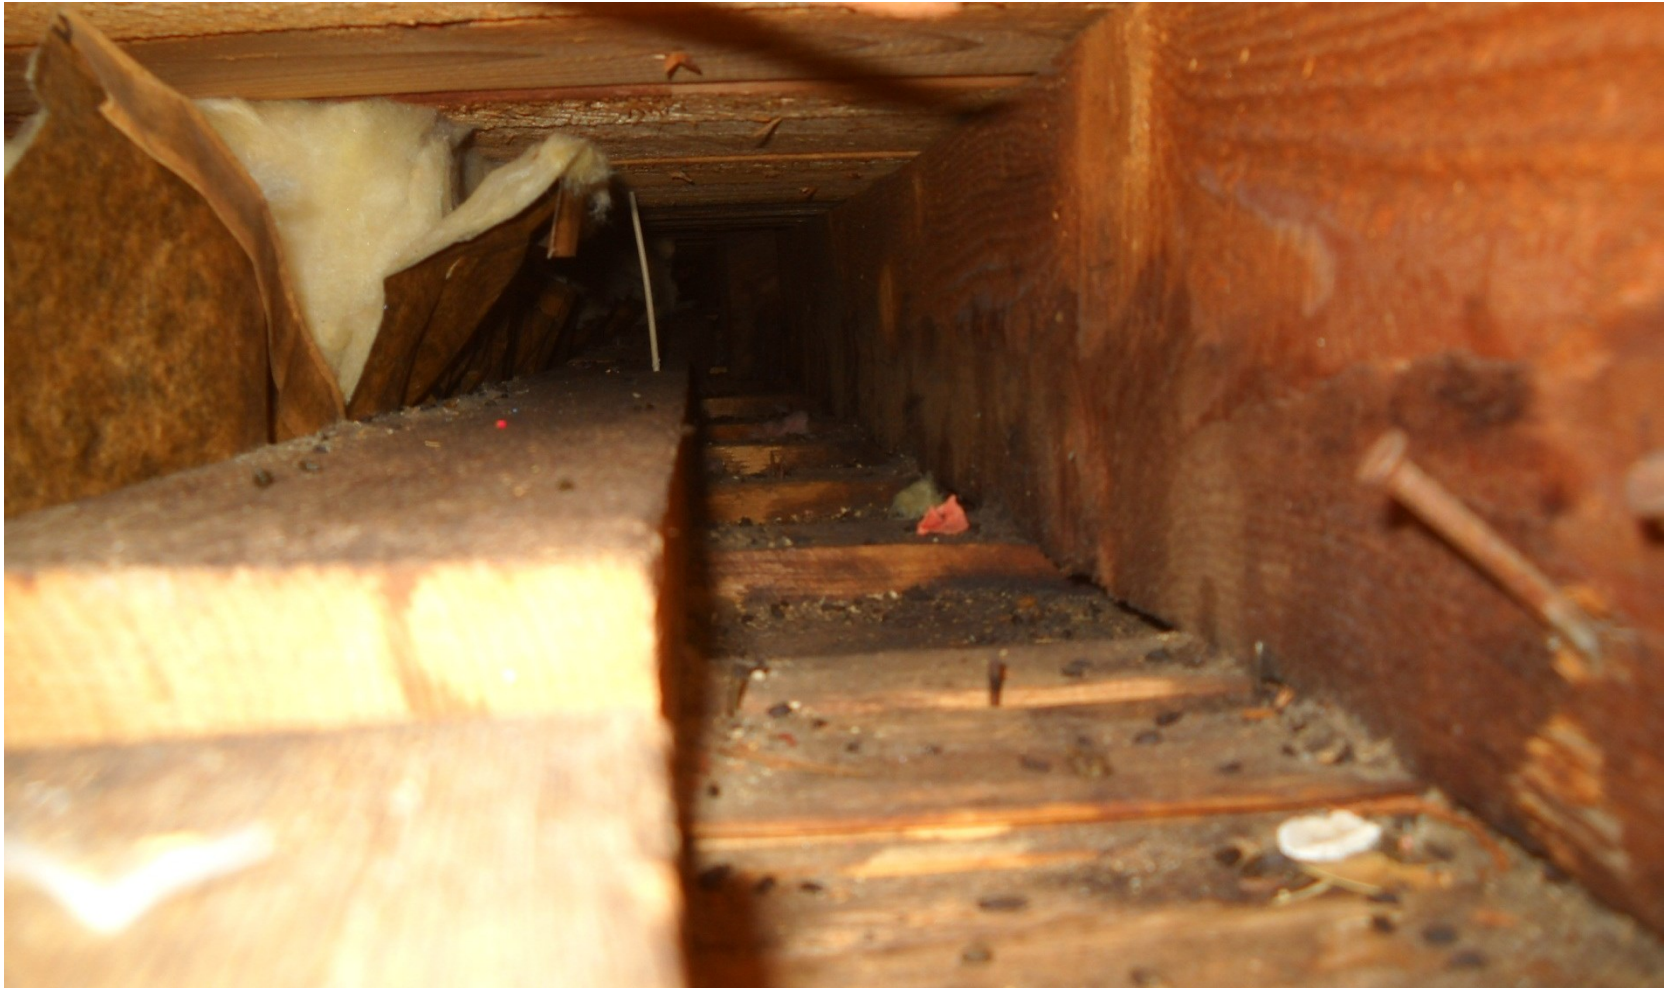
Air Sealing, Interstitial squirrel cavity between 1st & 2nd floors were accessed for cellulose dense packing

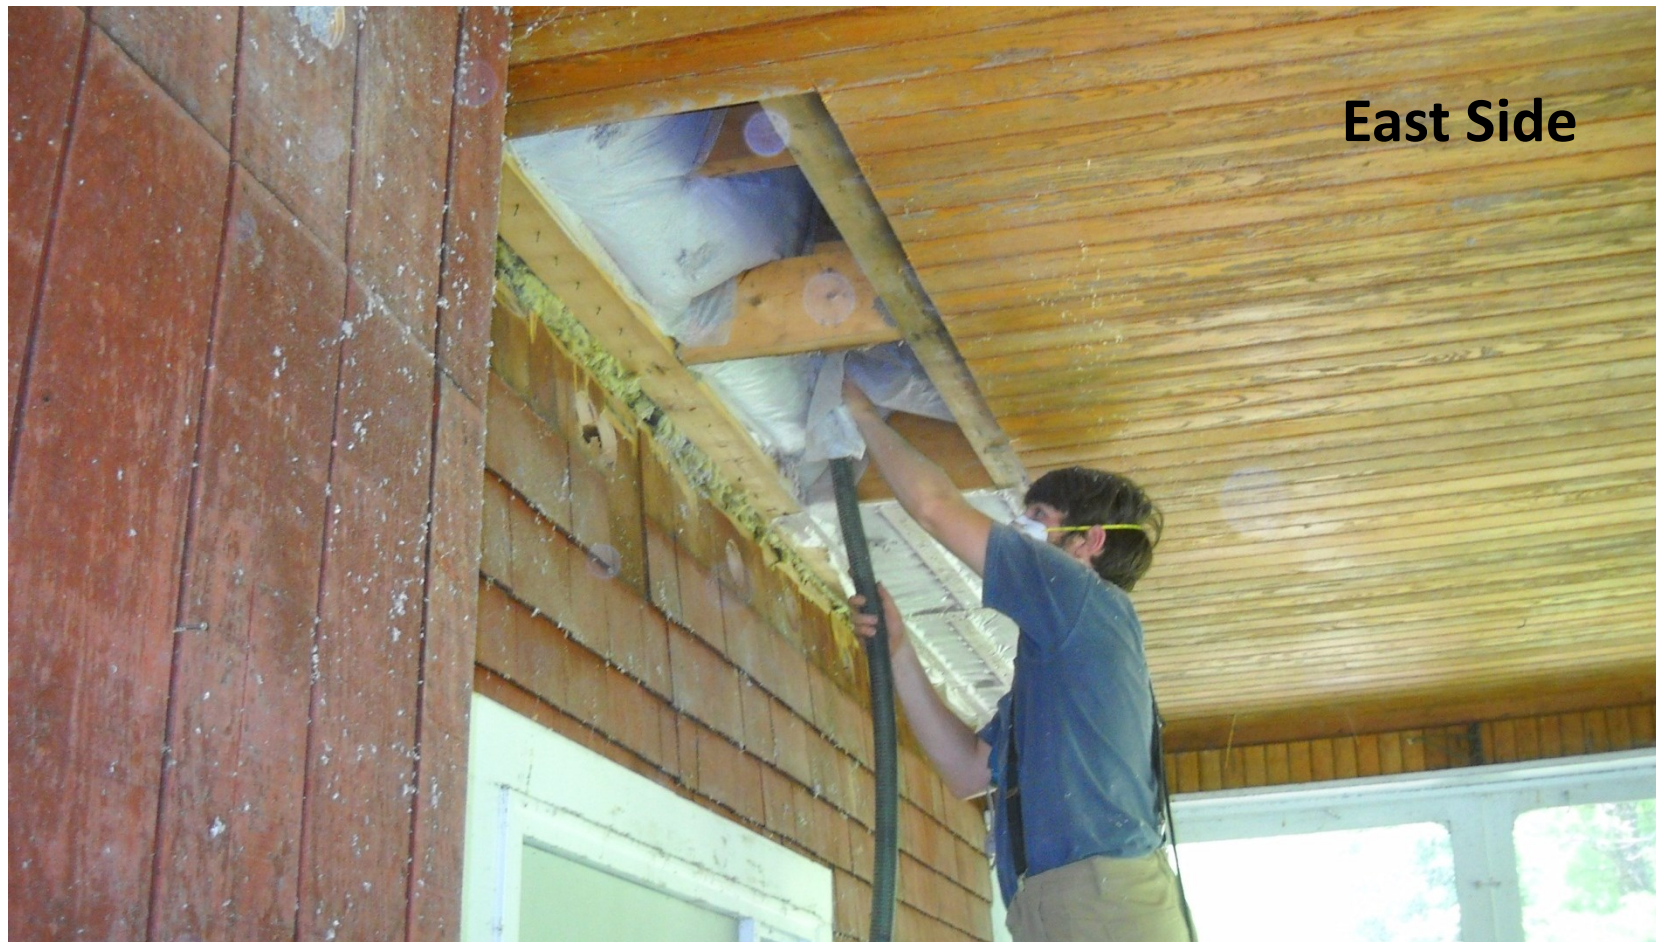
Interstitial cavity between floors accessed for cellulose dense packing (185 bales added including 18" attic)

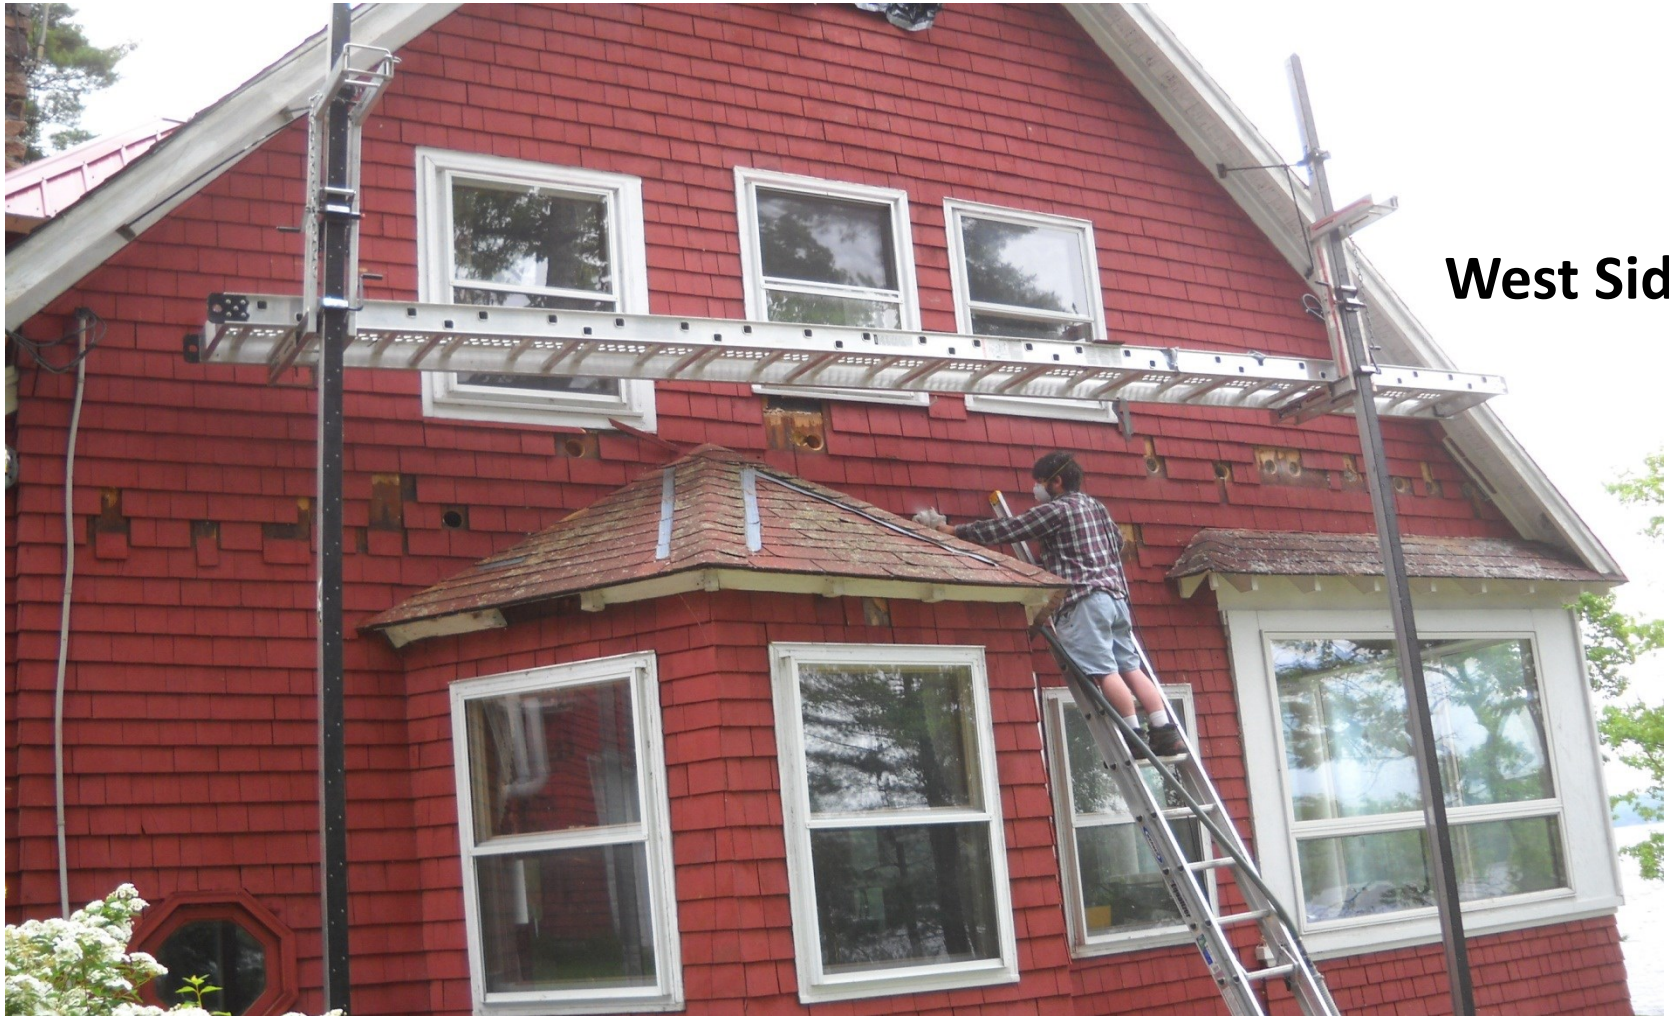
Addressed Lead Paint On All Trim

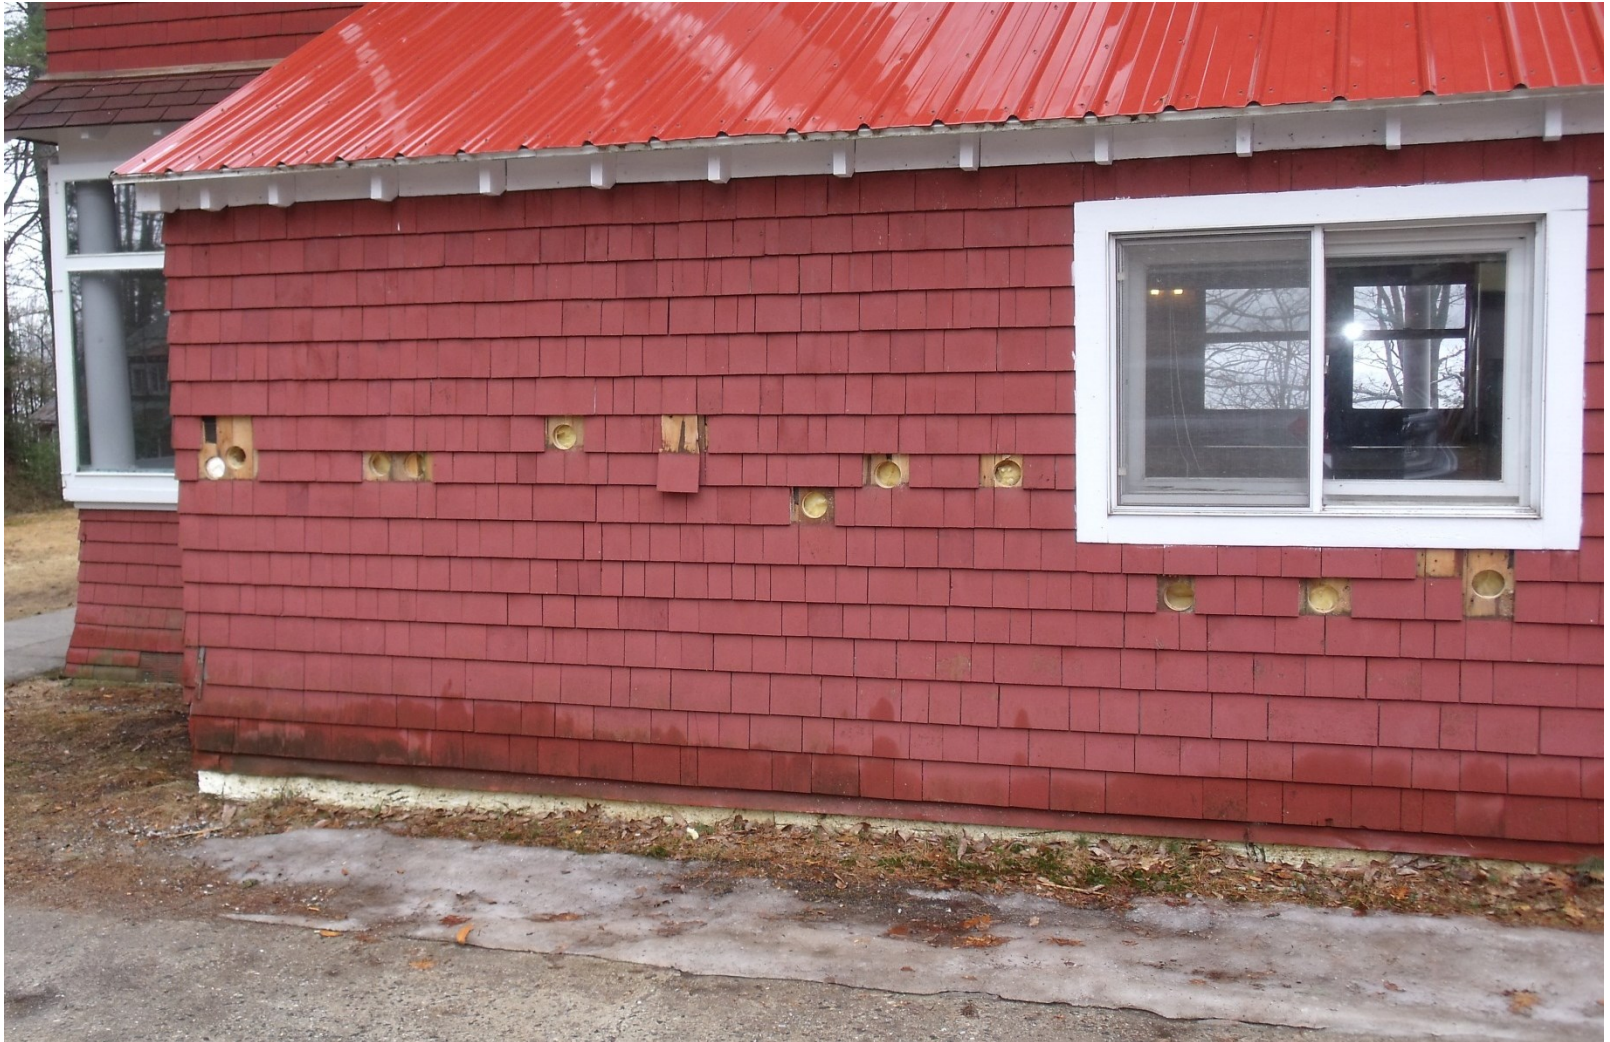
2013 1st Ductless Heat Pump: one DHP serves about 2/3 of home, 1.5 ton

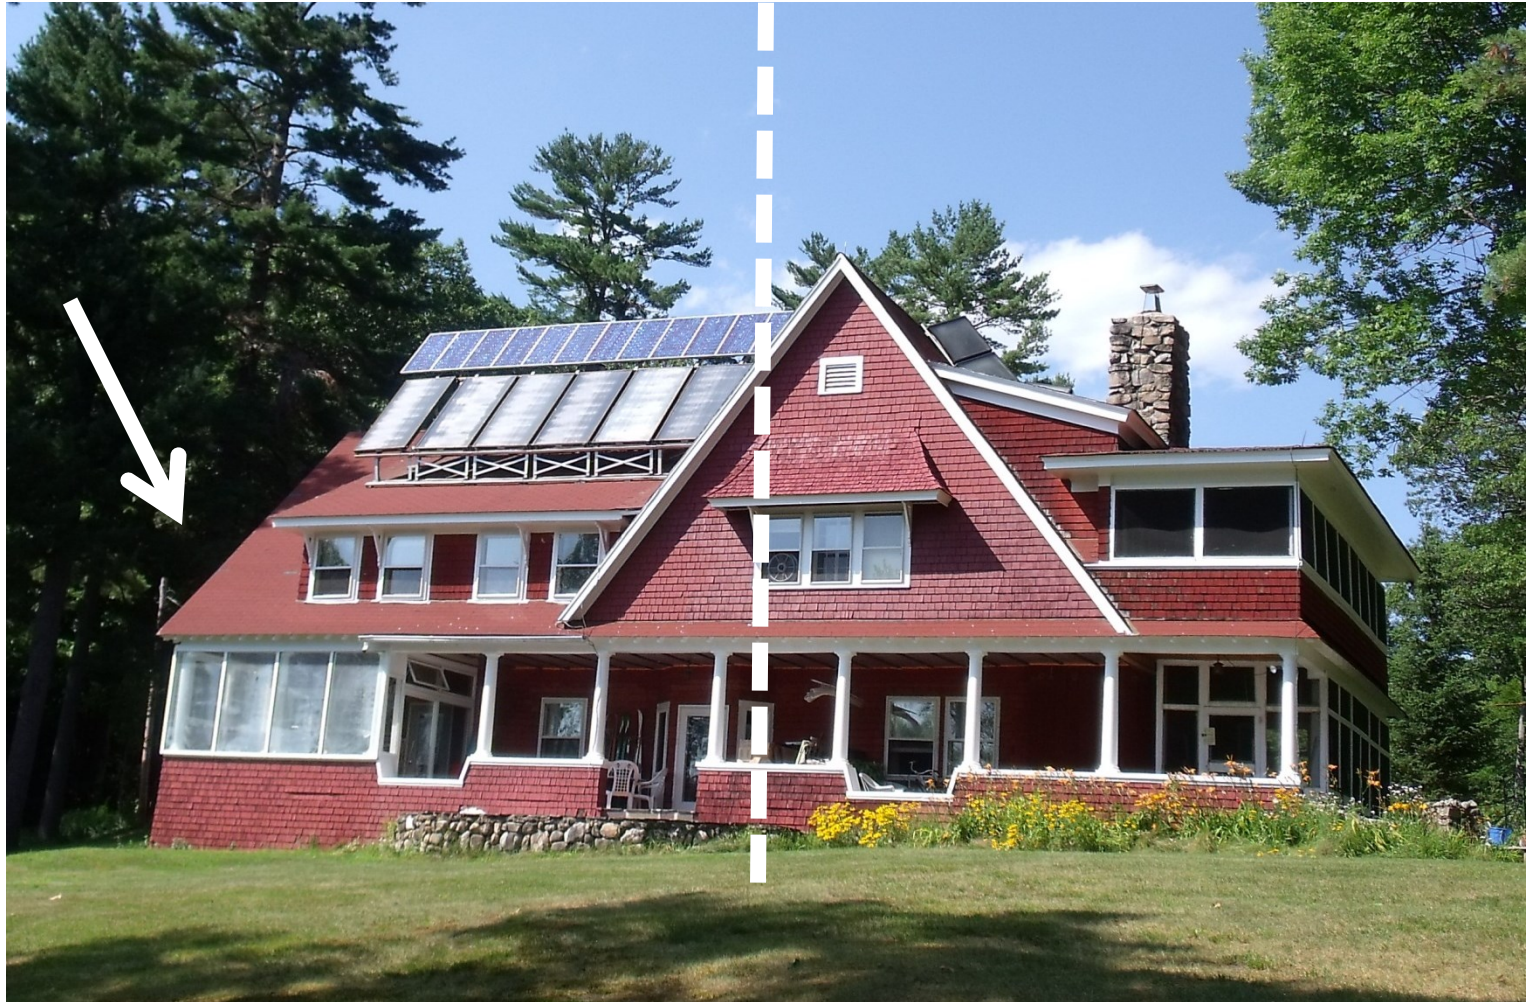
Outside Unit (3 ft. above earth, out of snow, SW exposure)

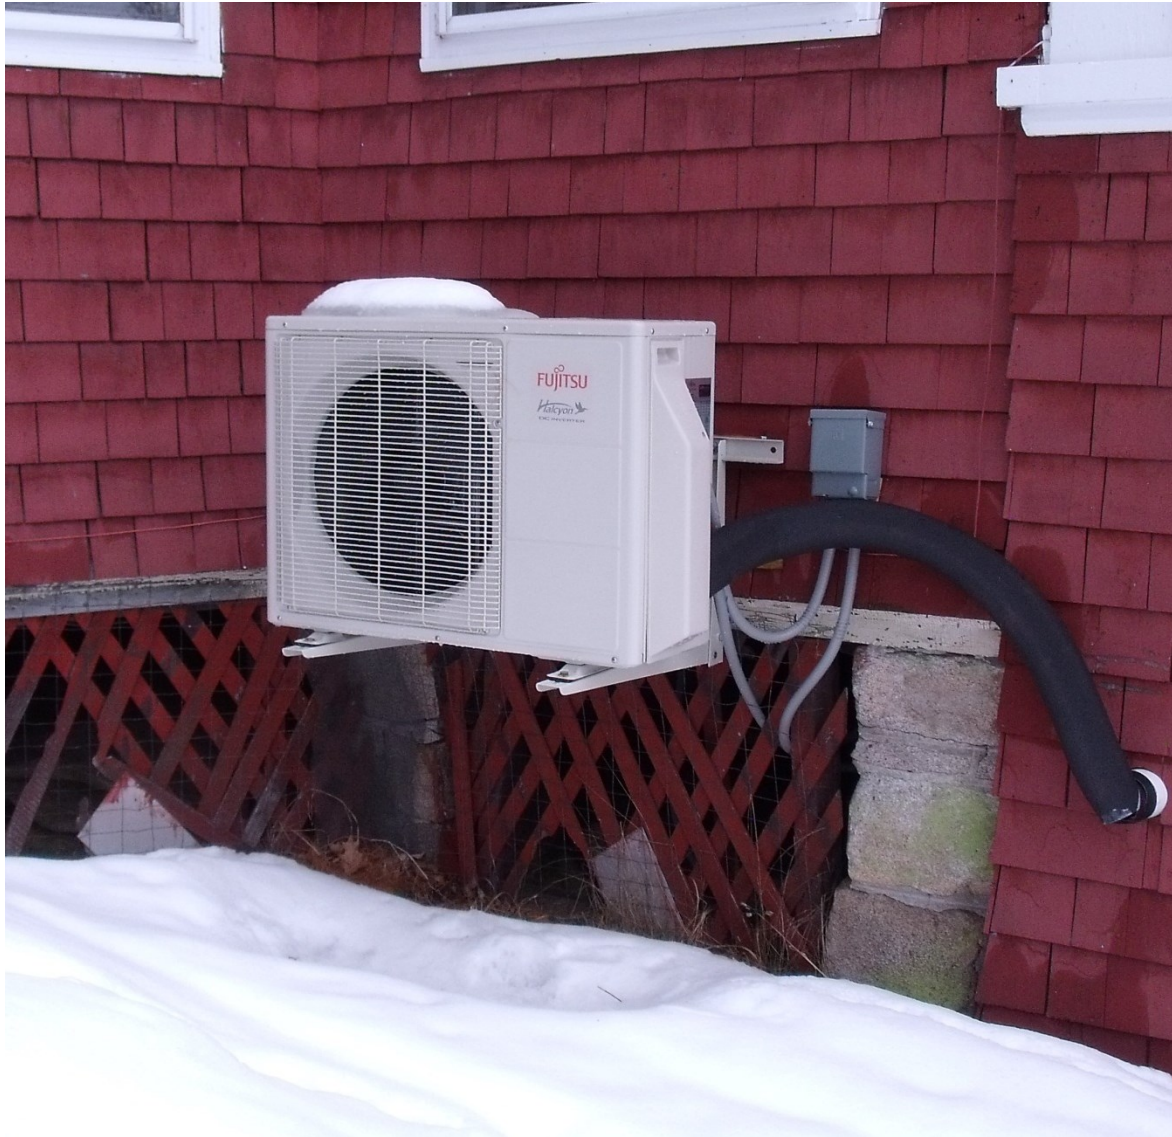
Inside DHP Unit & Low Wattage Ceiling Fan

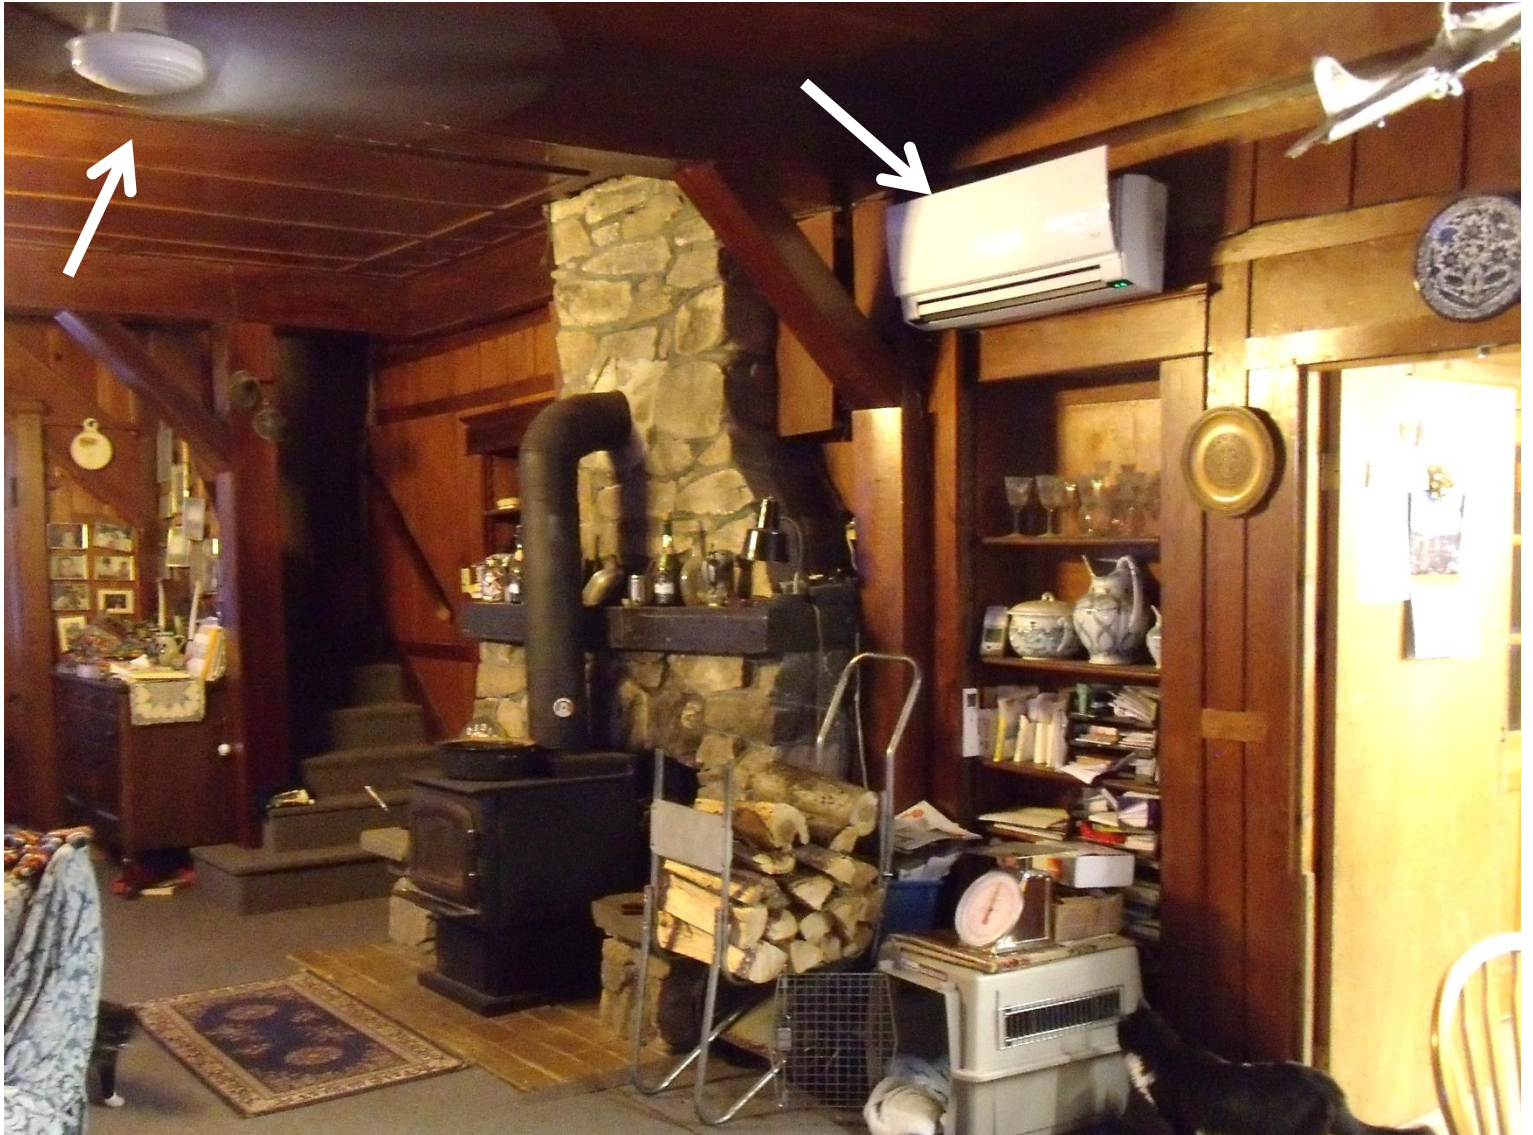
Pleasant Surprise DHP Sub- Meter \$30.00

(March 2013 about 0.33 kWh per DD) Cheaper than wood burning.

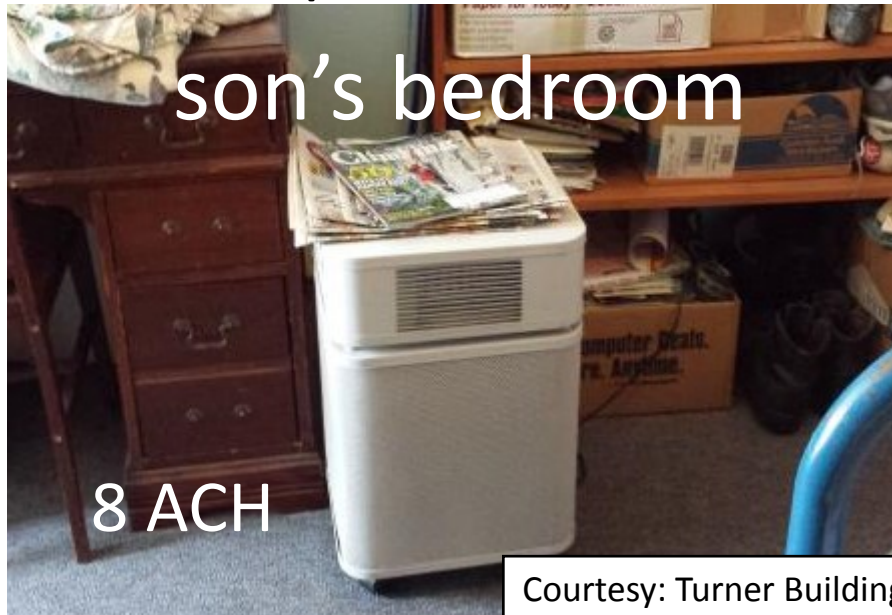
son's bedroom

8 ACH
