**LEA's Maine Lake Science Center
High Performance Renovation
Bridgton, Maine, 04009
8,000 Heating DD, 3,500 Sq. Ft.**

Goal of Project

Convert residential log cabin with attached garage into a year-round institutional science center with lab, conference room, offices, & researcher housing

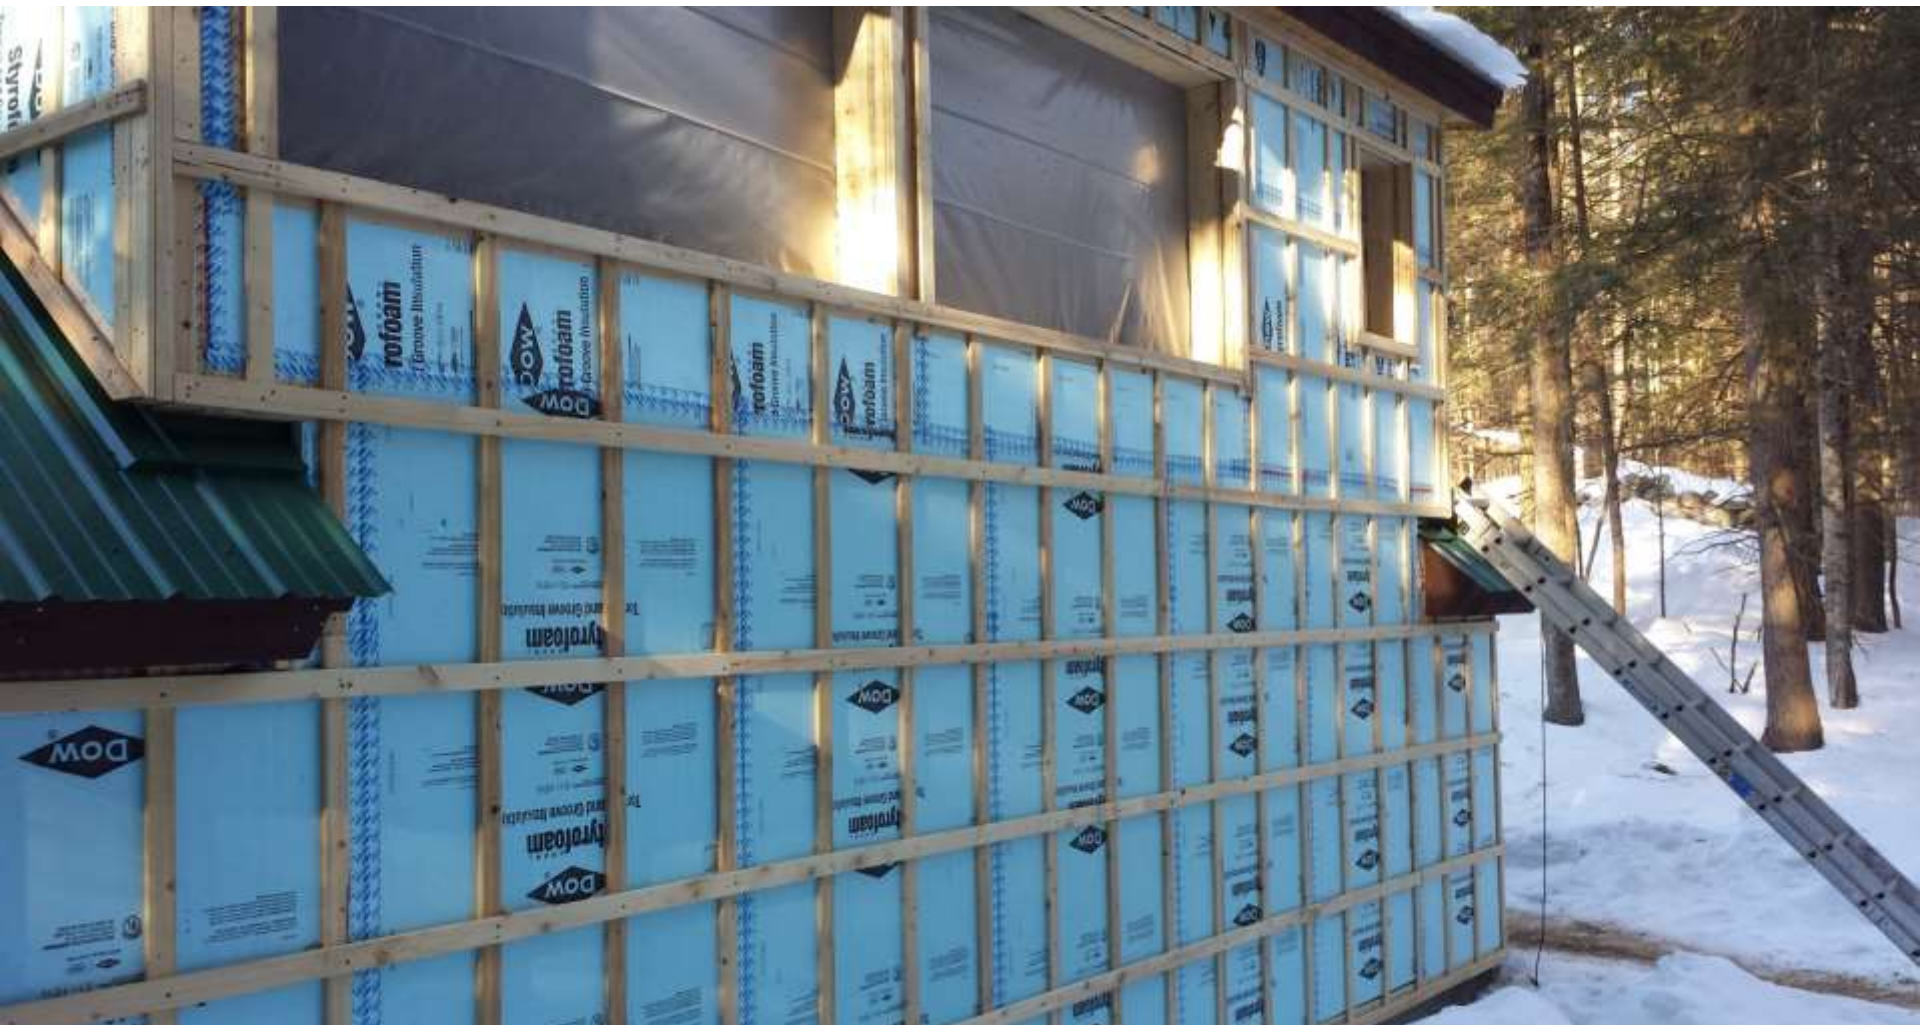
Original Garage

1.5 bay garage with
oil boiler room & oil tank

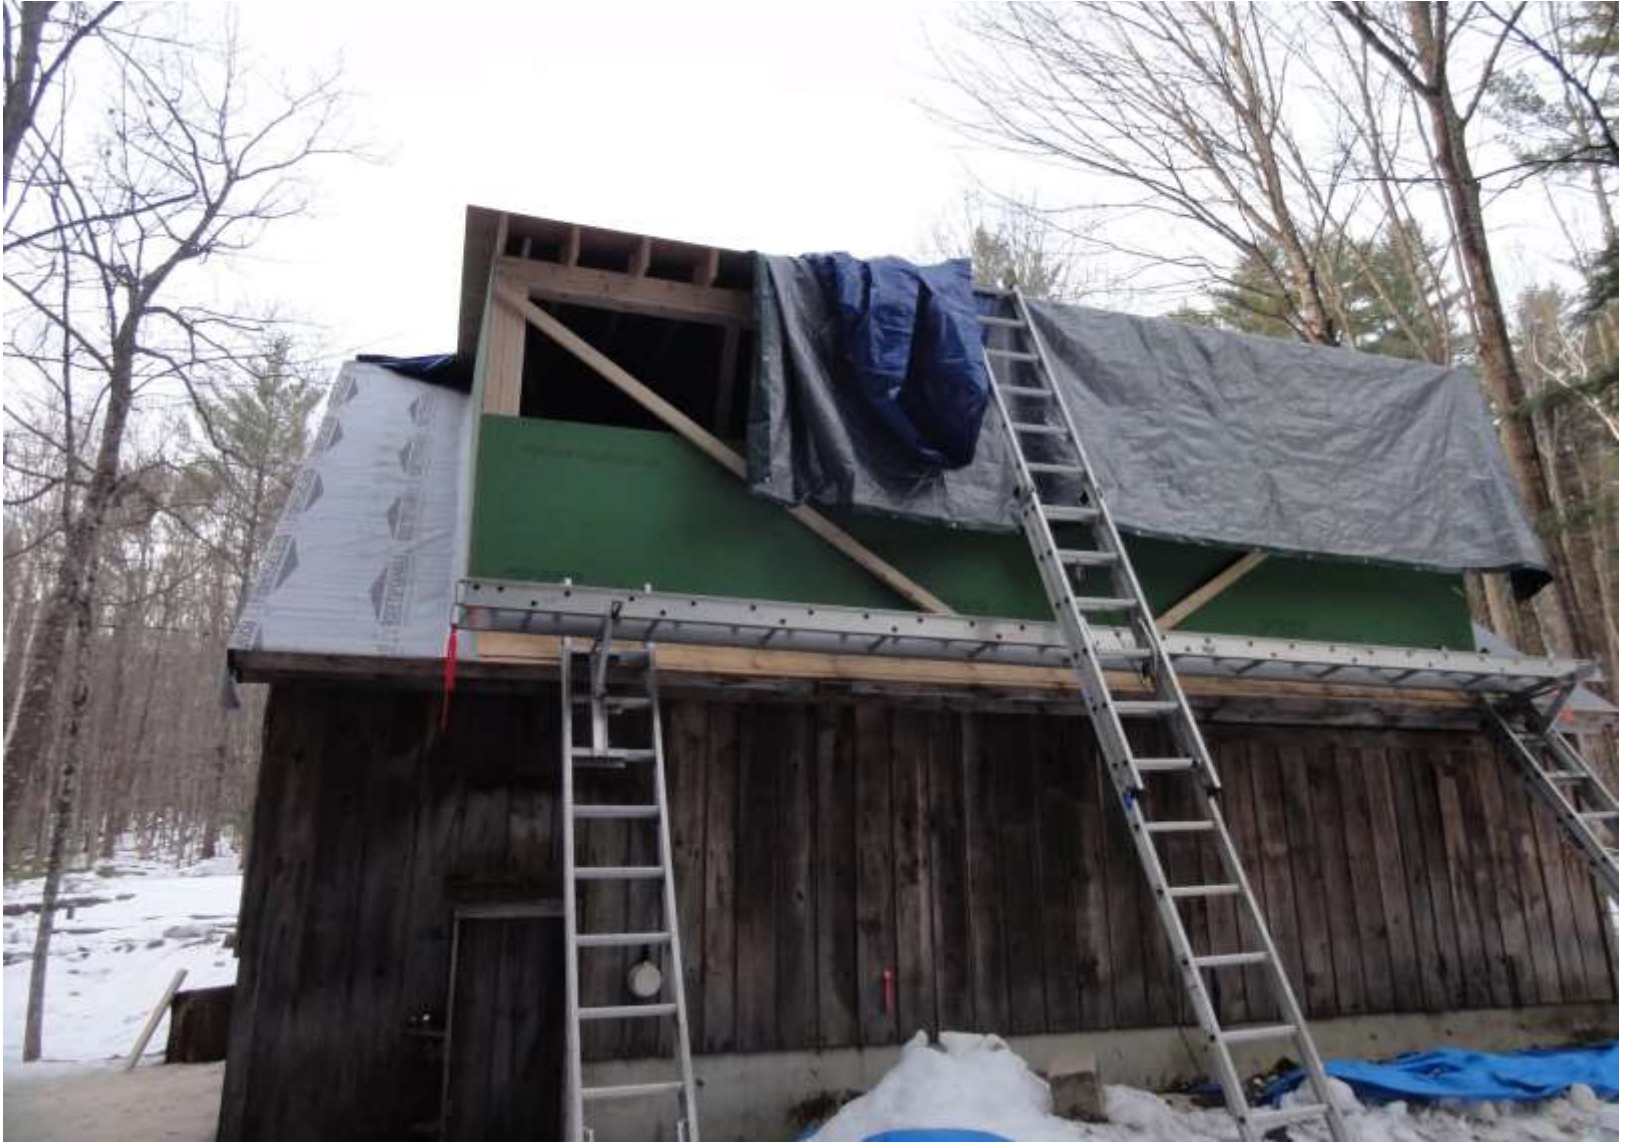
Wall Renovations

Exterior or Interior 2" XPS

Dormer added above garage for office space

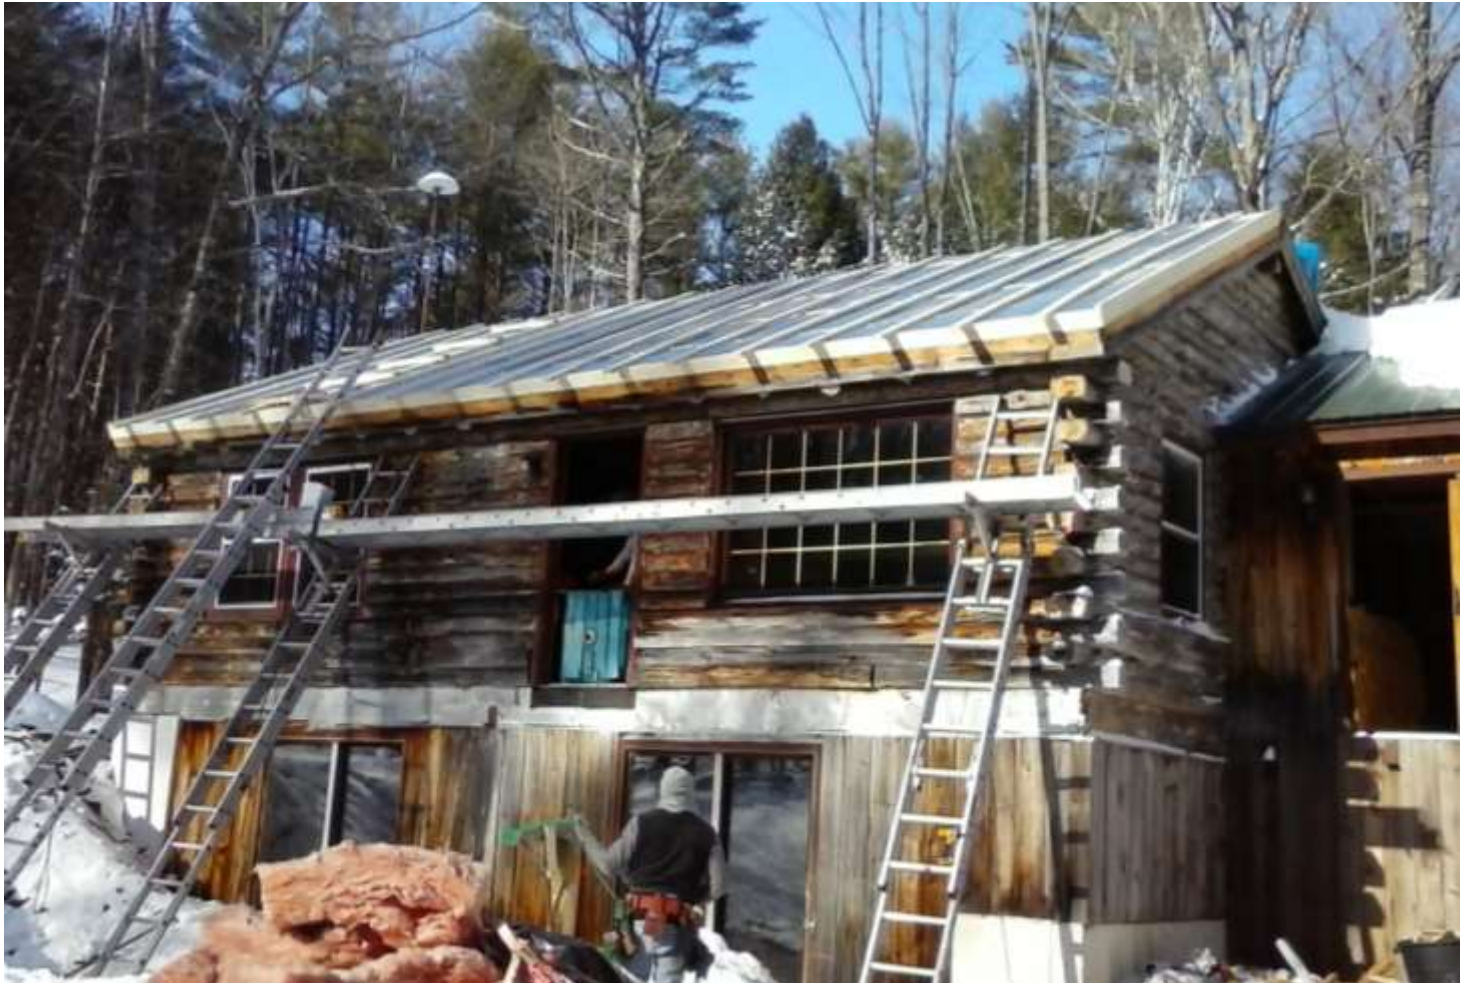
Roofs 4-6" XPS

Plus cellulose between rafters

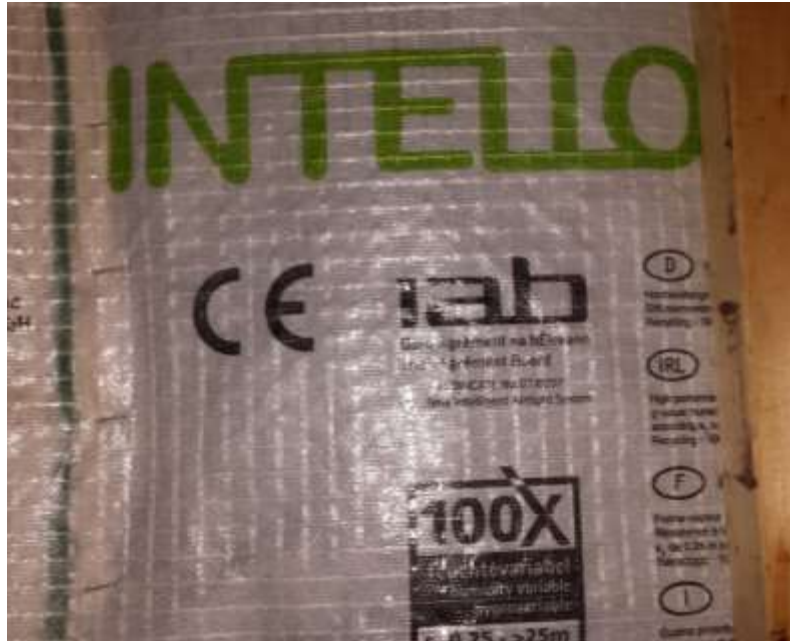
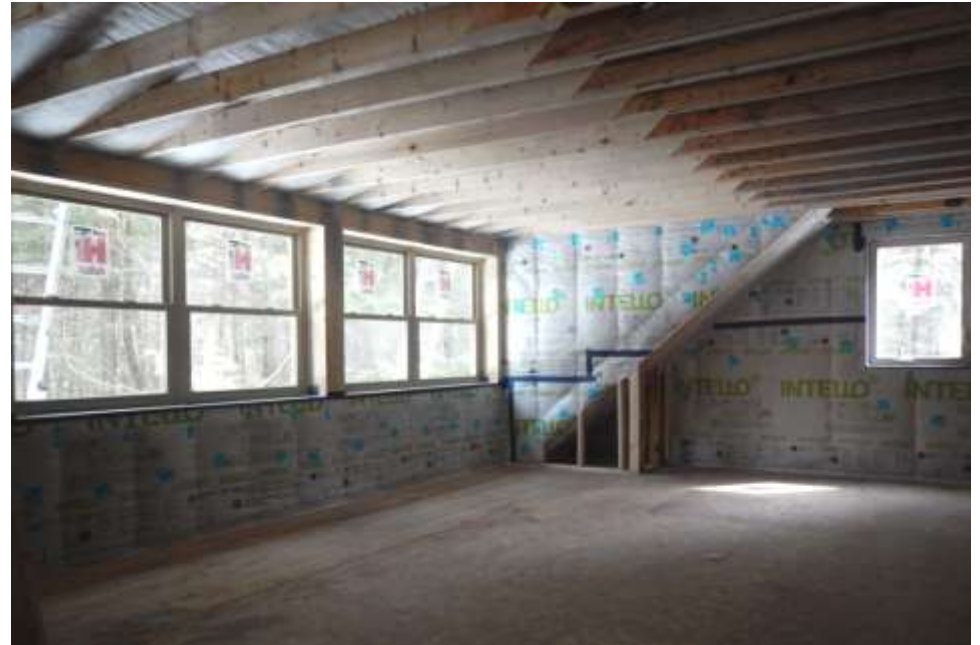
All Cavity Walls & All Roof Rafters Dense Pack Cellulose 6-8" or more

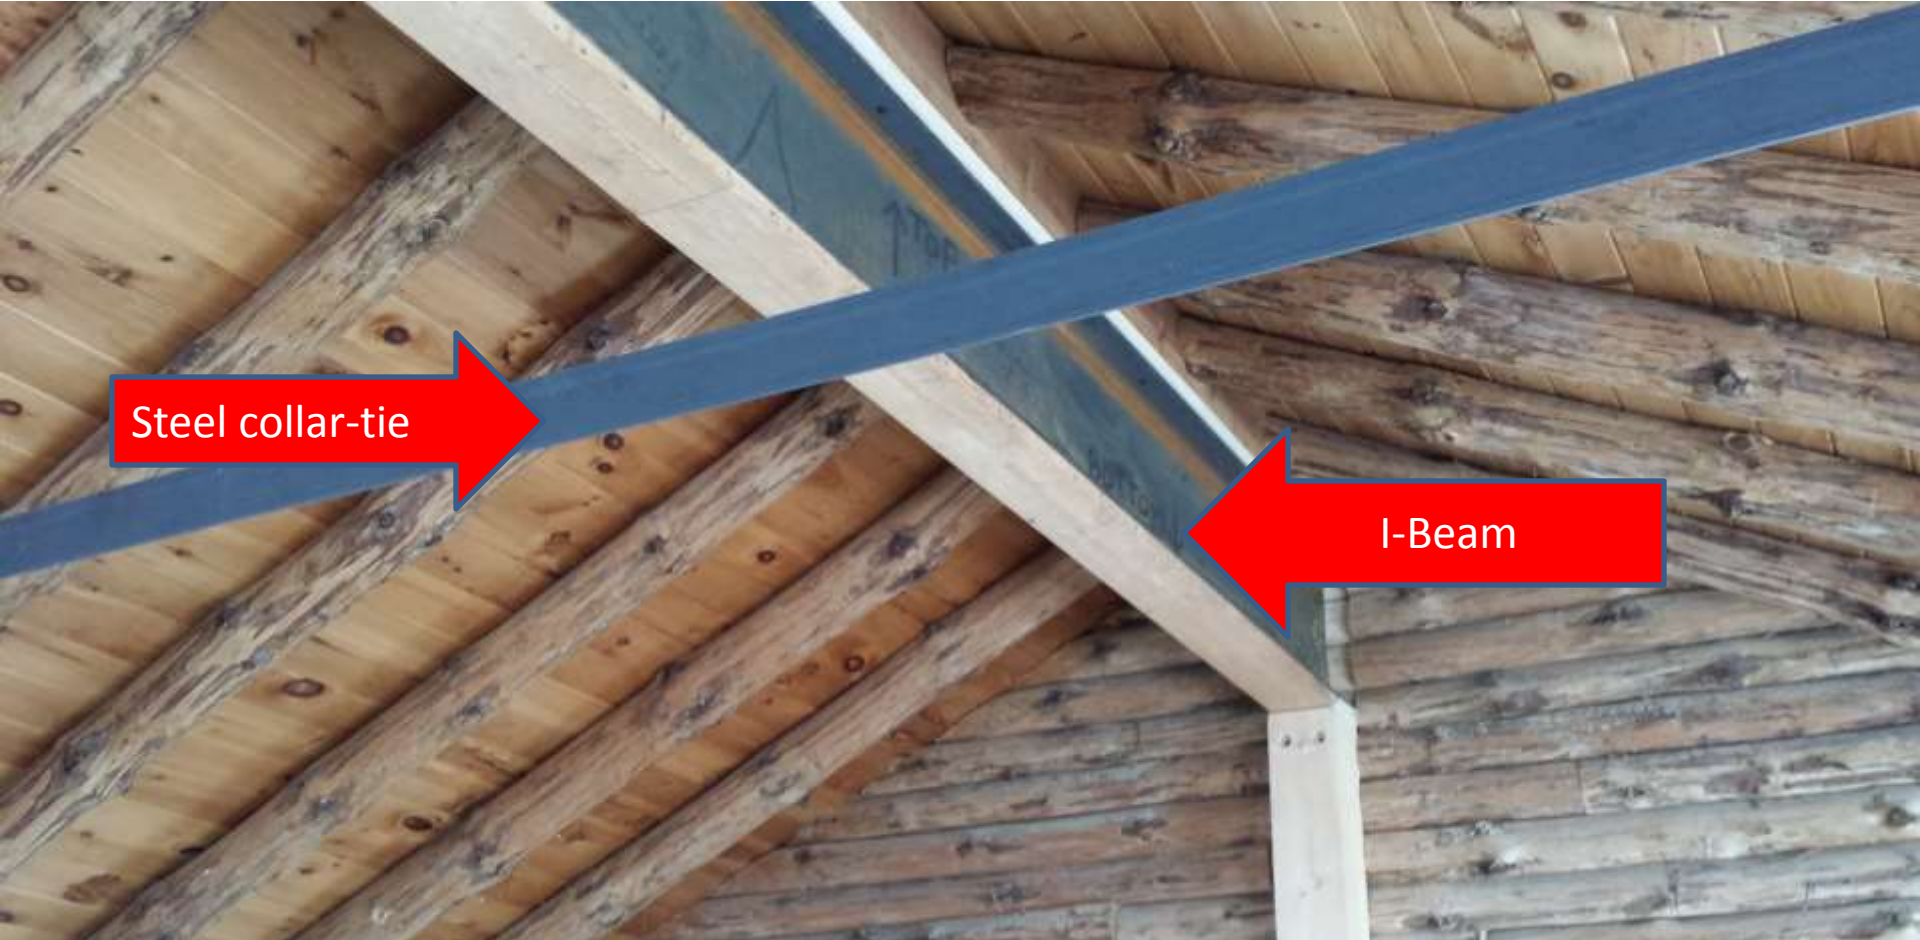
Interior Ridge Pole Strengthening

Thin, high, steel collar ties replaced one large and low, log collar tie – thus providing for a better view of the presentation screen. One large steel beam was also installed to carry the weight of the roof without the need of an obstructive post in the center of the room.

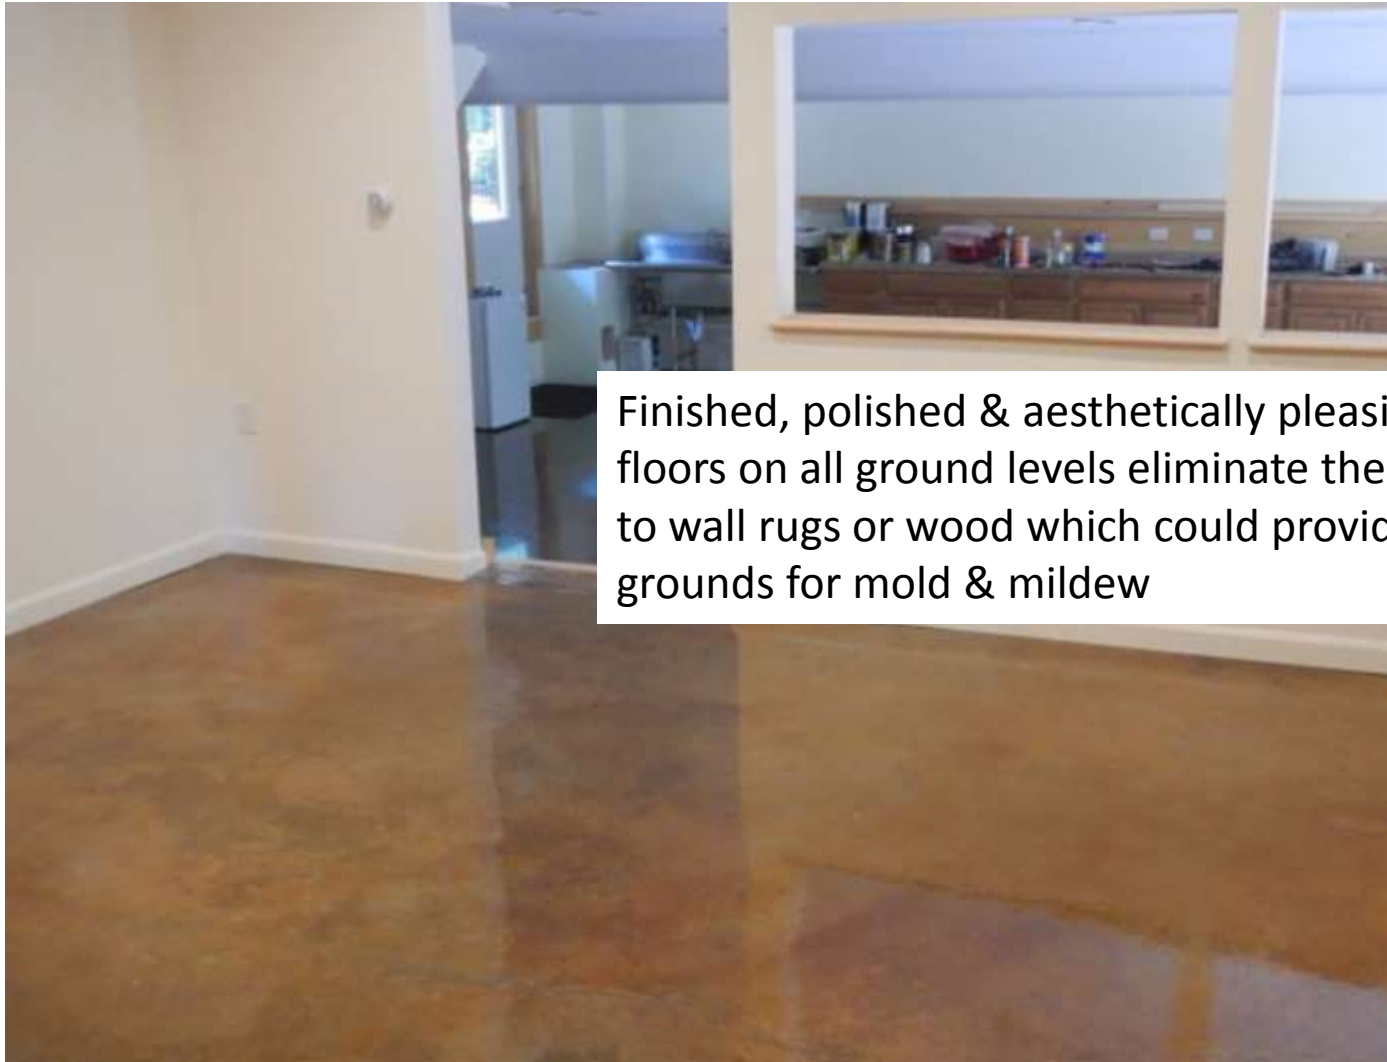
Ground & Polished Concrete Floors

Finished, polished & aesthetically pleasing concrete floors on all ground levels eliminate the need for wall to wall rugs or wood which could provide breeding grounds for mold & mildew

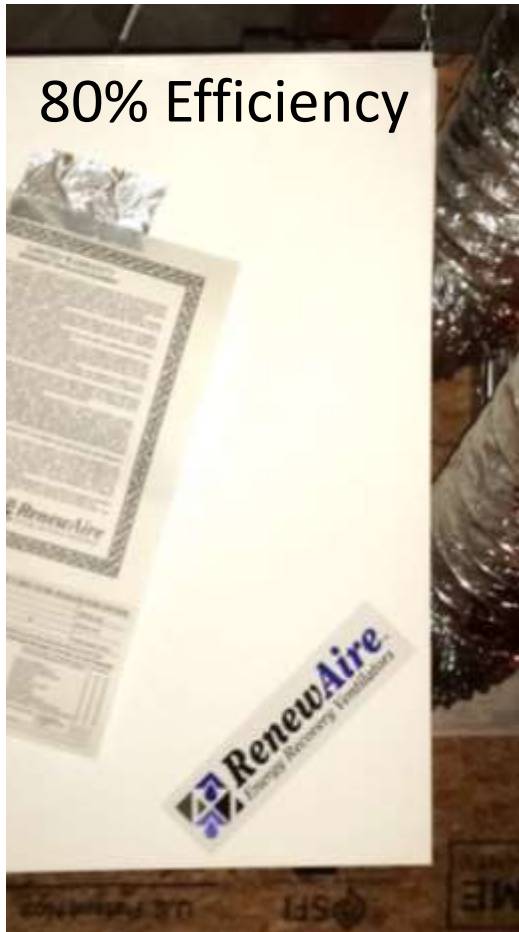
Ventilation with very limited heat loss & humidity controls

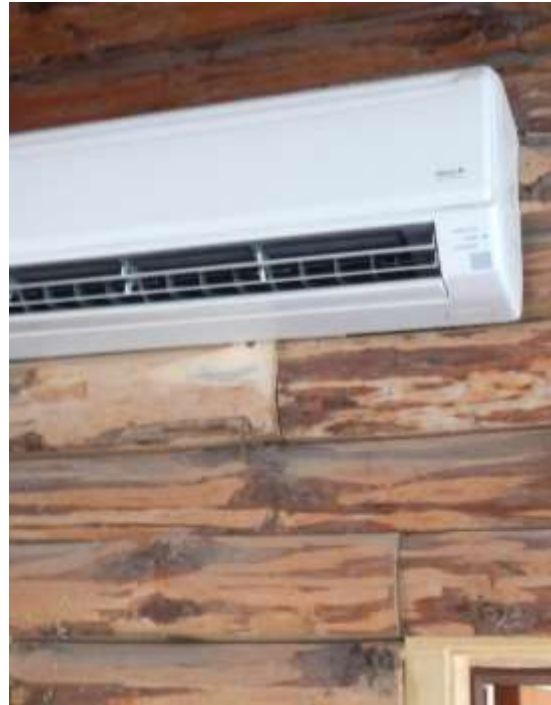
High efficiency heating & air conditioning

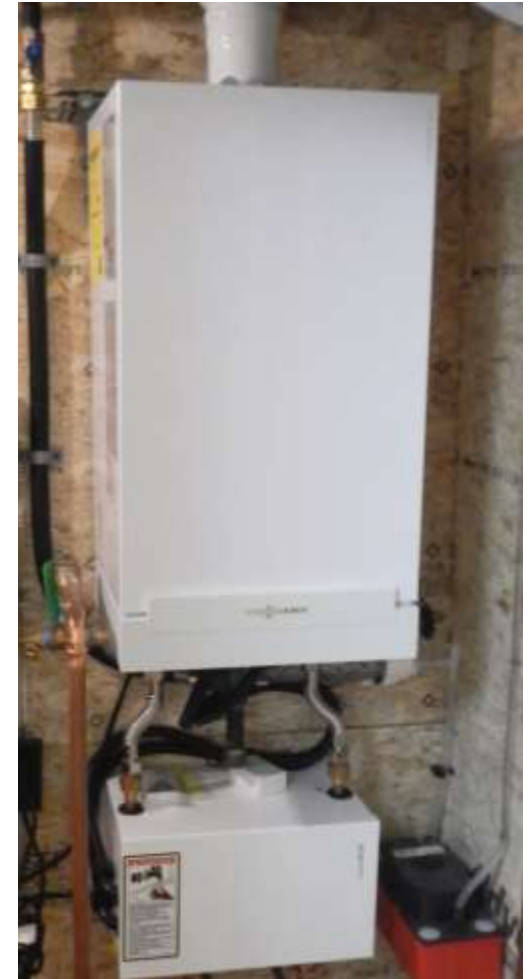
Efficient propane boiler

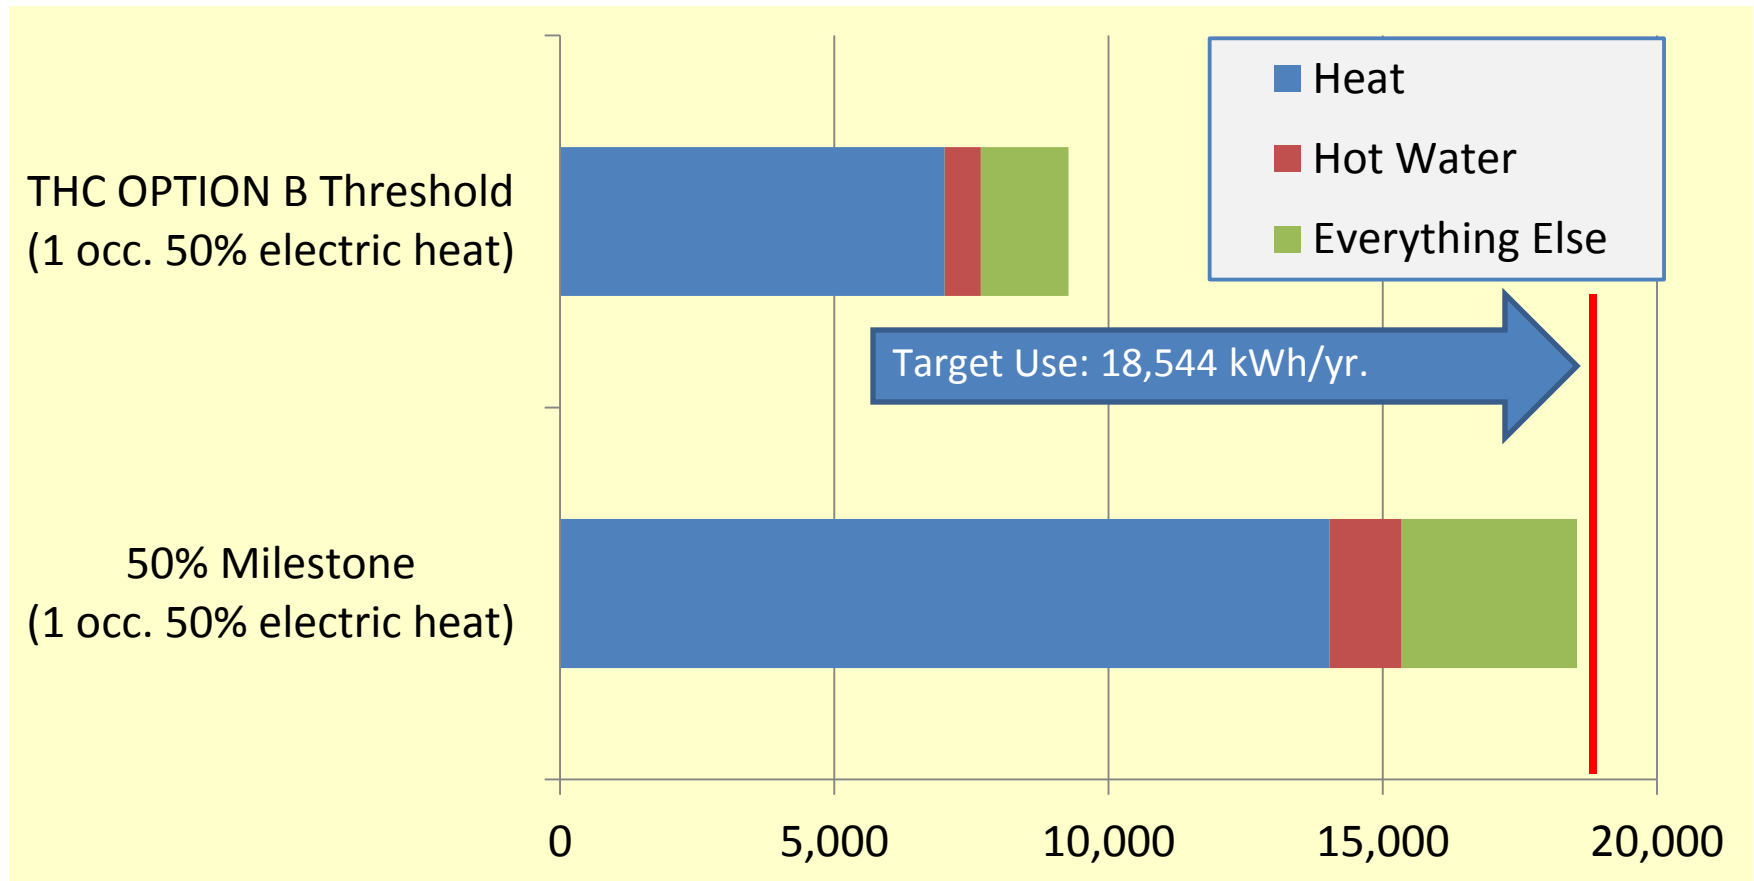
Thousand Home Challenge OPTION B & 50% Milestone Threshold in kWh/yr.

OPTION B Inputs: ZIP Code: 04009; 3,500 Ft² FFA; 1 occupant; 50% electric heat
