# Portland, Maine Loft

## Thousand Home Challenge/Case Study

Richard Renner | Architects Revised 8/06/2015

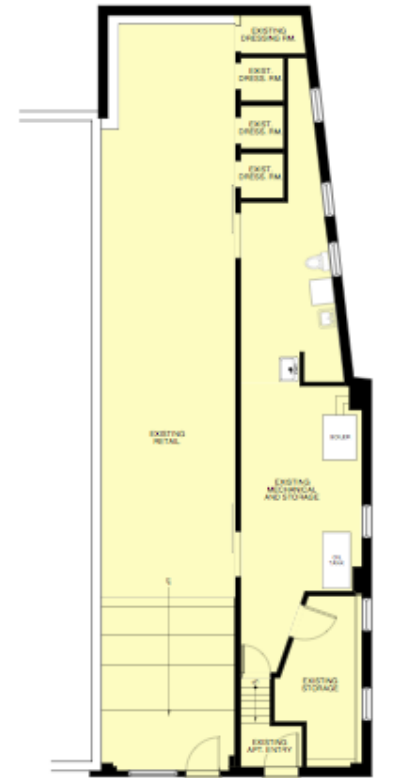
Original Floor Plan

Existing Loft/Storage Plan  
(Apartment)

Existing Lower Level Plan  
(Retail)

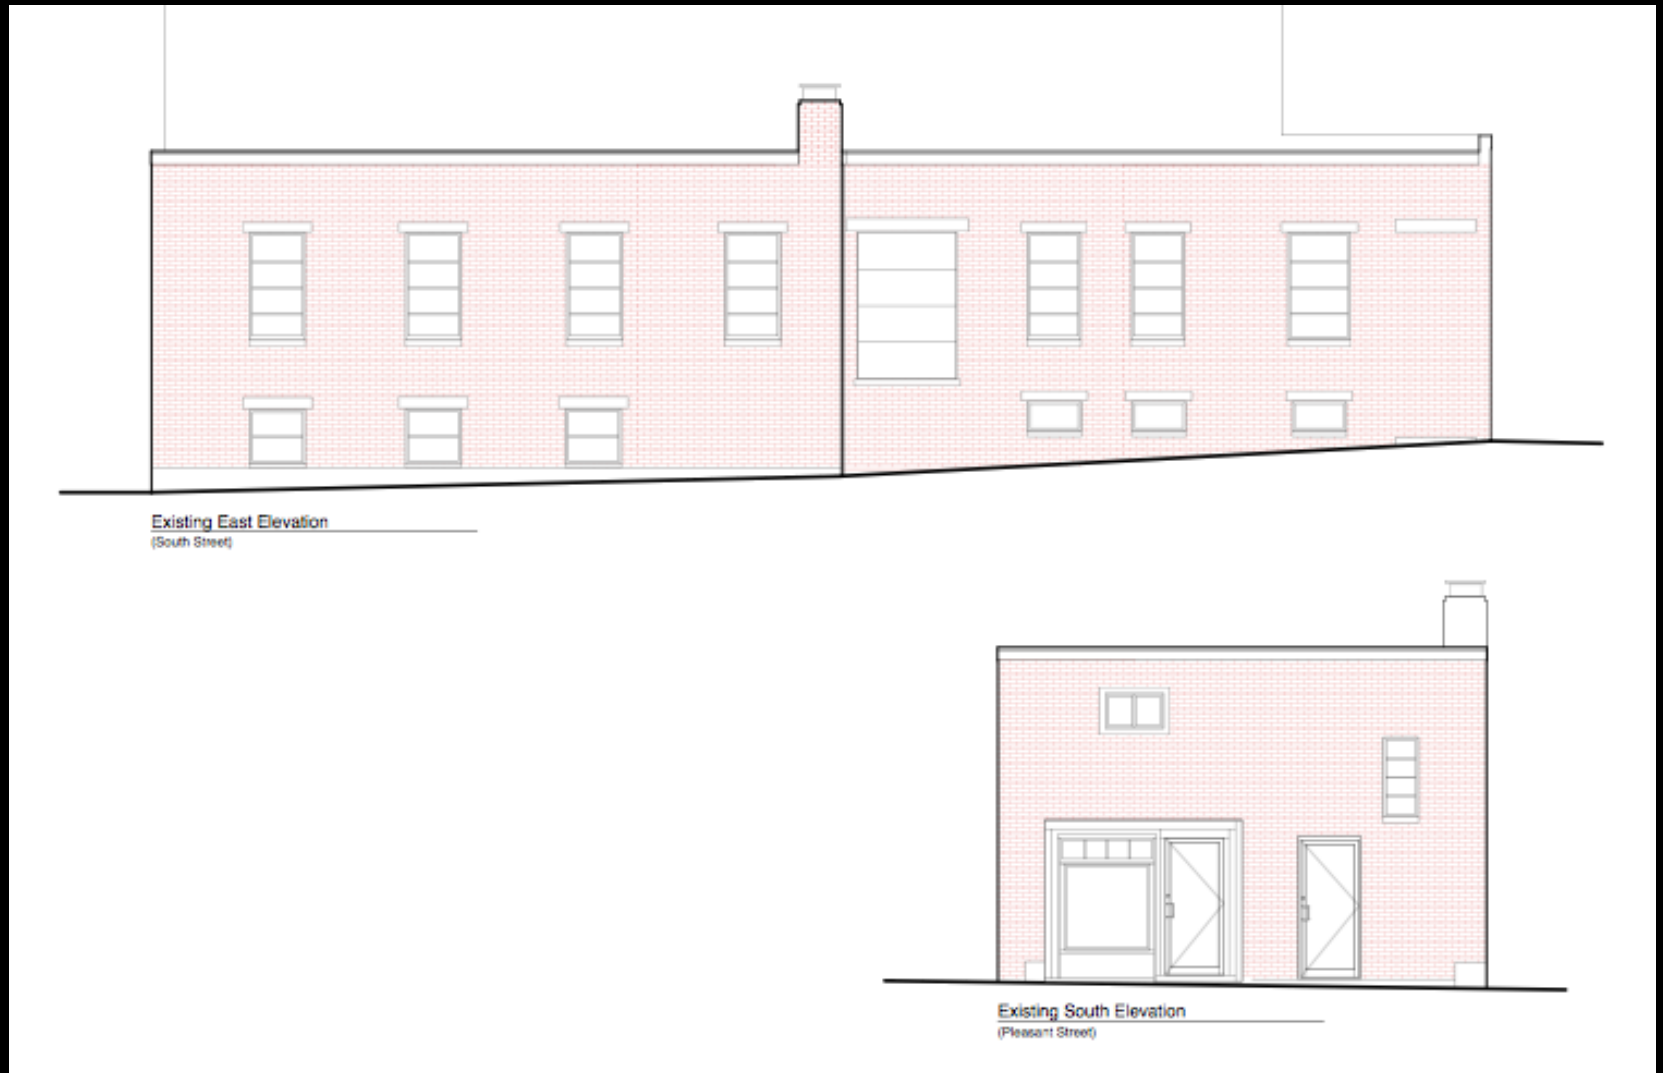
Original Building Elevation

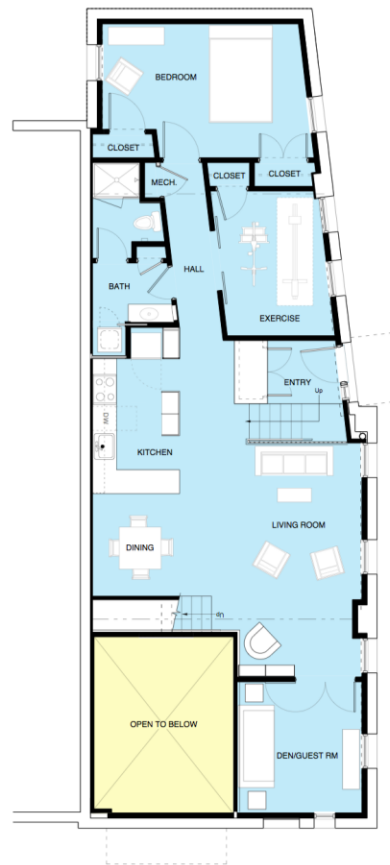
Completed Floor Plan

Loft Plan  
(Apartment)

First Floor Plan  
(Apartment)

Lower Level Plan  
(Professional Office)

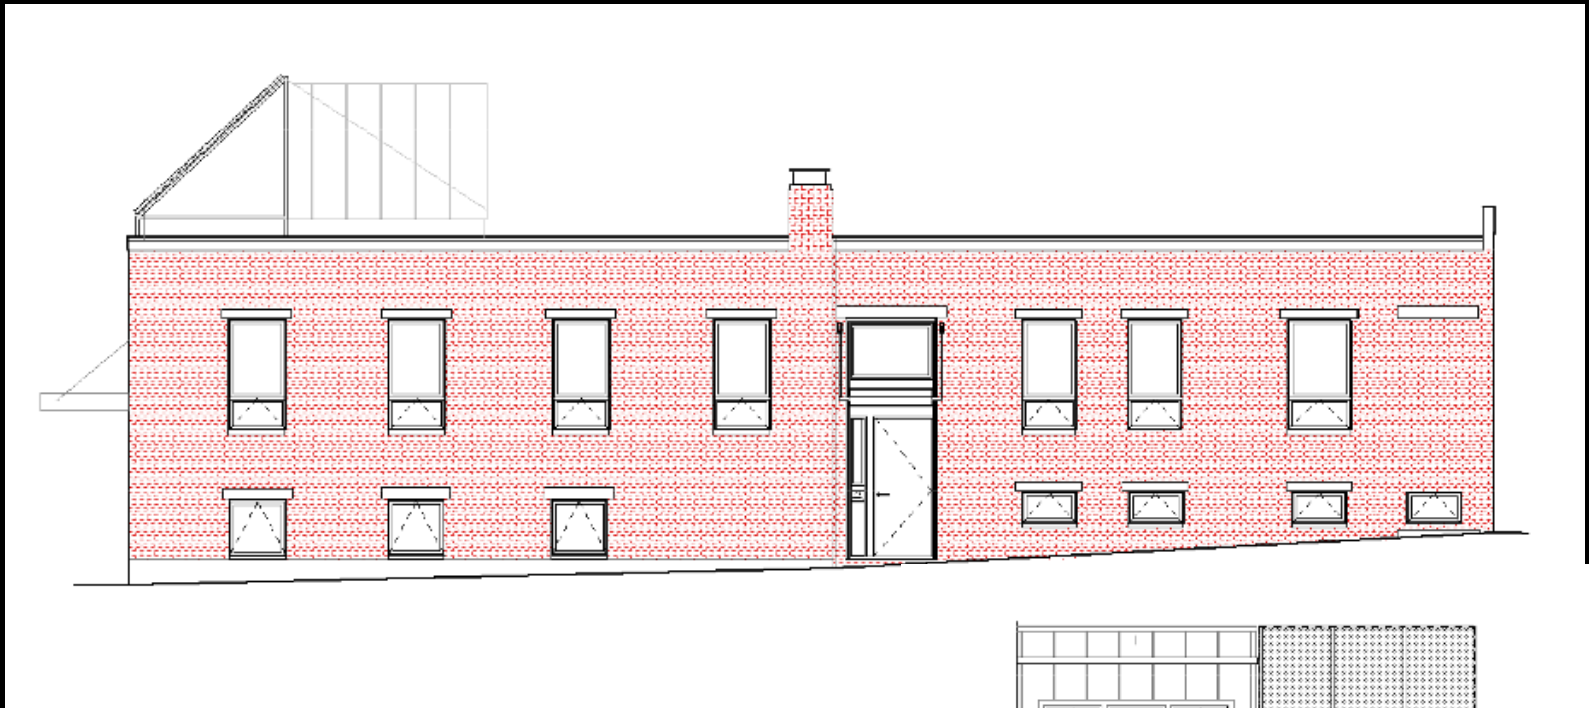
Completed Building Elevation

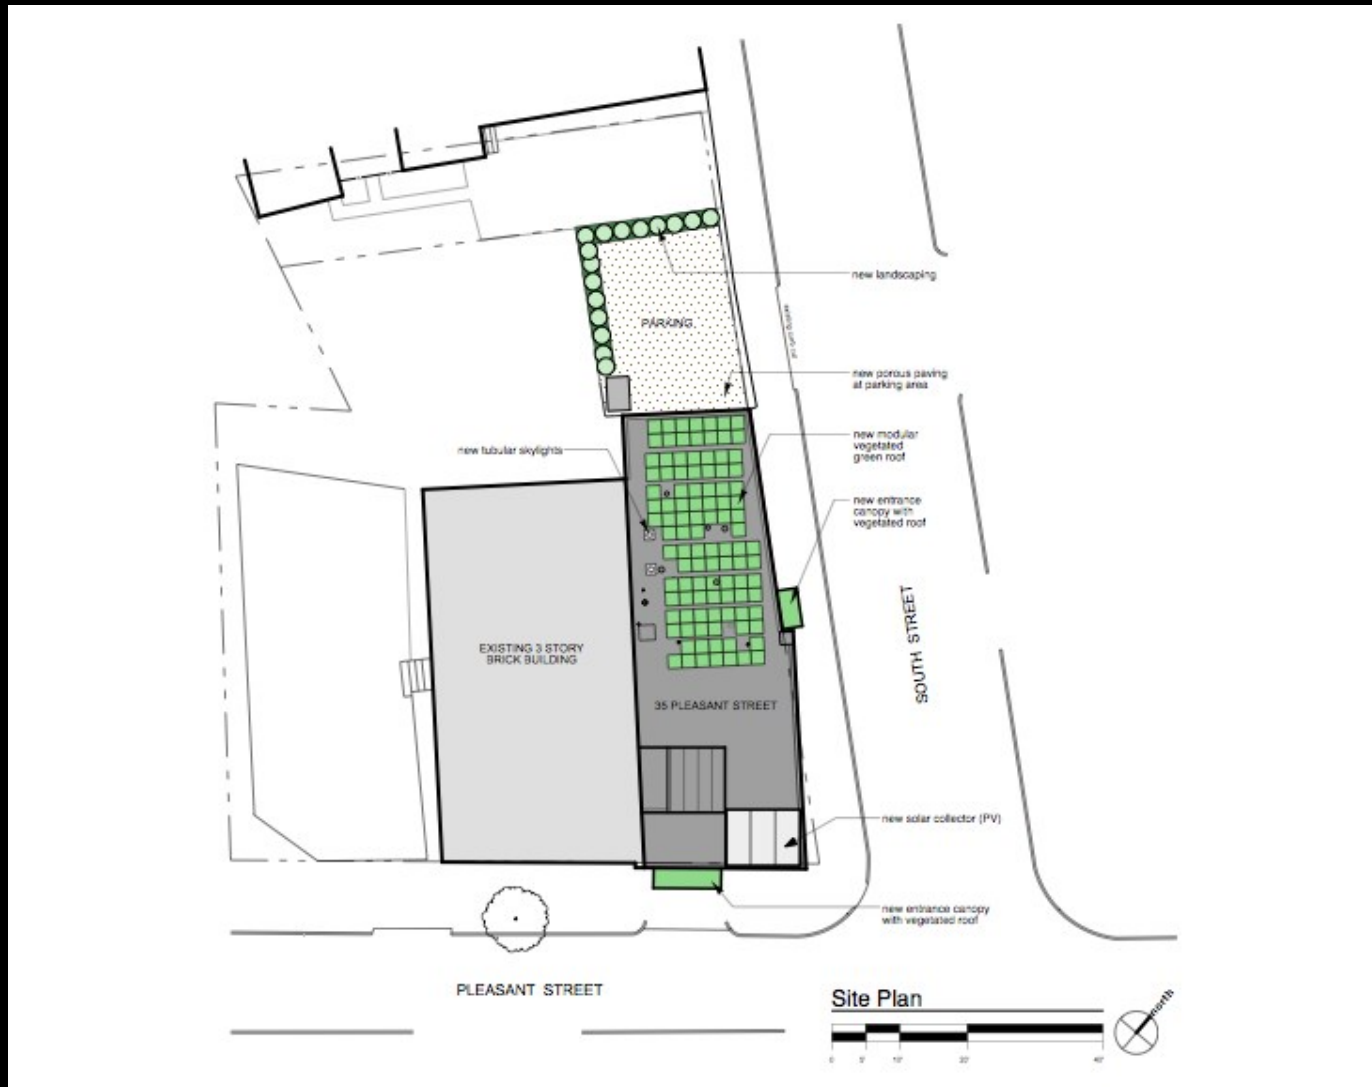
Site Plan - Completed

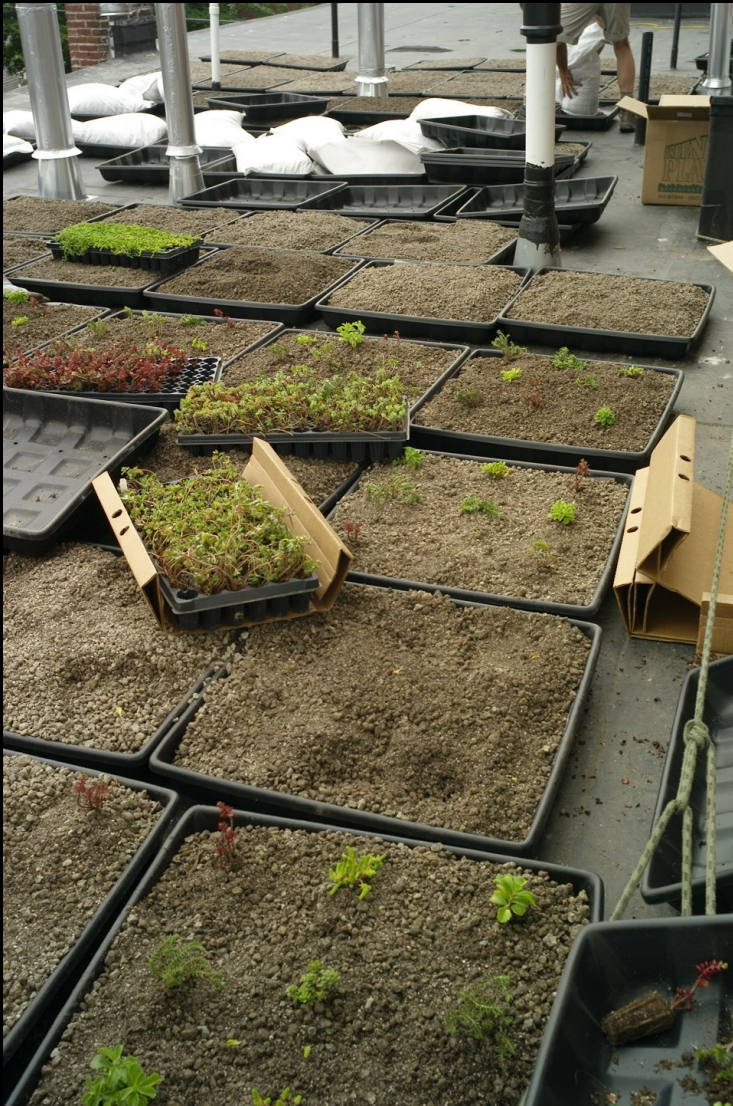
Installation of vegetated roof

Roughly 1/3 of the roof is covered with vegetation in trays. This reduces runoff from the hard surface of the roof and may reduce cooling loads in the summer.

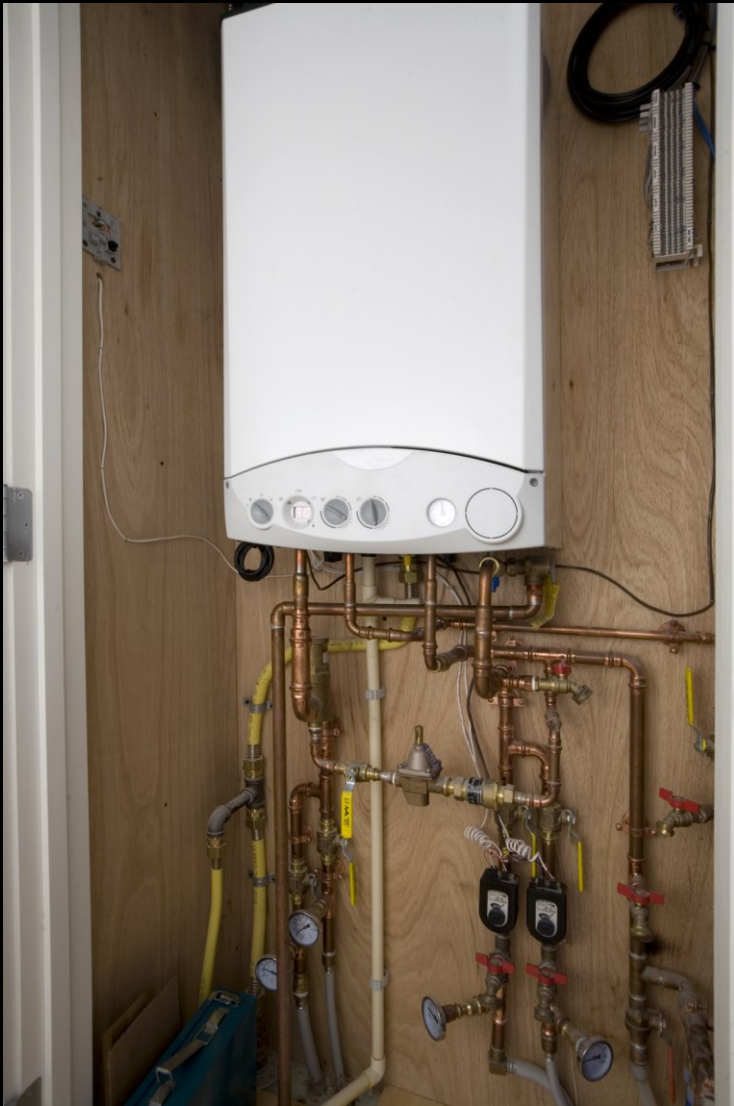
Boiler - Heating and demand hot water

Mechanical systems for the loft and the office are completely separate. The loft has radiant floor heating, a heat recovery ventilator, and a two-zone mini-split air conditioner. The 1 KW grid-tied solar collector serves the loft. There is a two-zone mini-split air conditioner to cool the unit in very hot weather; it is seldom needed.

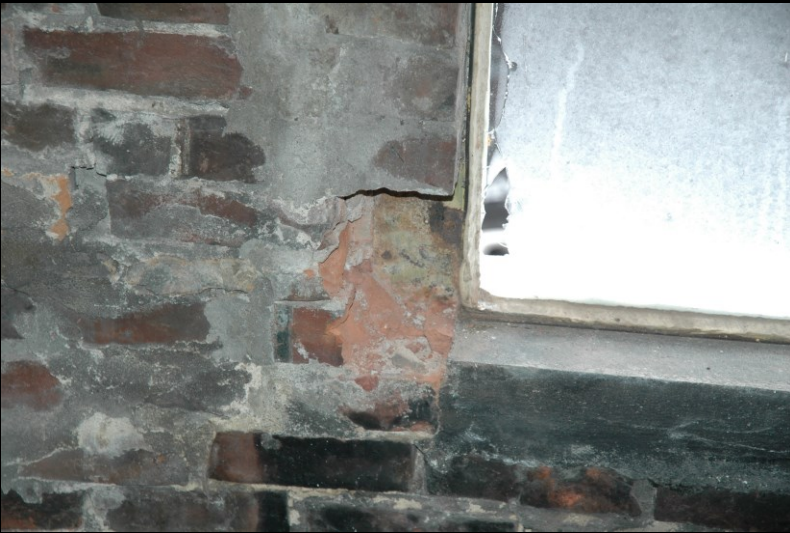
Demolition - Existing single-glazed, steel frame windows had to be removed, but they had steel flanges embedded in the surrounding brick. The windows were cut out of the walls, making it possible to install new triple-glazed fiberglass windows. Some of the removed steel window frames were cut into short lengths and used as door handles and drawer pulls in the new kitchen.

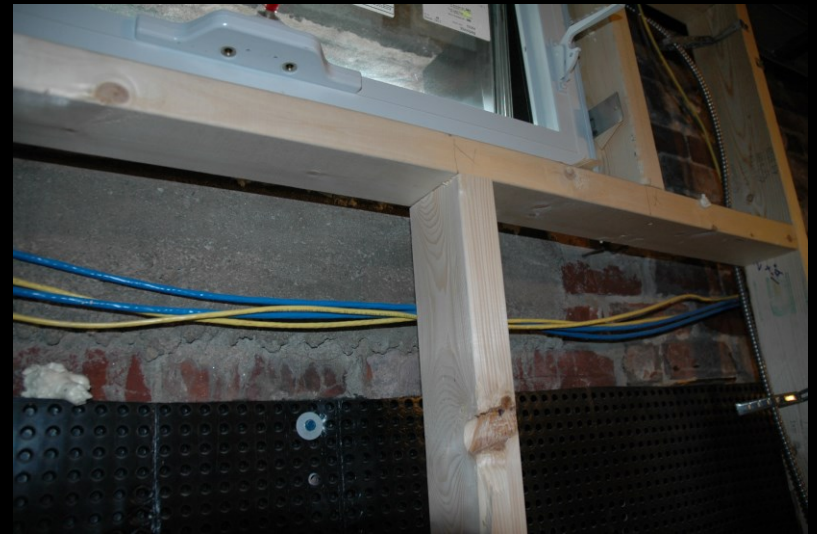
Gap between framing and exterior masonry wall to eliminate thermal bridging

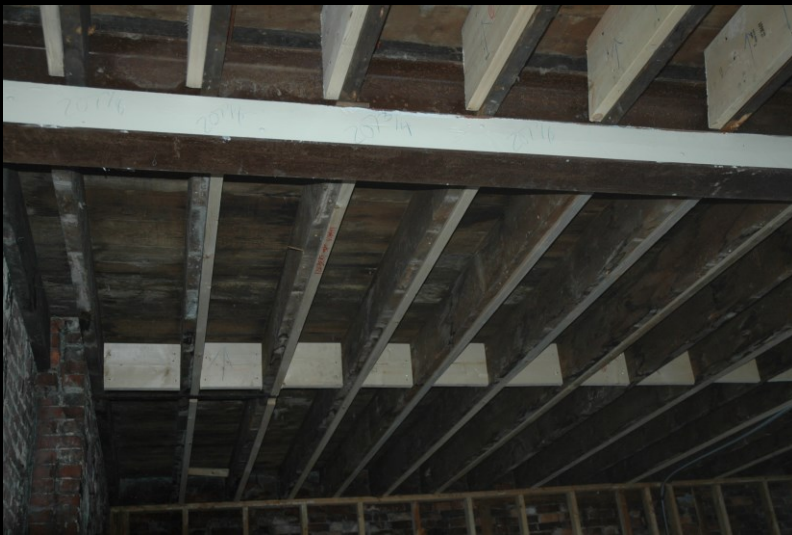
Reinforced roof structure

The existing roof structure had to be reinforced to meet code for snow loads and to carry the additional weight of the vegetated roof. Steel was added to the main cross beams, and existing joists were reinforced in three of the four bays. The roof monitor was added at the fourth bay. The windows in the monitor bring sunlight into the loft and assist with natural ventilation.

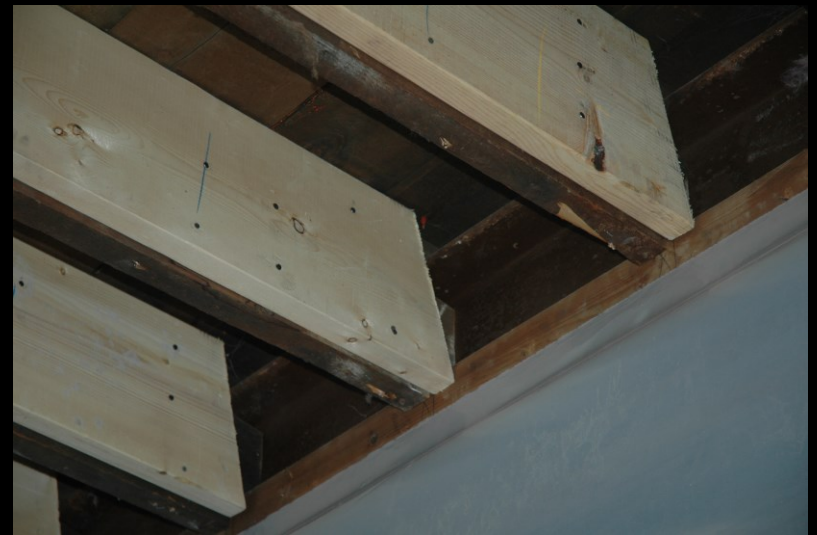
Detail of roof reinforcing

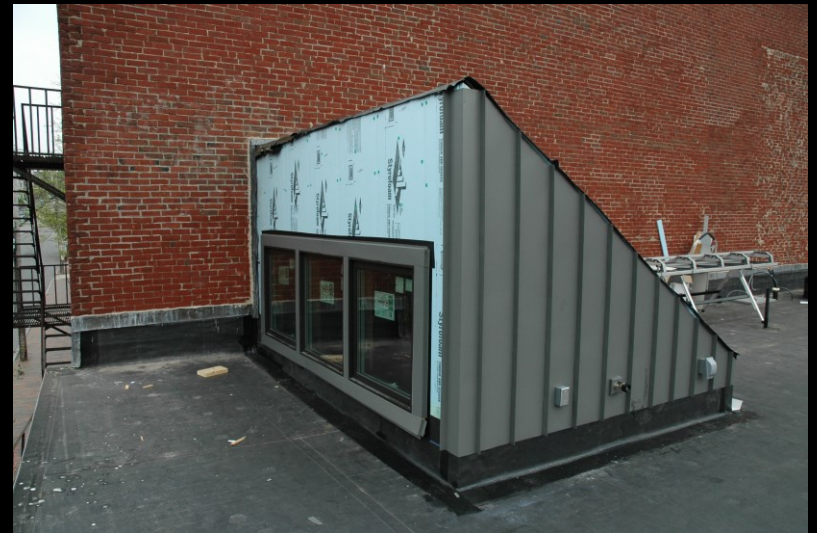
New roof monitor

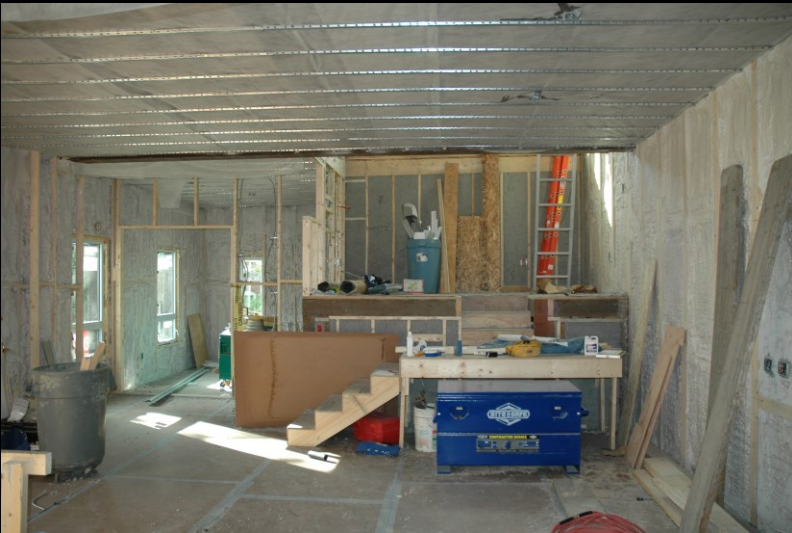
Insulation - Foam in walls; foam+cellulose in roof

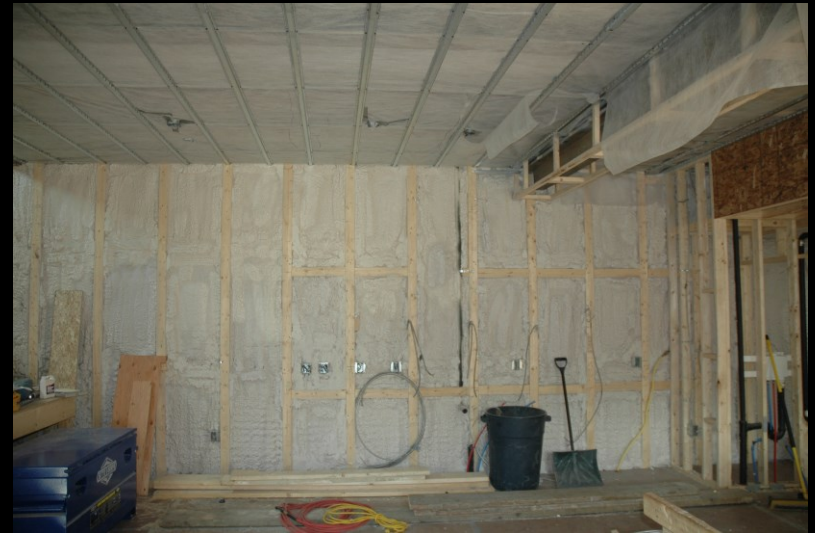
Foam insulation at party wall

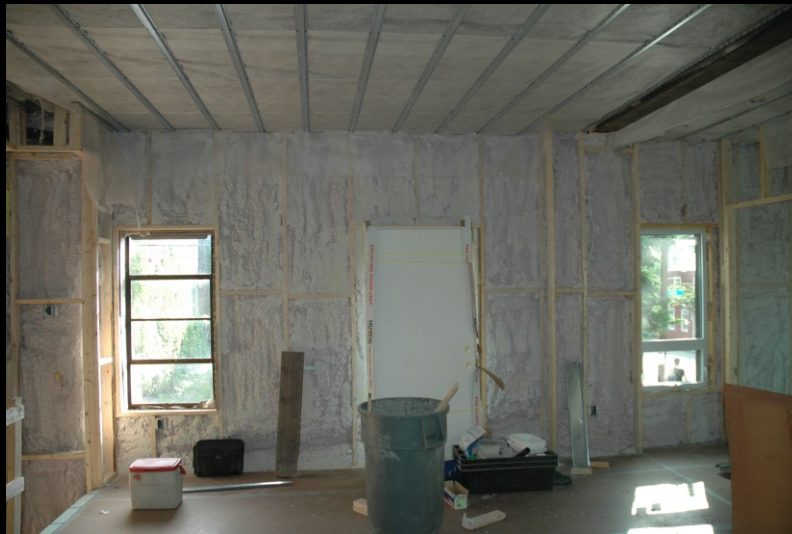
Foam insulation at exterior wall

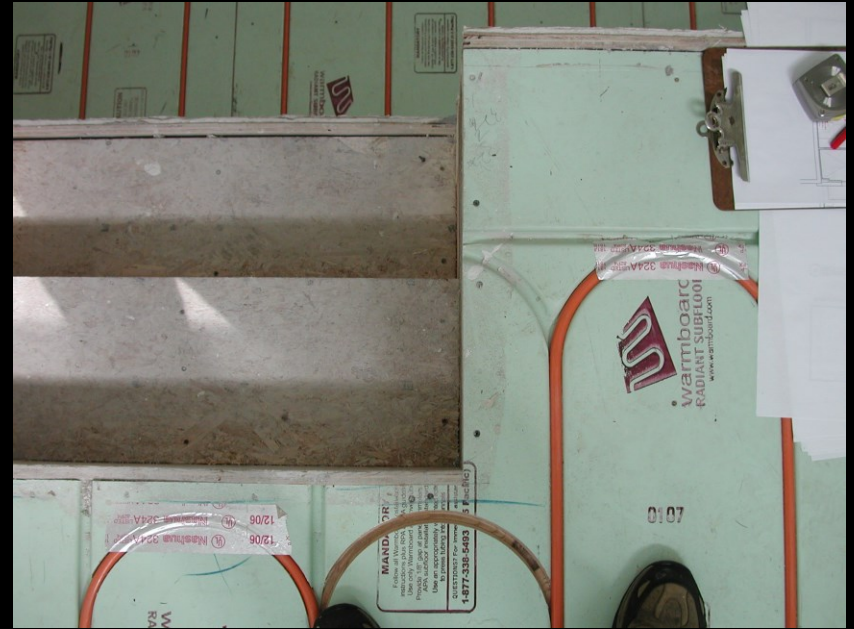
Warmboard detail

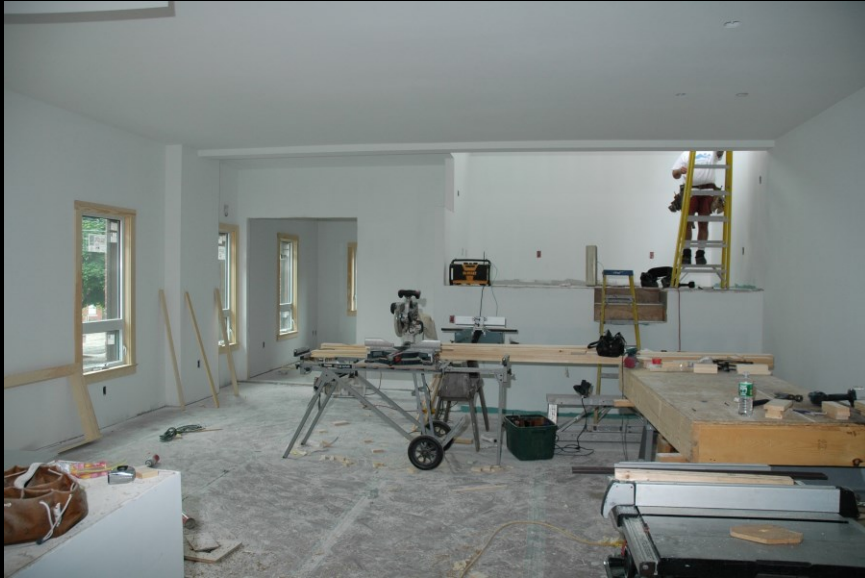
Installation of drywall and trim. Note that new windows are installed in the plane of the insulation, not in the plane of the brick wall. This was done to (a) maximize the continuity of the thermal barrier and (b) to maximize the size of the glass opening.

- Recessing the windows to maximize size and thermal efficiency required complicated head, jamb, and sill flashing. Snow frozen on the deep sill occasionally restricts the operation of the awning windows.

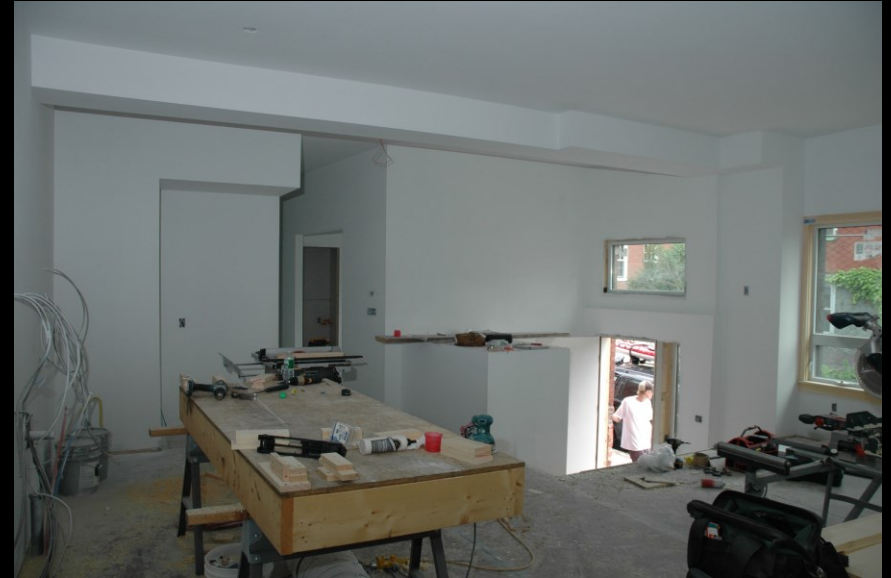
Installation of drywall and trim. Note the new entrance door at the level of the sidewalk. This was cut out of what had been a loading dock in this location.
