Portland, Maine Loft

[Full Case Study](#)
www.1000HomeChallenge.org
Updated August 06, 2015

Portland Loft

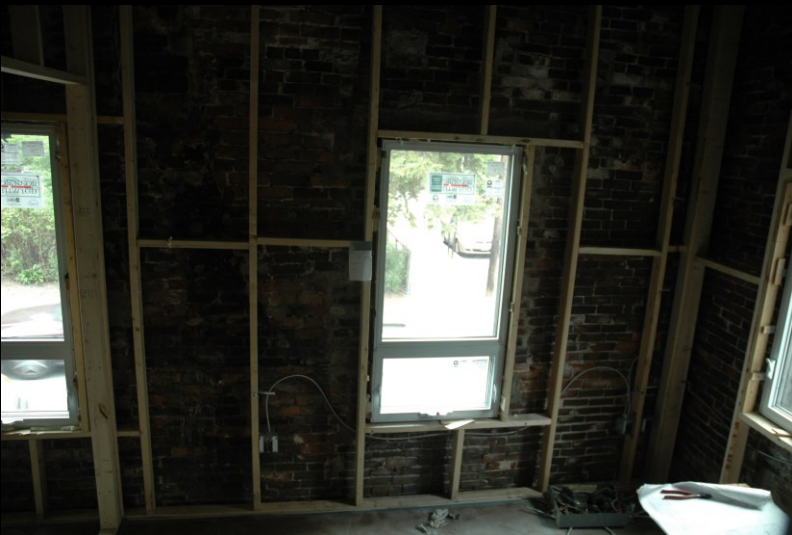
Framing at windows

- Locating the heat recovery ventilator above the bathroom ceiling makes maintenance more difficult. However, there was no other place to put it.
- Recessing the windows to maximize size and thermal efficiency required complicated head, jamb, and sill flashing. Snow frozen on the deep sill occasionally restricts the operation of the awning windows.

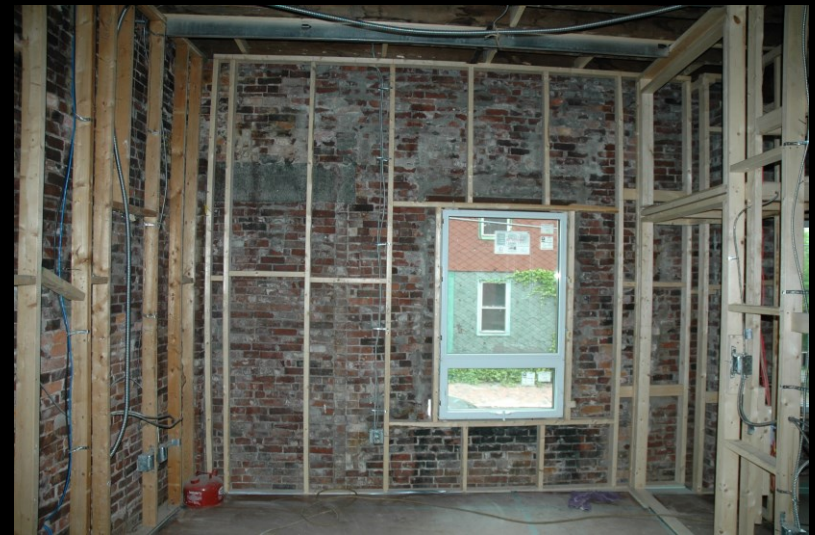
Framing at master bedroom

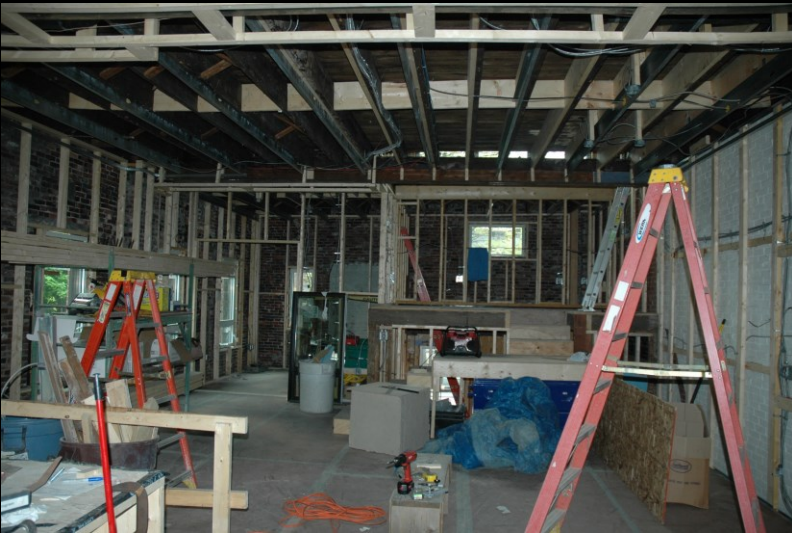
Framing - Loft, looking north

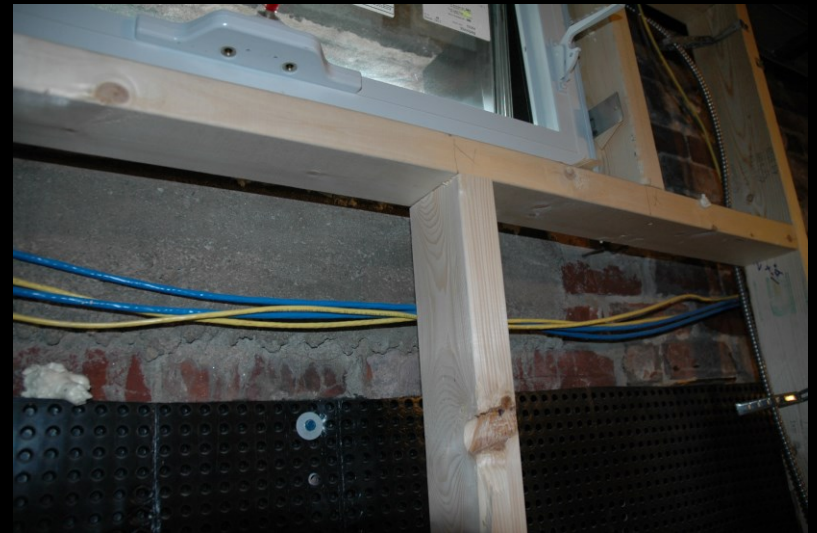
Gap between framing and exterior masonry wall to eliminate thermal bridging

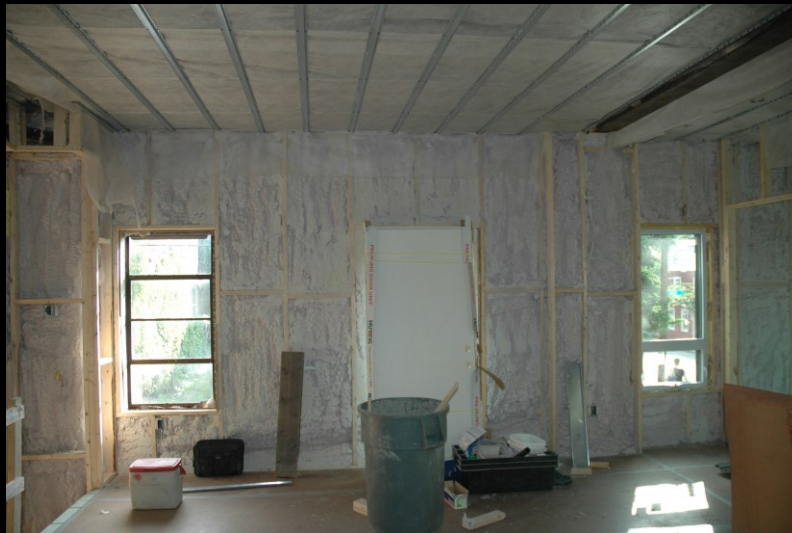
Foam insulation at exterior wall

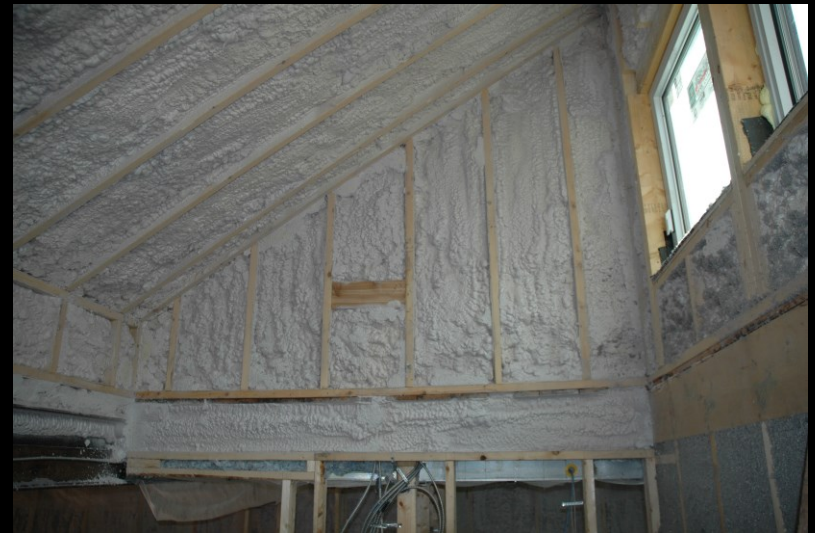
Foam insulation at roof monitor

- The high windows in the clerestory are only ten feet above the windows on the main level, but this is enough of a difference to create air flow for natural ventilation. These high windows deliver sufficient daylighting on all but the darkest days. A shade, which was planned but omitted for budget reasons, would have reduced solar gain in the summer.

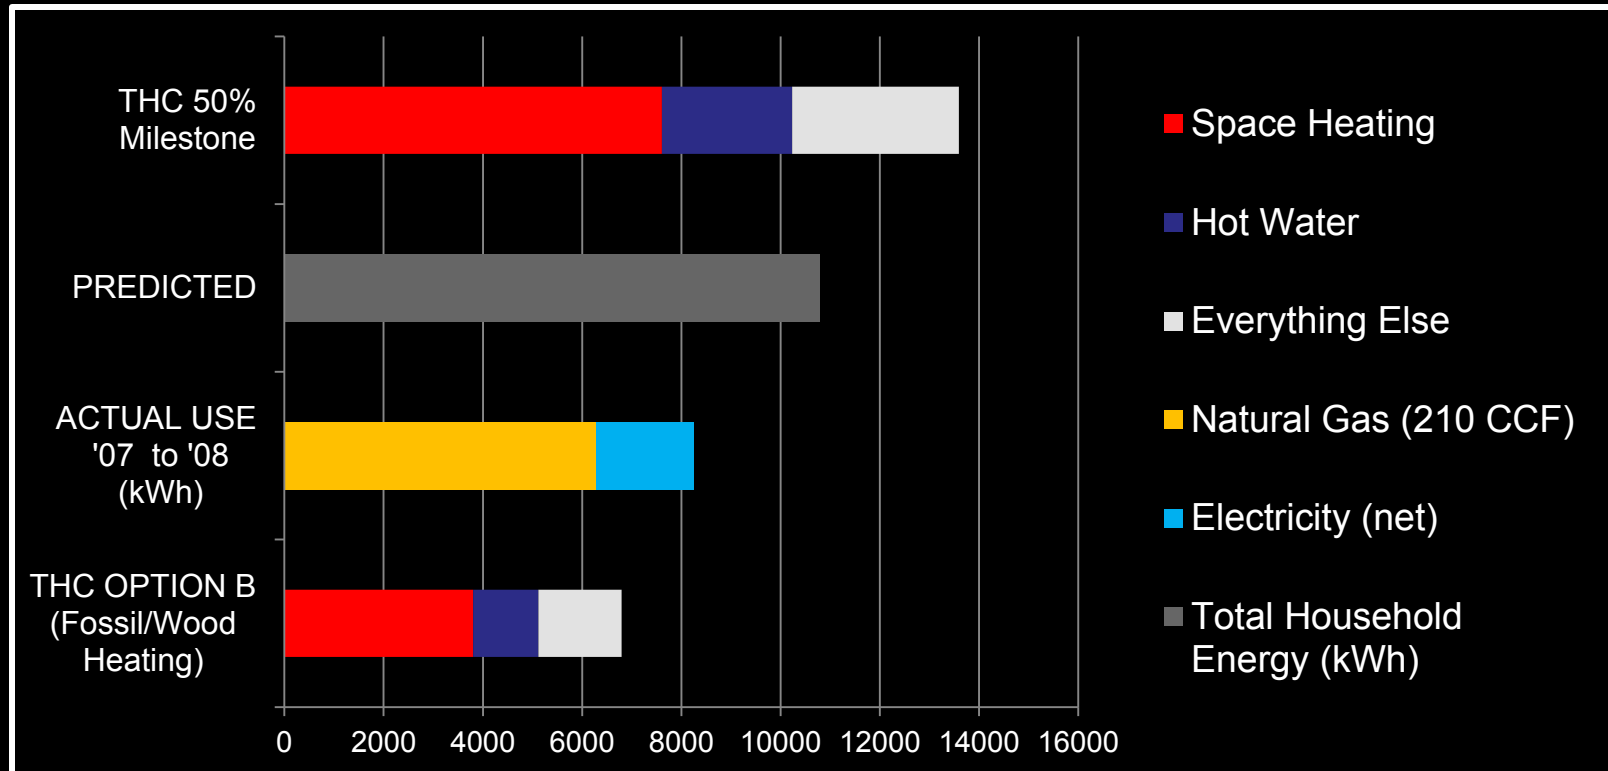
Comparing Predicted & Actual Post Use Against THC OPTION B Threshold & 50% Milestone (kWh)

This project does not quite meet the OPTION B 1000 Home Challenge threshold: 6,796 kWh/yr. (site energy).

OPTION B Inputs: ZIP code:04101; 2 occupants; 1,400 FFA; 45% common wall
