Deep Energy Retrofits
Ten California Case Studies

A thesis submitted in partial satisfaction of the
requirements for the degree of
Master of Science
in
Architecture
in the
Graduate Division
of the
University of California, Berkeley

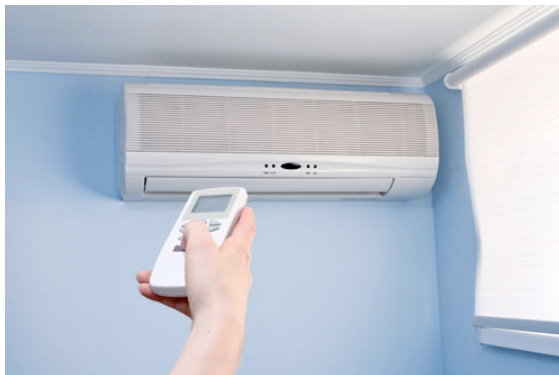
days to supplement the home's passive design and solar-assisted ERV. However, in the home's first heating season, this did not prove to be the case, as the mini-split heat pump was needed on a daily basis to maintain the homeowners desired comfort levels in the home. Unfortunately, further complications were encountered due to the placement of the mini-split wall unit, or head. The head is typically considered somewhat unattractive; see figure 40 below.

Figure 40 - Wall unit of mini-split heat pump. Source: www.drenergysavervirginia.com

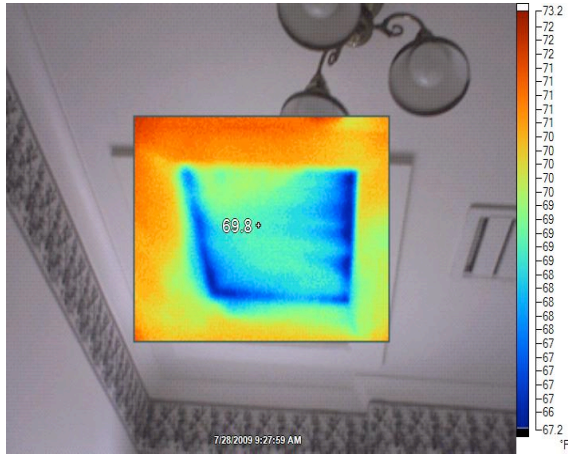
Figure 85 - P7 Pre-retrofit attic access door, very leaky
