**The first home of the
NorCal Collaborative (NCC)**

Ellen & George Beeler

Live/Work Building Rehabilitation

CASE STUDY

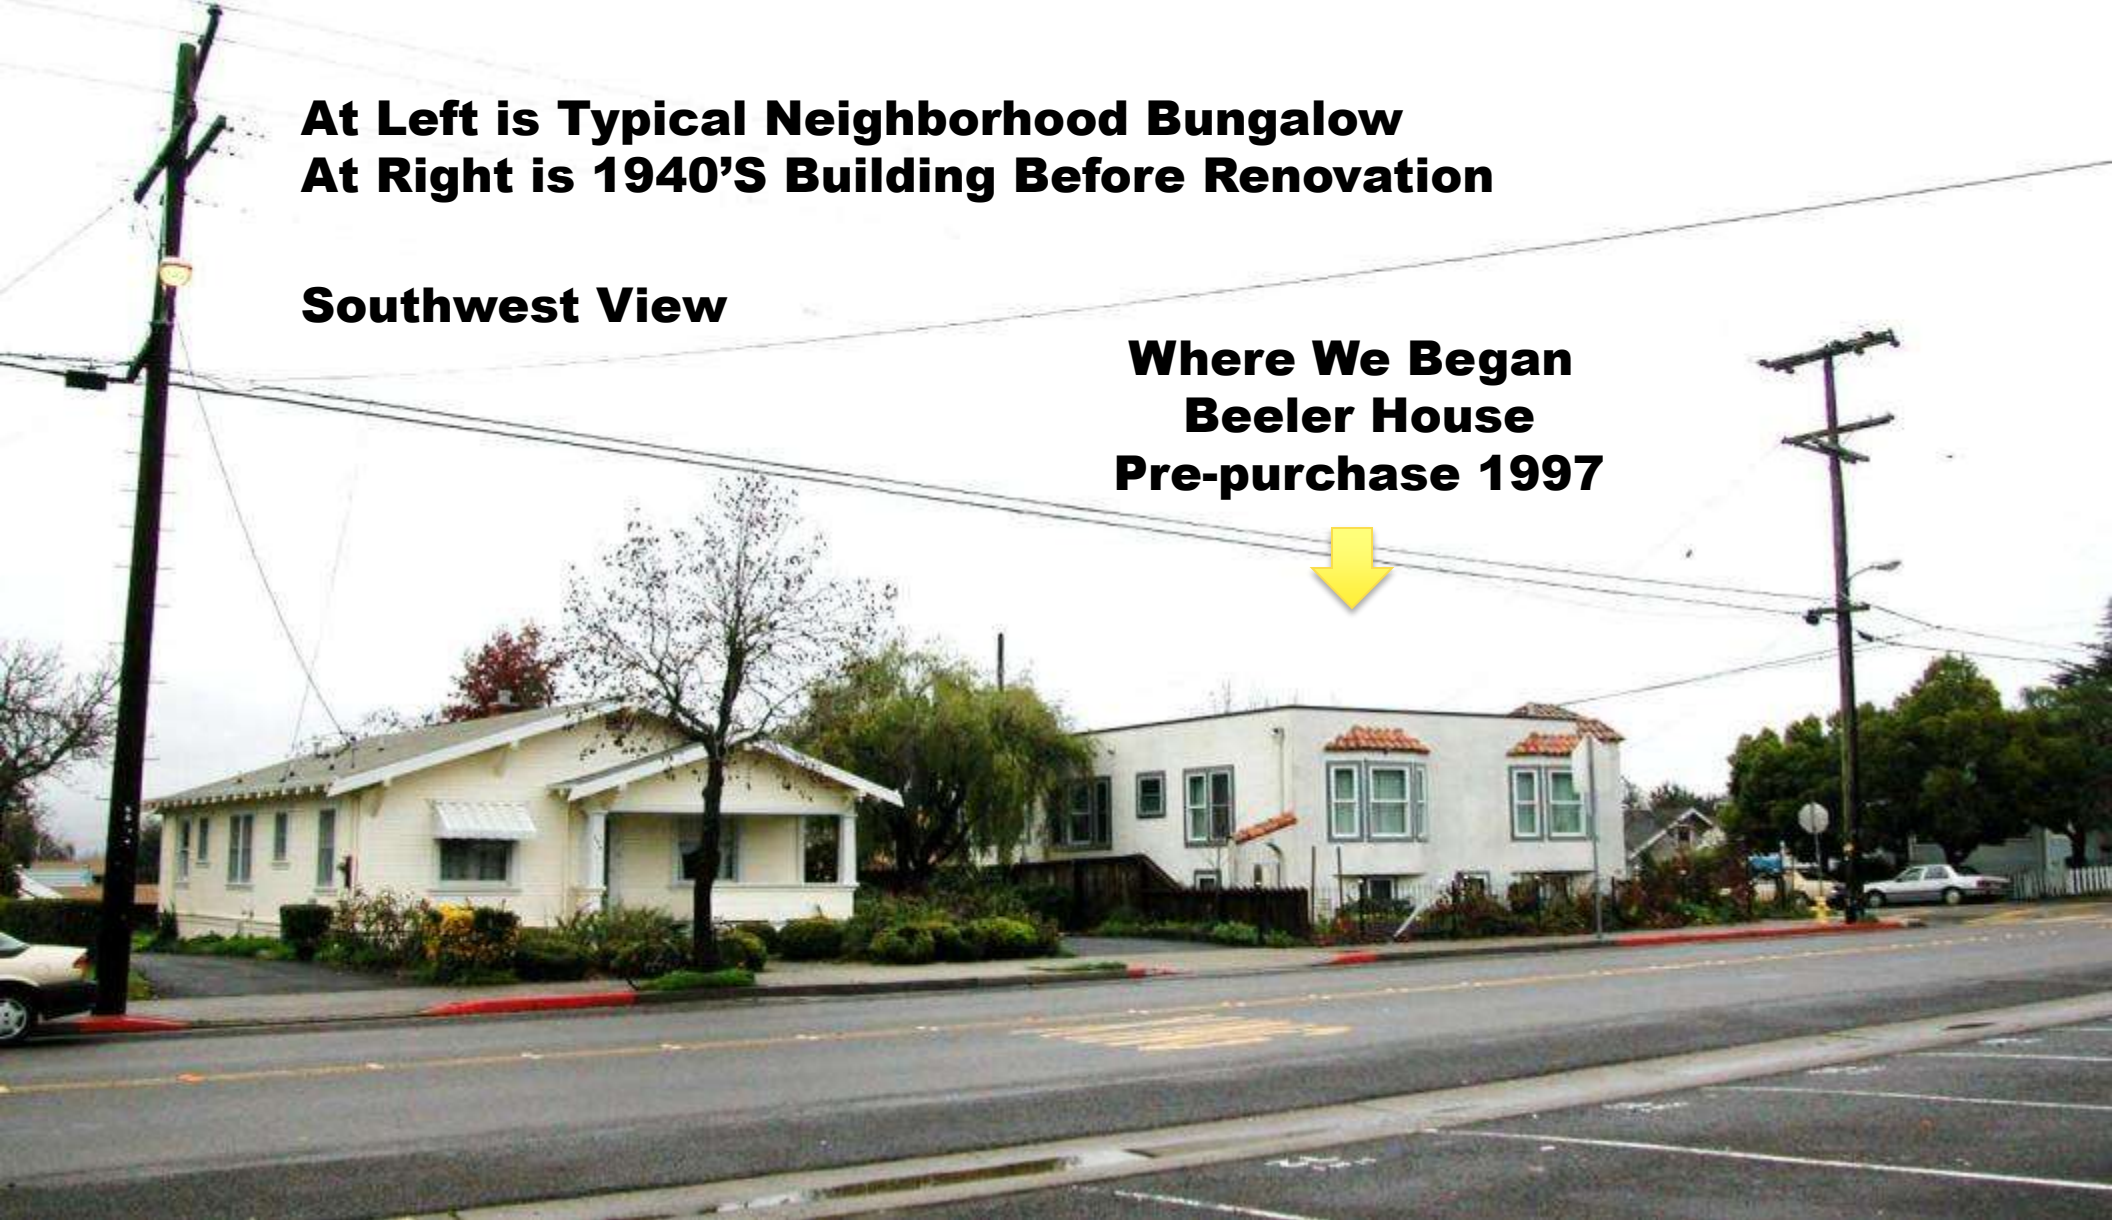
**At Left is Typical Neighborhood Bungalow
At Right is 1940'S Building Before Renovation**

**Where We Began
Beeler House
Pre-purchase 1997**

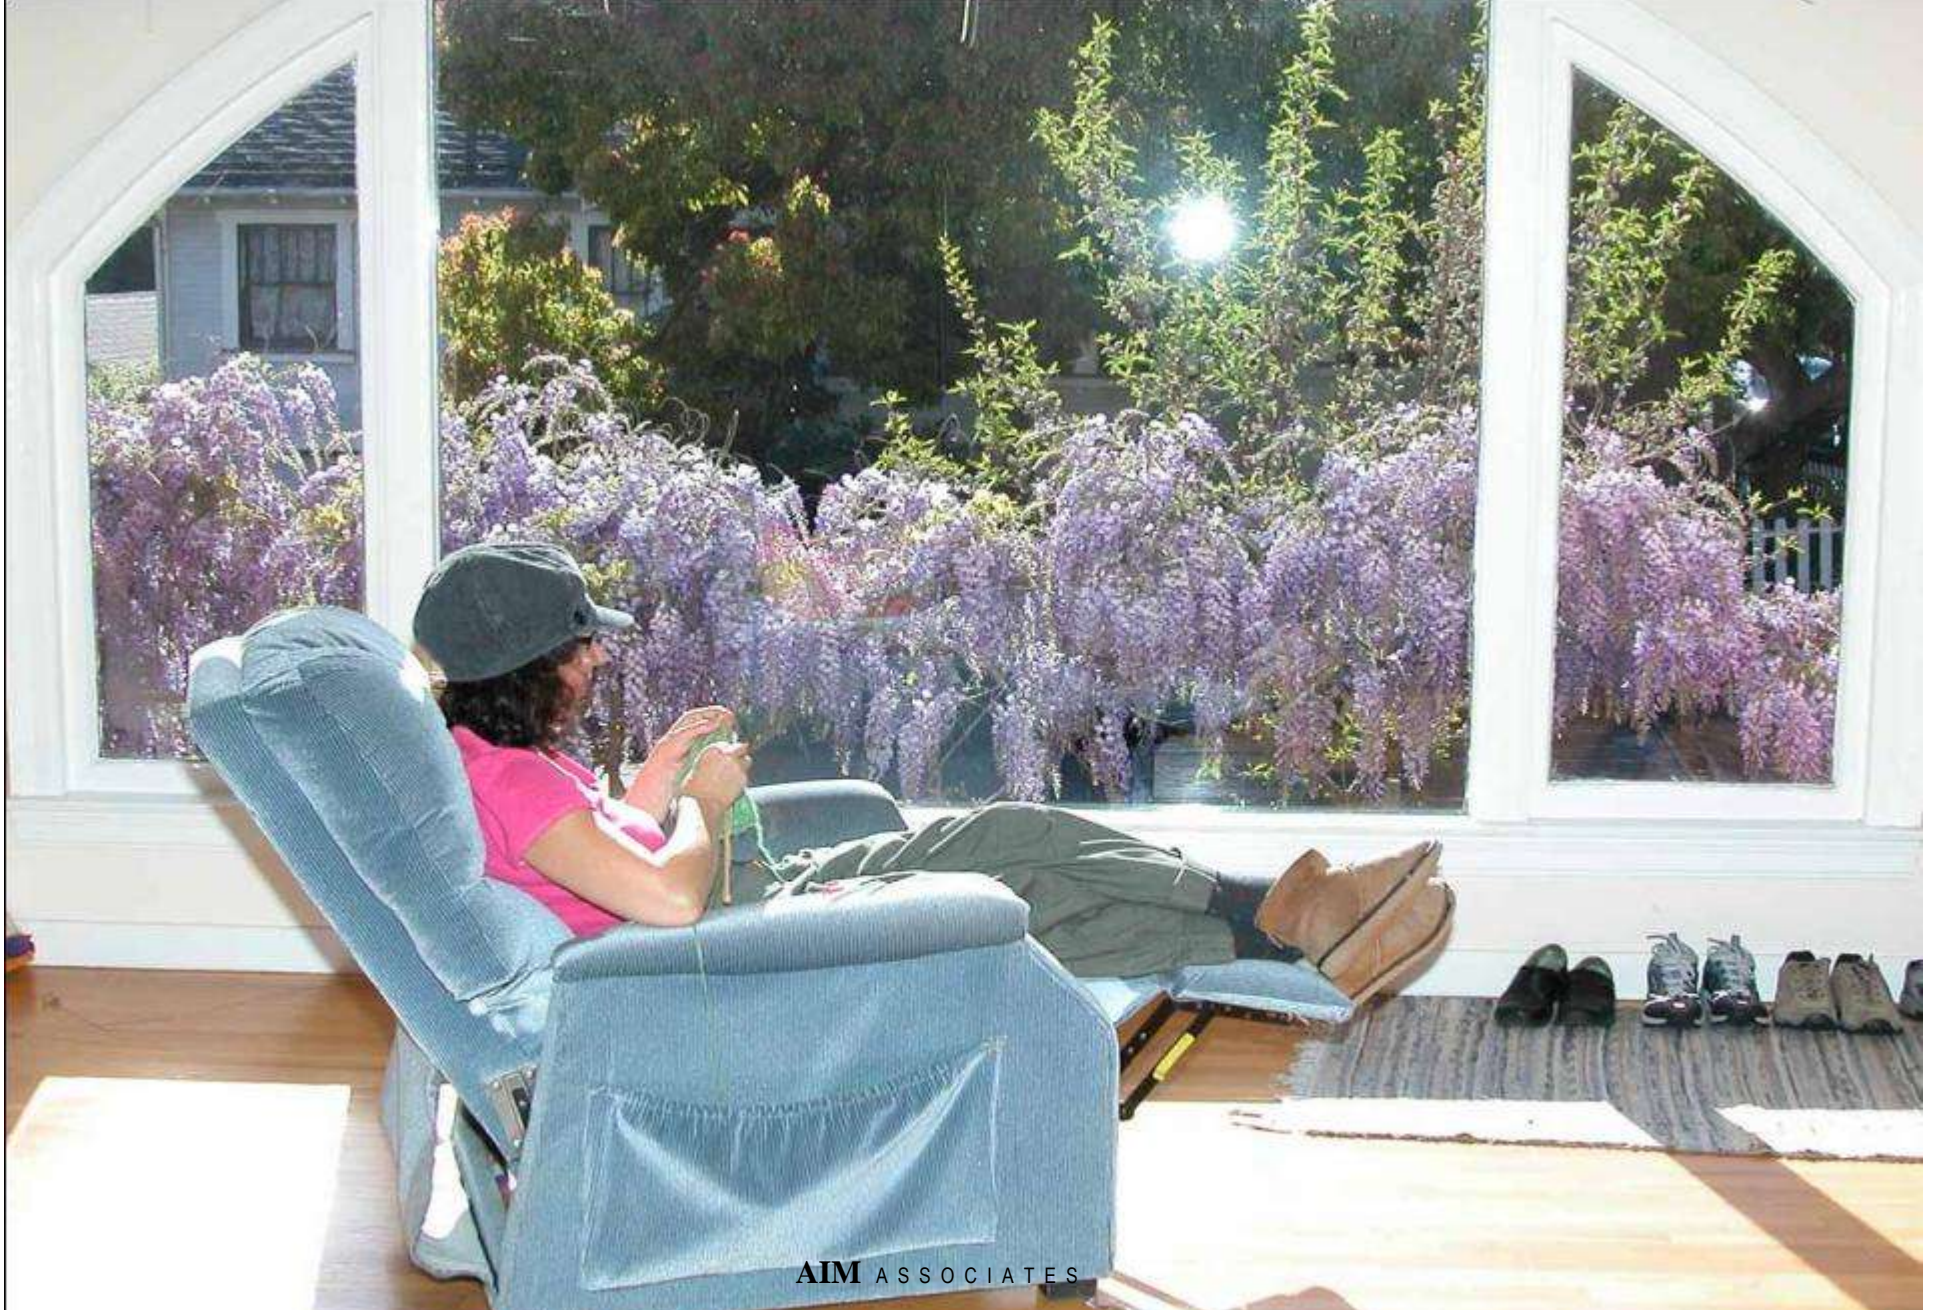
In the first phase, all existing windows were replaced with high-performance windows, except this living room window because it was too expensive (unusual shape). That is why the R-4, three-layer honeycomb interior shade is needed

However, it is difficult to keep cold air from flowing out from around the edges of the shade

Cable trellis was modified, so vines shade office glass door but do not shade living room window

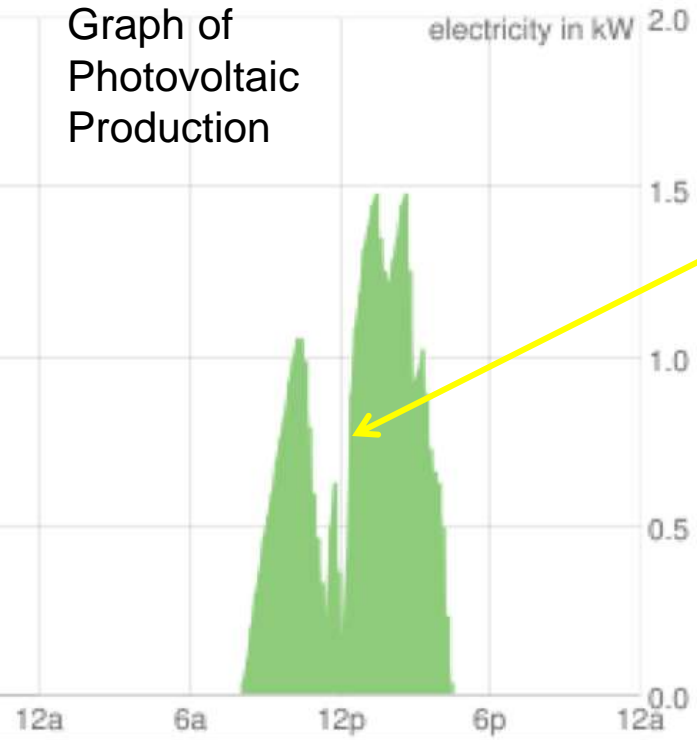
Graph of Photovoltaic Production

Shadow from utility pole reduces output from photovoltaic system more than expected as documented on graph by Google PowerMeter from electrical circuit monitoring by Jeremy Fisher & Brennan Less

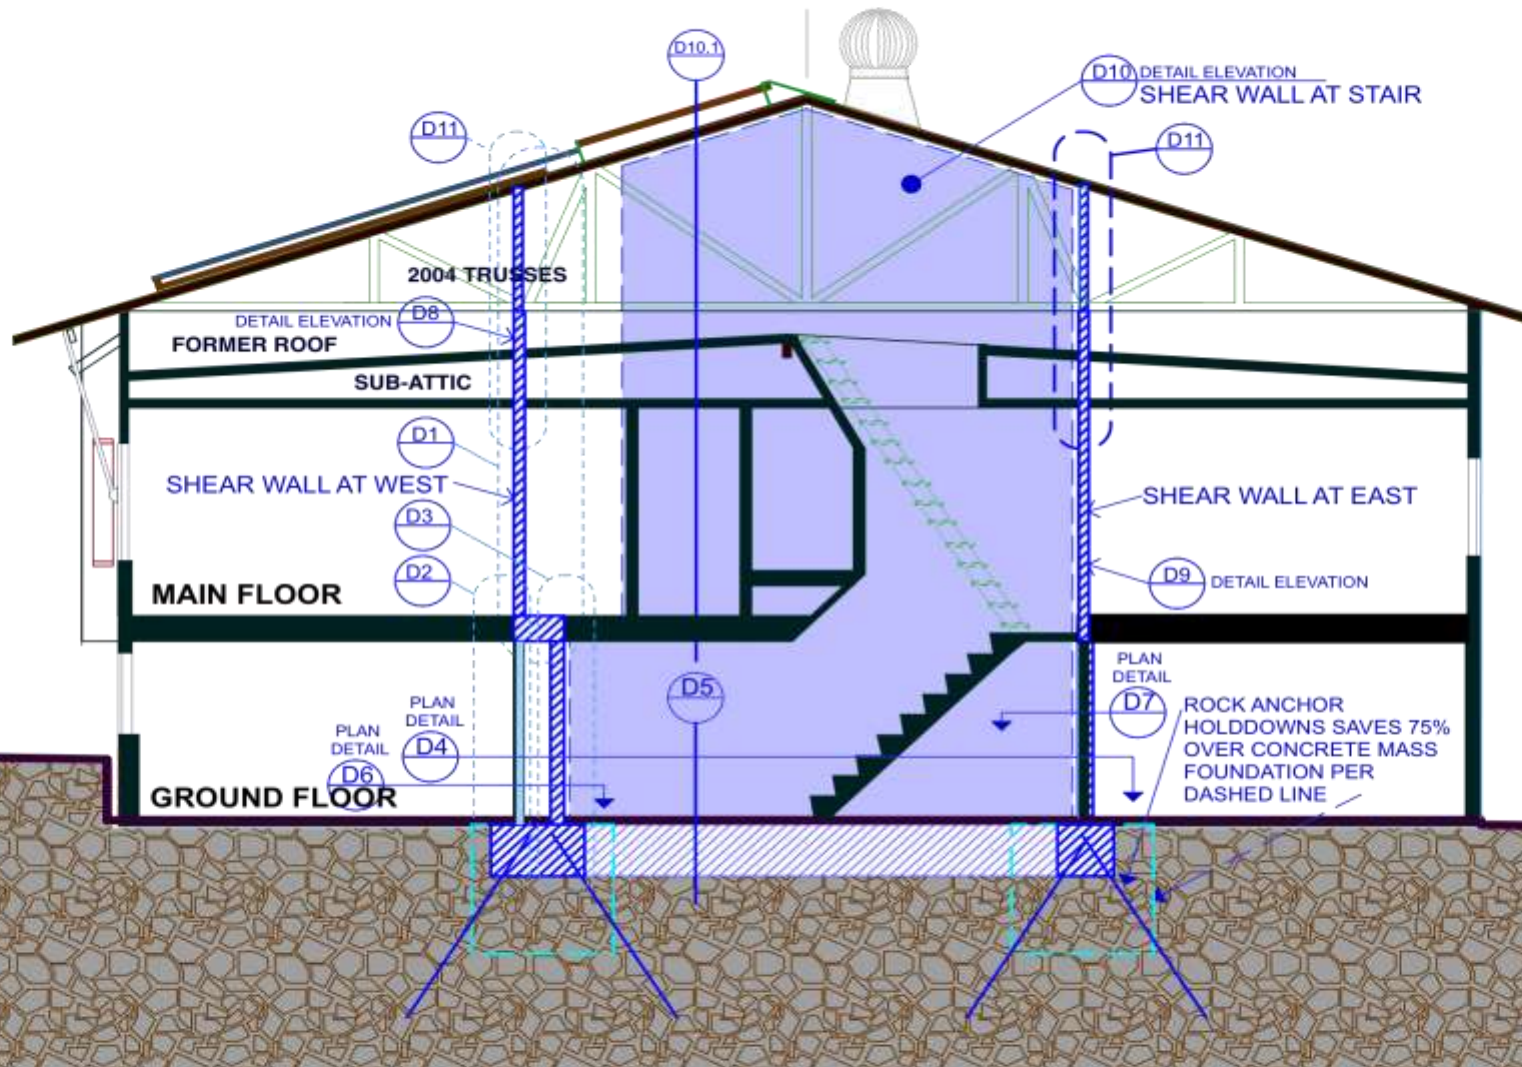
BUILDING SECTION

Strong, but short interior shear walls need massive holddowns. These typically require large concrete foundations whose weight will hold them down

The engineer agreed to use rock anchors to save concrete

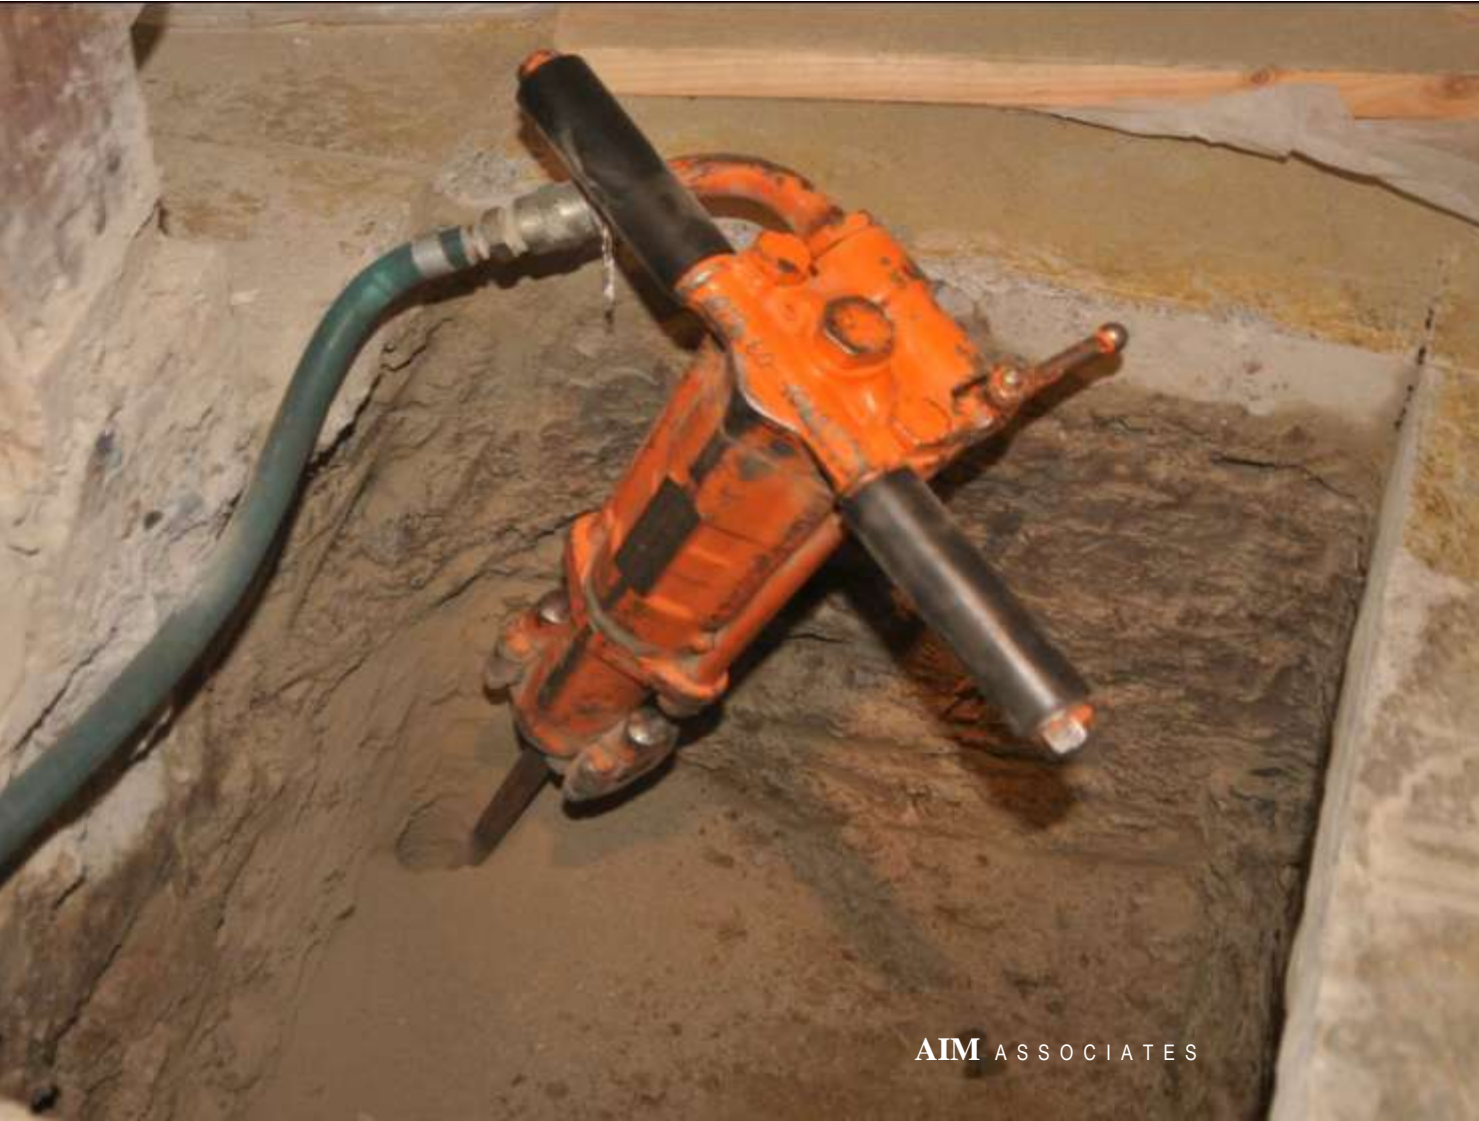
We tried this 3” diameter drill bit with a jackhammer

It took 1½ weeks to drill 12 holes

Kent Williams, concrete repair journeyman of Durling Concrete, determined that core drilling was the appropriate technique even with the clay veins

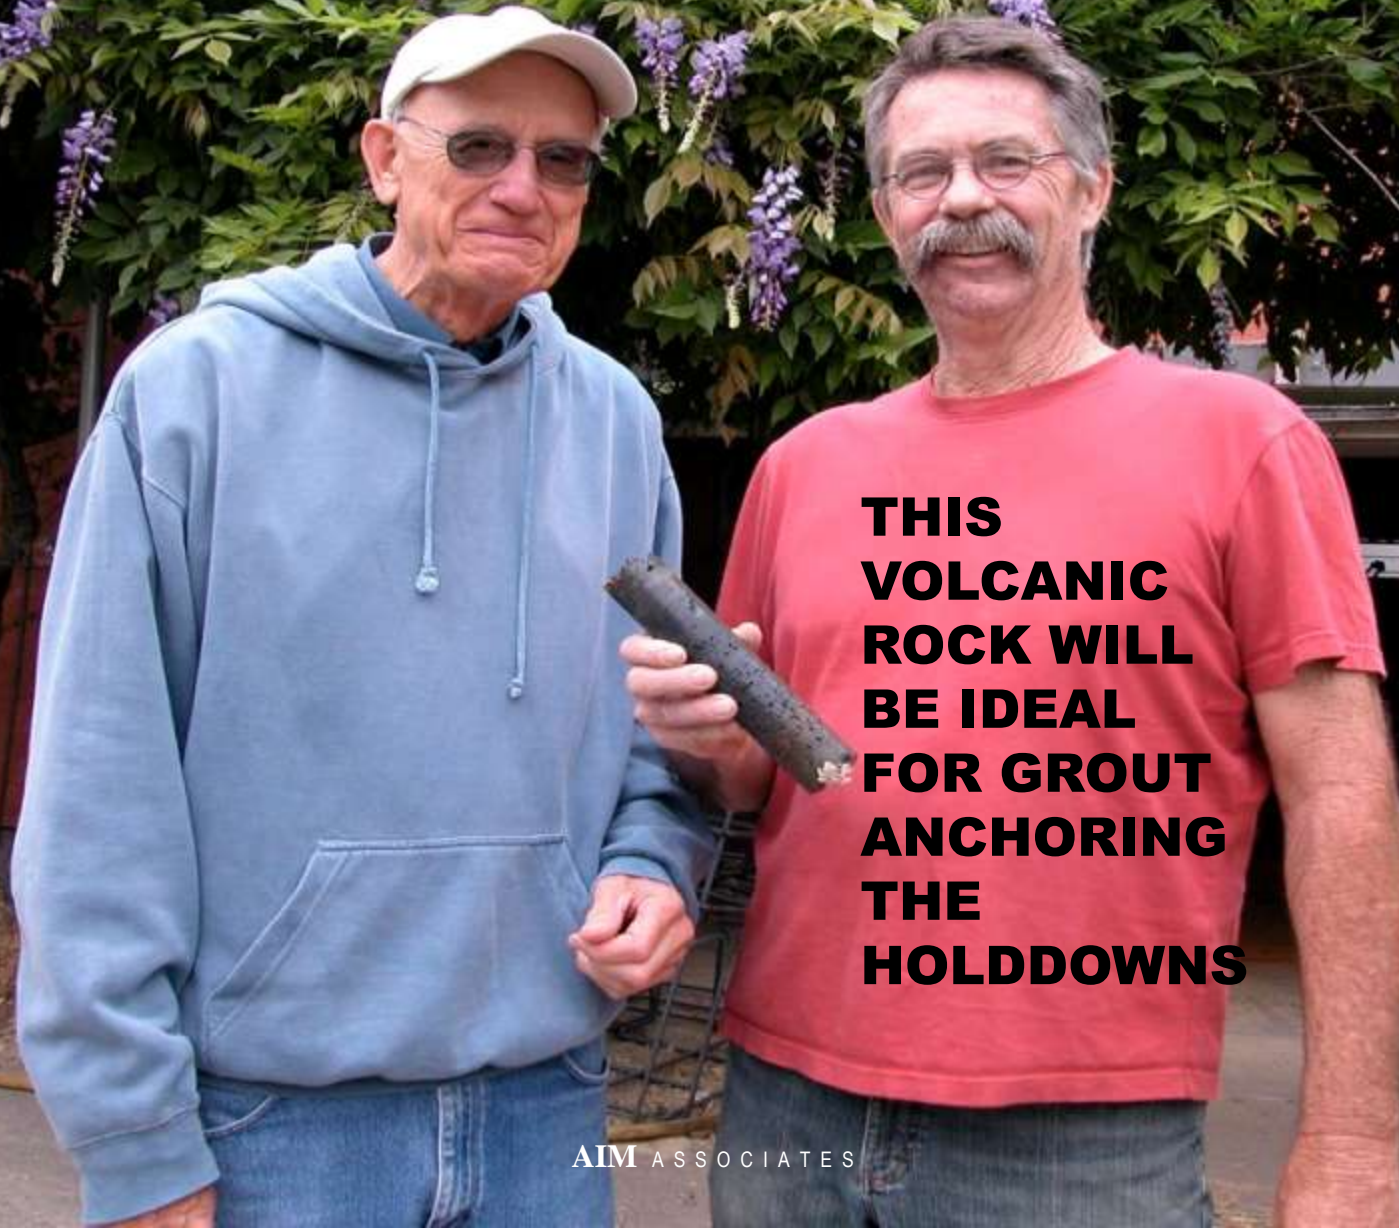
**THIS
VOLCANIC
ROCK WILL
BE IDEAL
FOR GROUT
ANCHORING
THE
HOLDDOWNS**

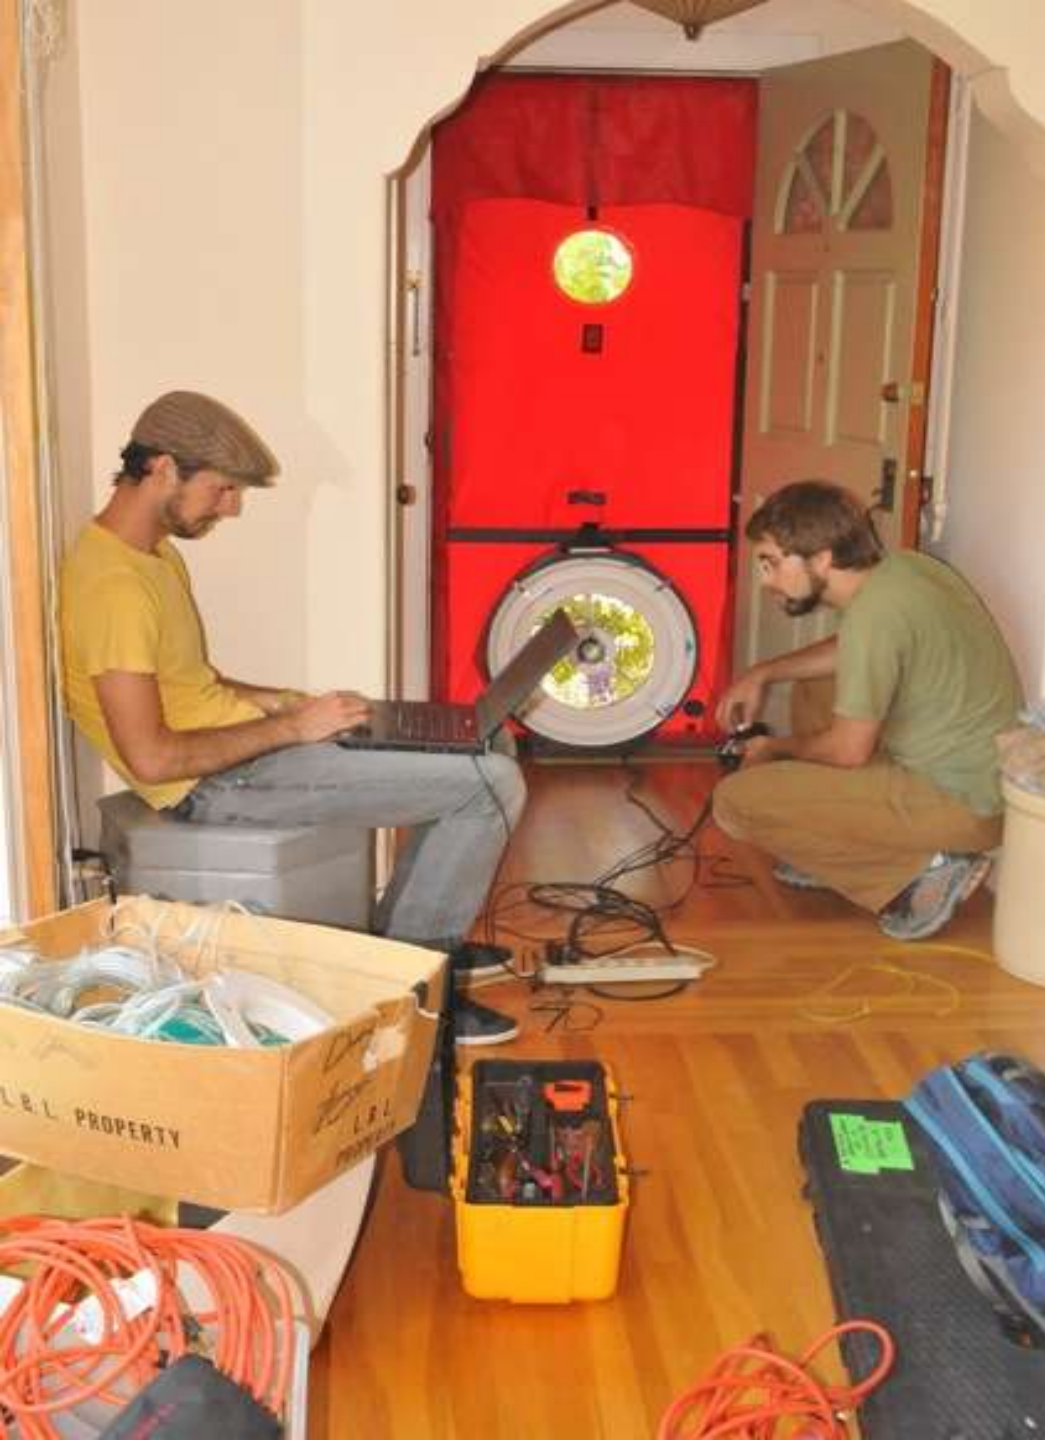
AFTER BLOWER DOOR TEST

A blower door test was performed after more sealing was completed & more attic insulation was installed

Jeremy Fisher & Brennan Less operate a blower door to test the combined air leakage of the ground & main floors
