MAJOR ENERGY CONSERVATION RETROFITS

A Planning Guide For Northern Climates

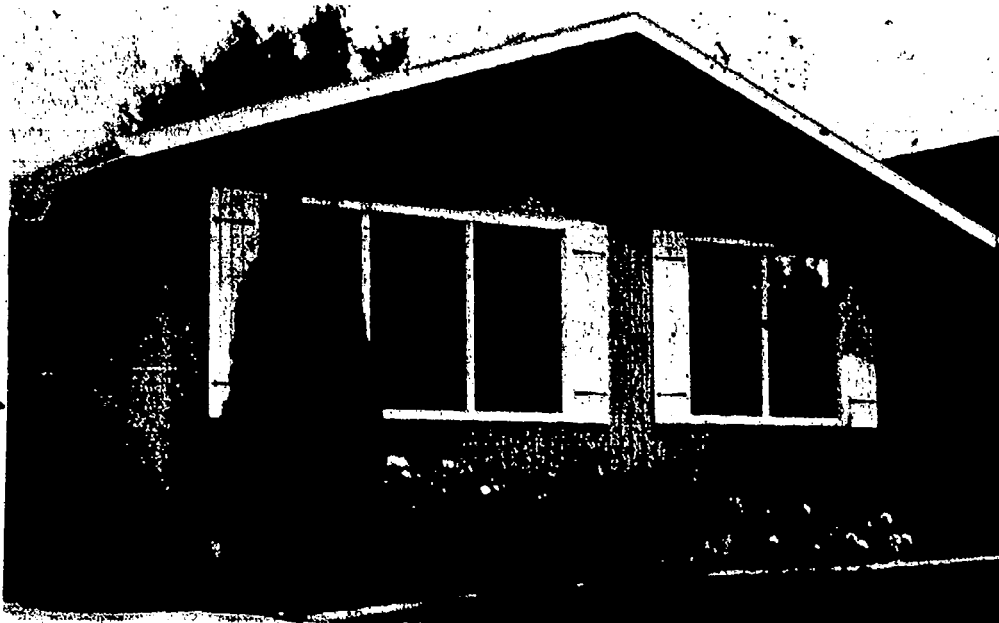
Before the Retrofit: R-8 walls Double glazing
R-15 ceilings Yearly electrical usage: 40,662 kWh
