Thousand Home Challenge, <u>Phased</u> <u>Retrofit</u> Cold Climate Sustainability₃₋₁₂₋₁₅ Case Study By: W. Turner & K. Turner (70%? Reduction)

Year-round home, 800 ft², 8-9,000 degree days

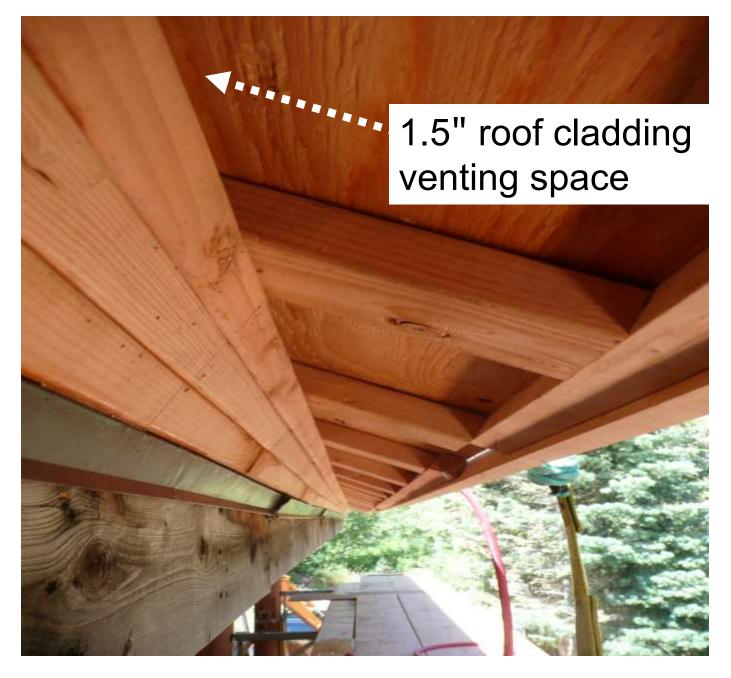
Existing ridge vent covered New ridge vent added

Plumbing vents to be extended

Type B gas vent reused to create an exhaust-only ventilation (EOV) system

Optimize Enclosure: 4.5" built-up rigid foam & vented roof cladding system

Rigid foam, all joints staggered & taped, "vented roof cladding"

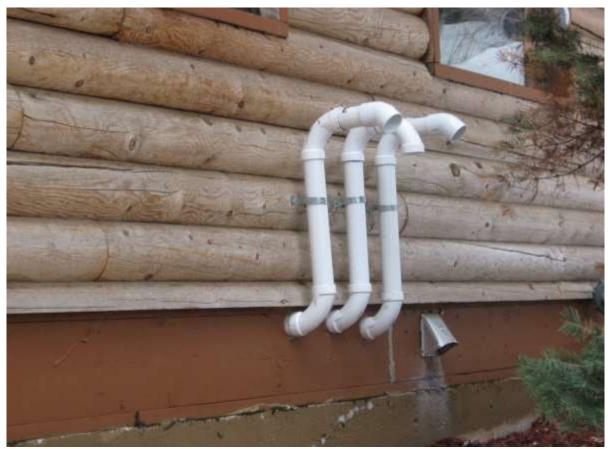
Combustion Safety:

Sealed combustion furnace, power vented hot water heater, currently no wood stove & some air leakage allows for exhaust only ventilation design

B Gas Flue Reused for Central Exhaust Only (EOV) Sealed combustion furnace & powered ex. hot water heater

"Central Exhaust" Radon-type 20 watt, inline duct exhaust fan

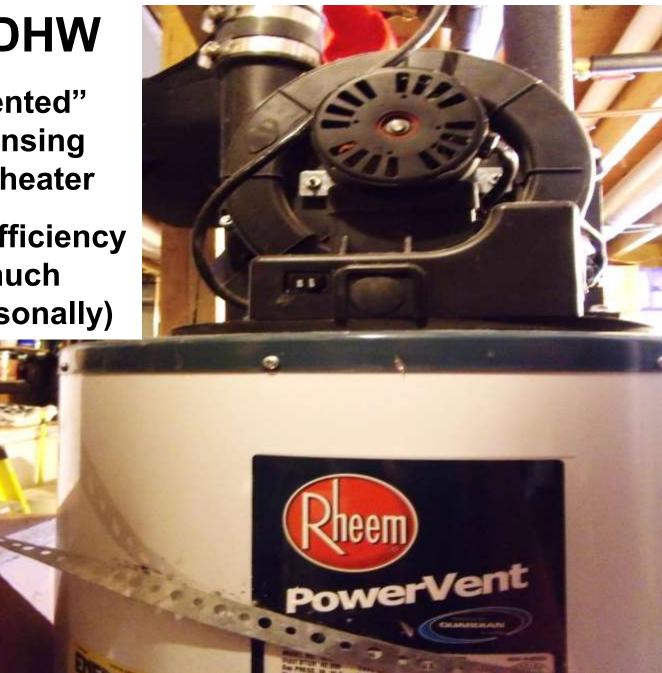
"Power vented" noncondensing hot water heater

65%??? efficiency (opps,...much lower seasonally)

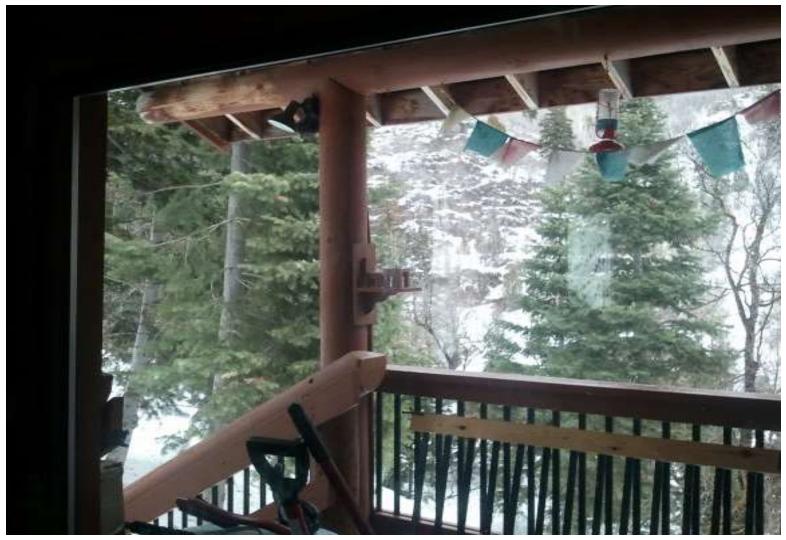
Interior *Thermolite* Glass Low E Storms on Fixed Windows U =.25 (2012)

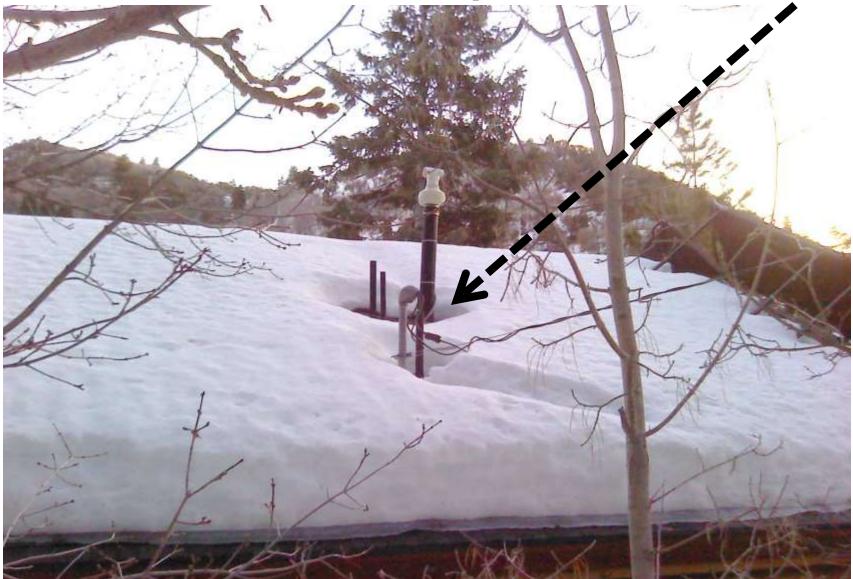
Also look at roof melt spot (not addressed yet)

Large transfer grills needed to relieve bathroom and bedroom pressures

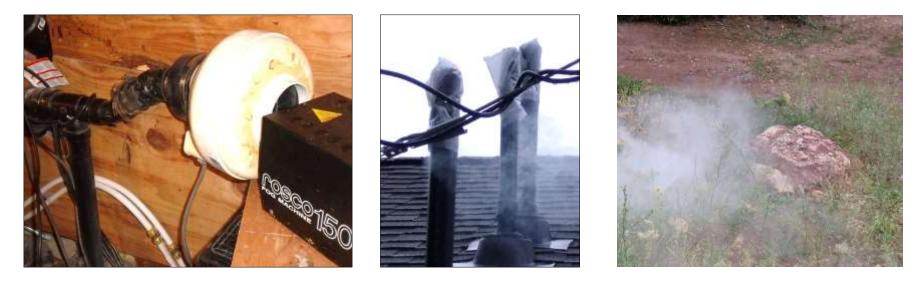
Obnoxious Smell: Diagnostics & Repairs Sewer Gas Smell: from Roof Vents? ...not
